## Aquatic Connectivity Through Climate-Ready Infrastructure

### Great Swamp Subwatershed Fact Sheet

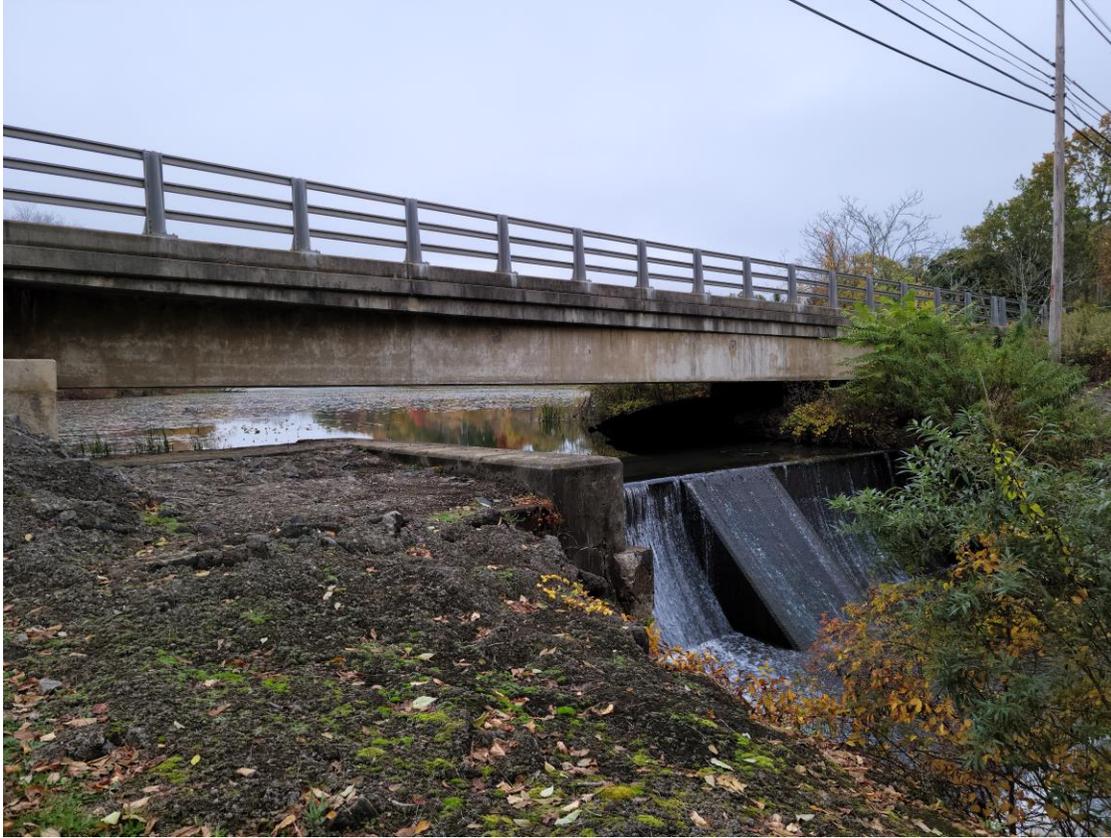
1. Osbourne Pond Dam – This is the first barrier on the Passaic River in the subwatershed and thus the most important for increasing anadromous fish habitat. Removing this barrier would open up ~1.5 miles of new habitat upstream. As the dam is unlikely to be removed, a fish passage could be considered.

1. Osborne Pond Dam – the first barrier to entering this watershed

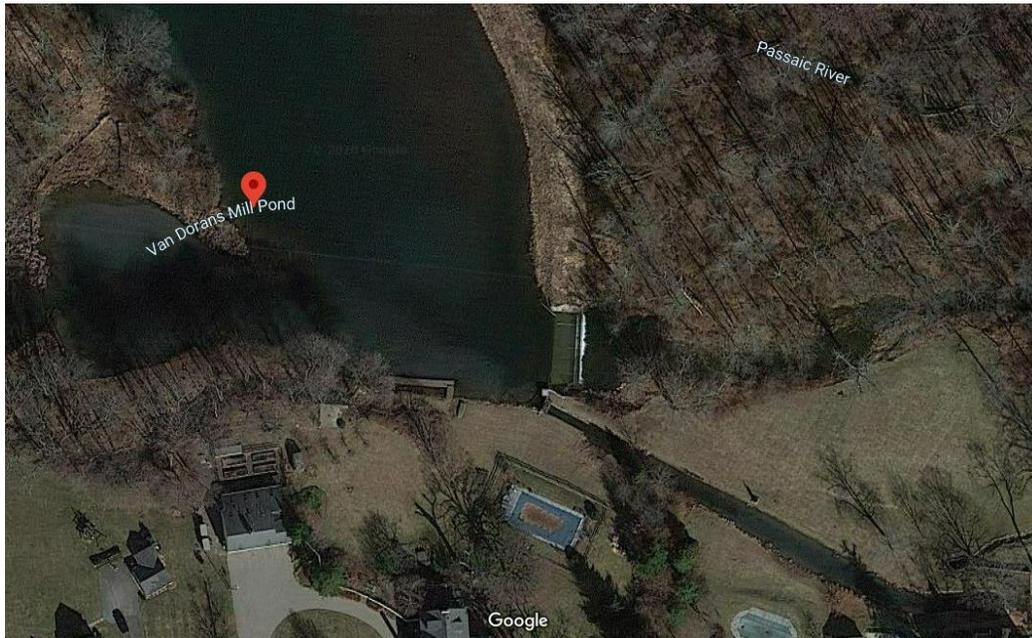
2. Van Dorans Mill Pond Dam – This is the most significant barrier in the watershed for the ability for potadromous fish to swim up and downstream. Removing this barrier would allow fish to swim along a 7-mile section of stream without major barrier. Restoration for this crossing could also include the creation of a side channel through adjacent wooded wetlands.

2. Google satellite image of Van Dorans Mill Pond Dam

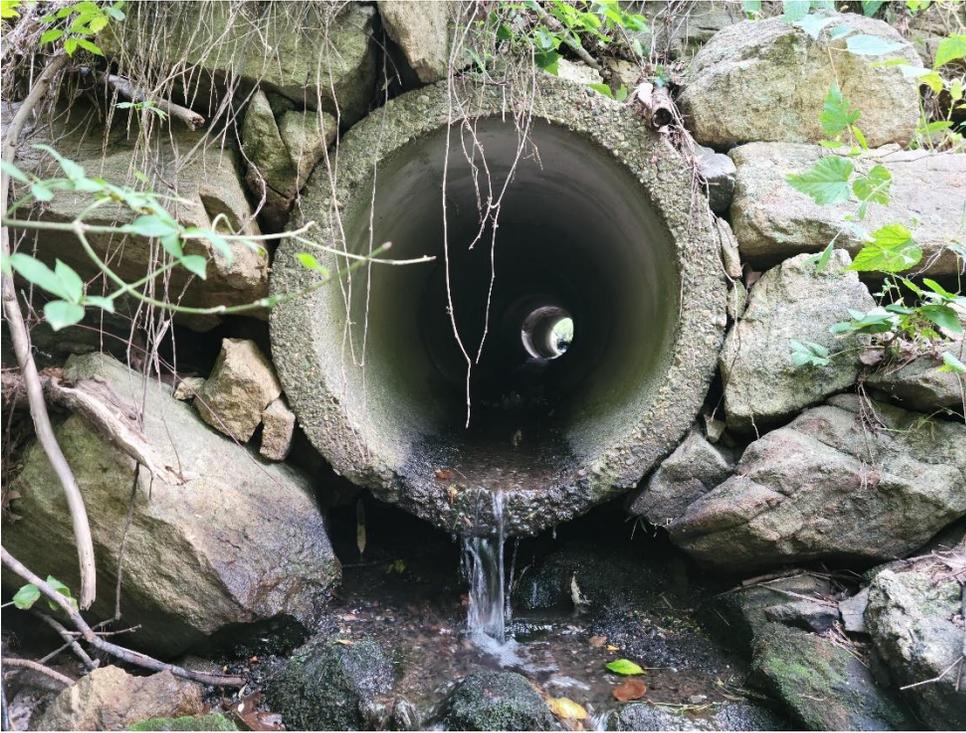
3. Indian Grave Tributary D1 – This tiny culvert is impassible to aquatic life because of an outlet drop. It is also in poor condition with a breakage in the middle that may lead to seepage under and around the pipe.

*3. Passaic tributary D1 outlet*

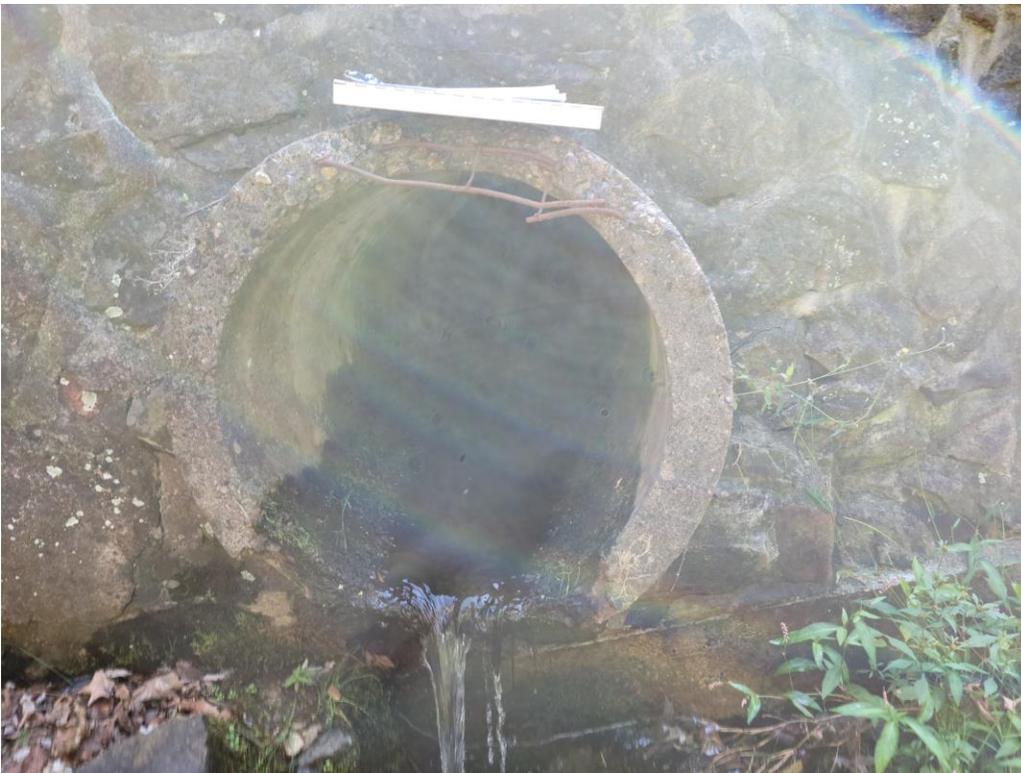
4. Indian Grave Brook 12.5 – This small culvert connects a small private pond to the main channel of Indian Grave Brook. This crossing scored poorly for both connectivity and can only accommodate a 1-year storm event, so may regularly flood the road. Ideally, this restoration would also address the nearby section of Indian Grave Brook where it runs directly adjacent to the road.

*4. Indian Grave Brook 12.5 outlet*

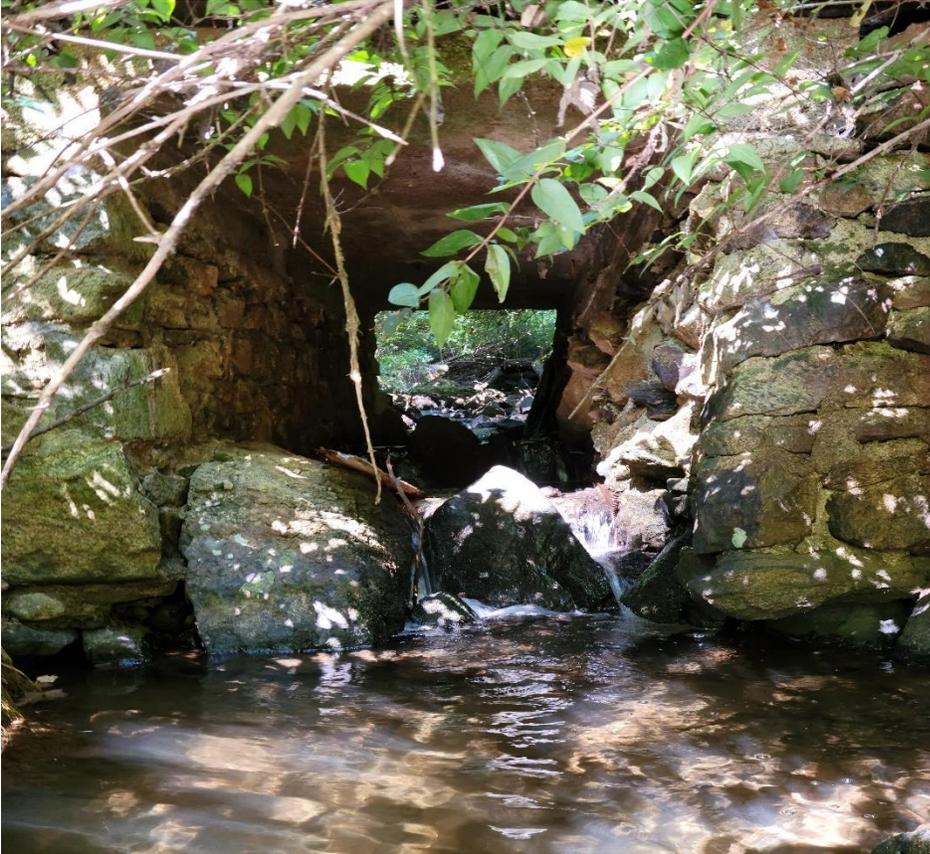
5. Indian Grave Tributary B4, B5, B1 - This is a series of three small crossings right next to each other; one of them on a road and two on private driveways. IGB4 is the most problematic because it can only accommodate a 5-year storm event and has a bad passability score. Restoring connectivity through IGB4 would open up nearly a mile of upstream habitat for aquatic life. Additionally, just upstream between IGB5 and IGB1 the stream bottom, including the crossings themselves, has been paved (concrete with cobbles), which is ecologically problematic in an otherwise nice stretch of stream.

5. IGB4 outlet

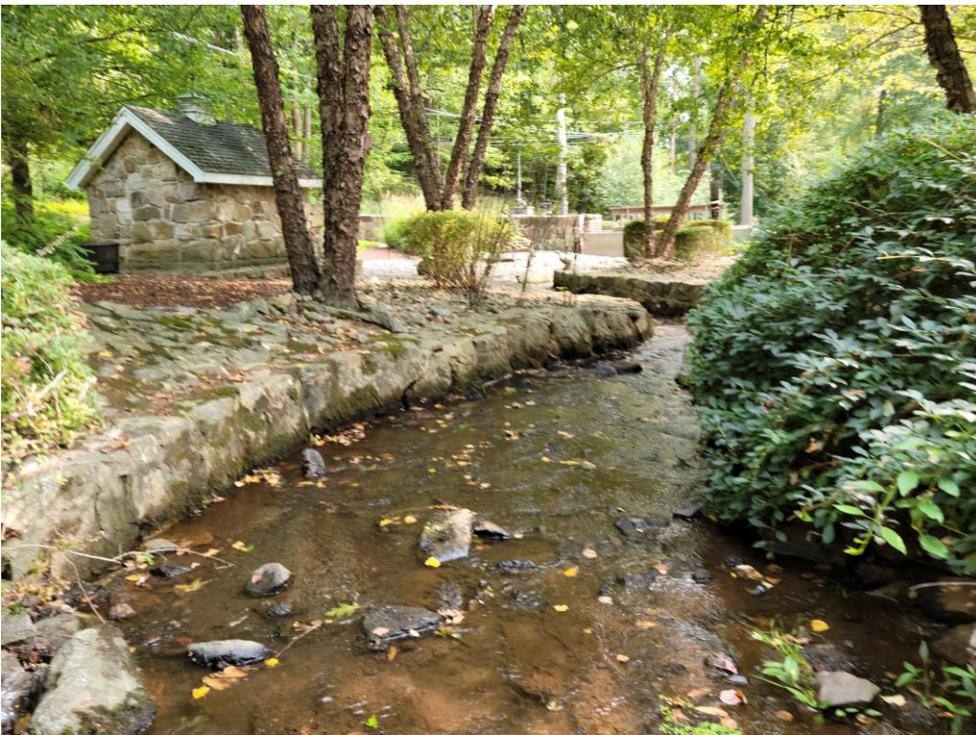
5. Artificial stream bottom between IGB5 and IGB1

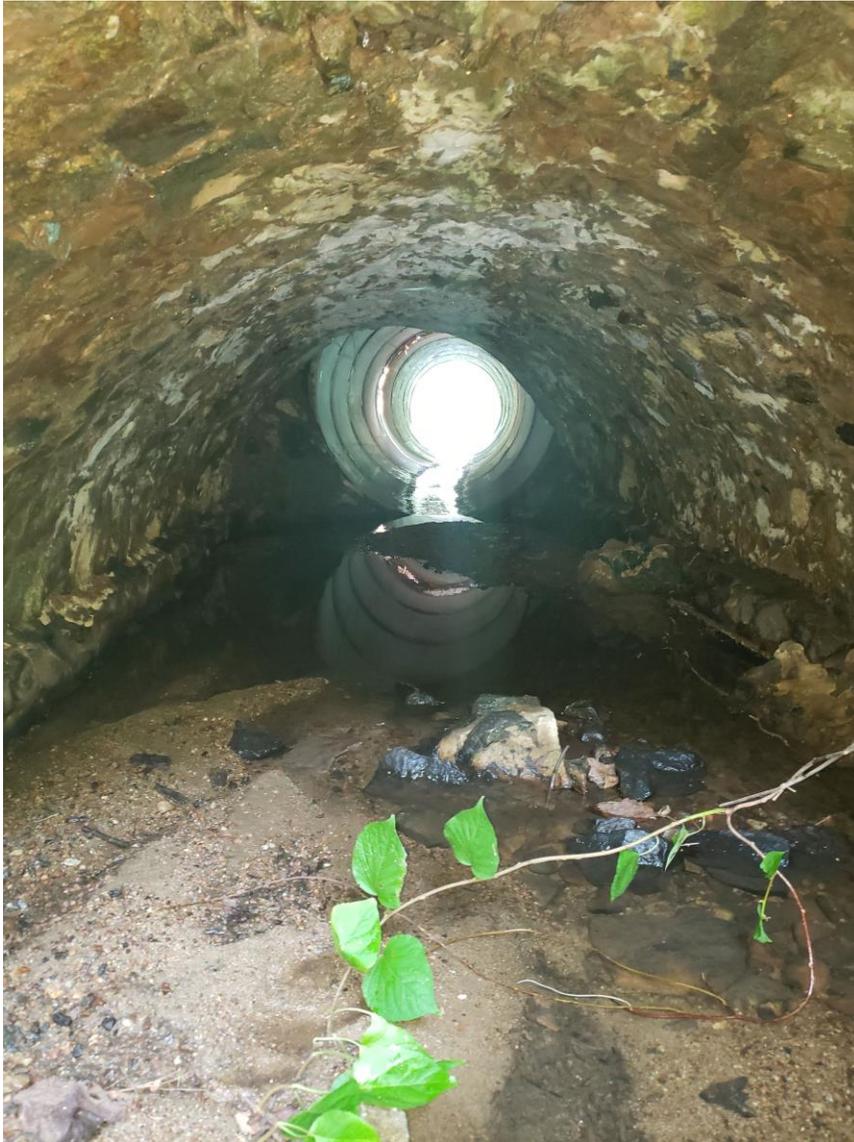
6. Childs Road Tributary 3 – This crossing includes an older-looking arch structure at the inlet that midway through the crossing changes to a round concrete culvert. The condition of the crossing is poor and there is a large drop at the outlet that completely cuts off all aquatic connectivity.

6. Inside of CR3 – you can see the change midway from stone arch to concrete culvert
