## Aquatic Connectivity Through Climate-Ready Infrastructure

### Passaic Subwatershed Fact Sheet

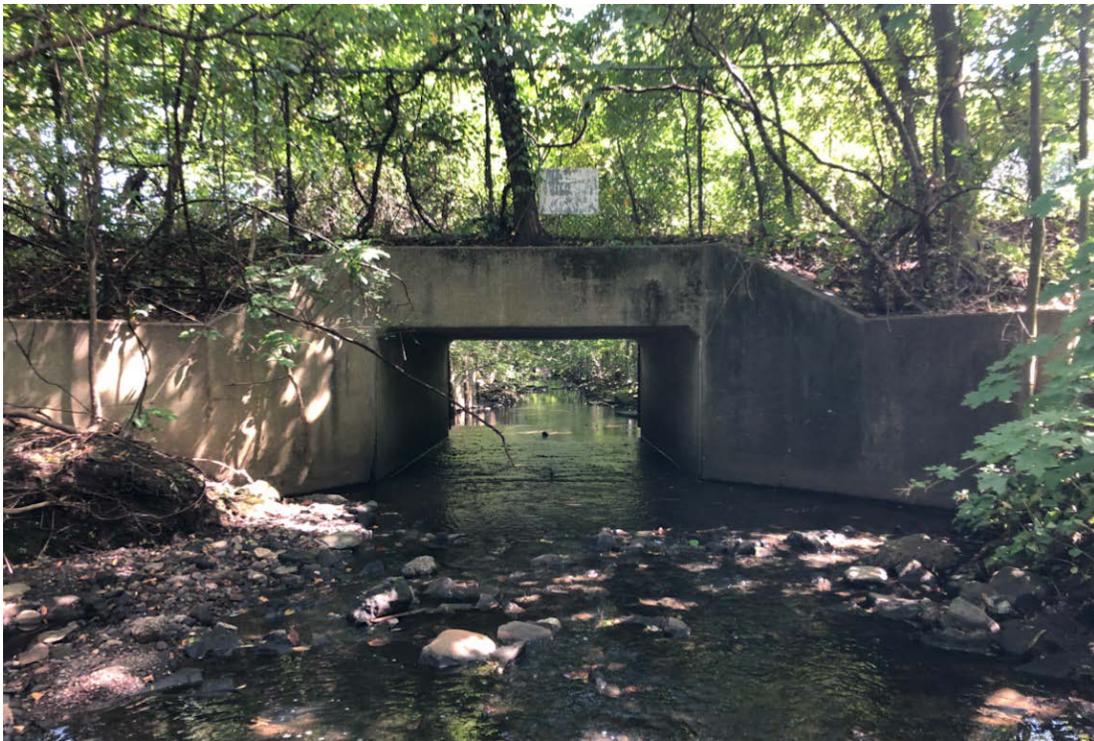
1 Weasel Brook 33a inlet

1. Weasel Brook 33a - Most important potadromous barrier, would open up over a half a mile of habitat. This crossing is superfluous, a historic bridge behind an apartment complex that is grown over and no longer in use. This may be a quick fix as the problem is only a small outlet drop.

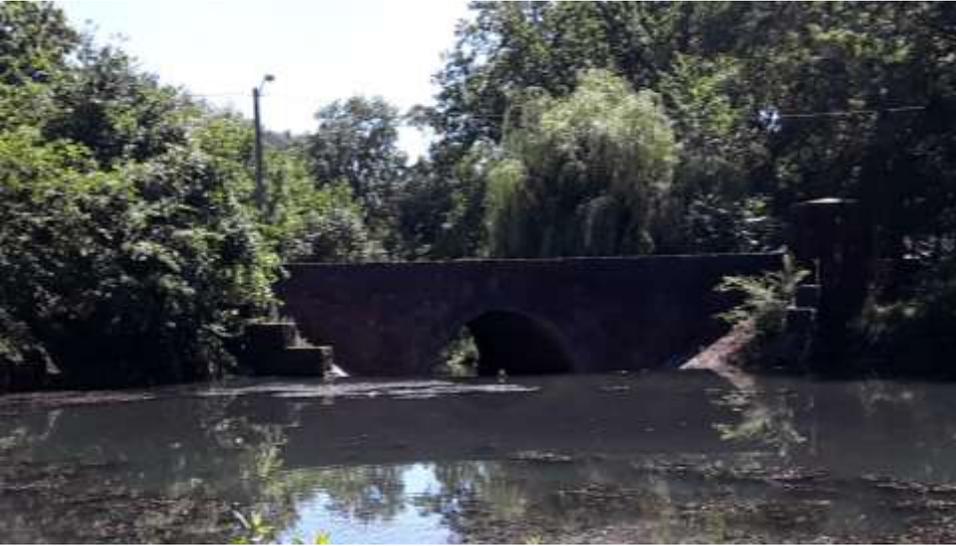
2. Weasel Brook 28 – This is the dam and crossing in the center of Weasel Brook Park. I witnessed a huge eel trapped below the dam, which means that eels are capable of traversing the 2.4 miles of largely concrete storm drains and spillways to get to this point. An eel ladder could be constructed in this Passaic County owned park, to continue the eel habitat.

*2 Weasel Brook 28 inlet - dam right at inlet*

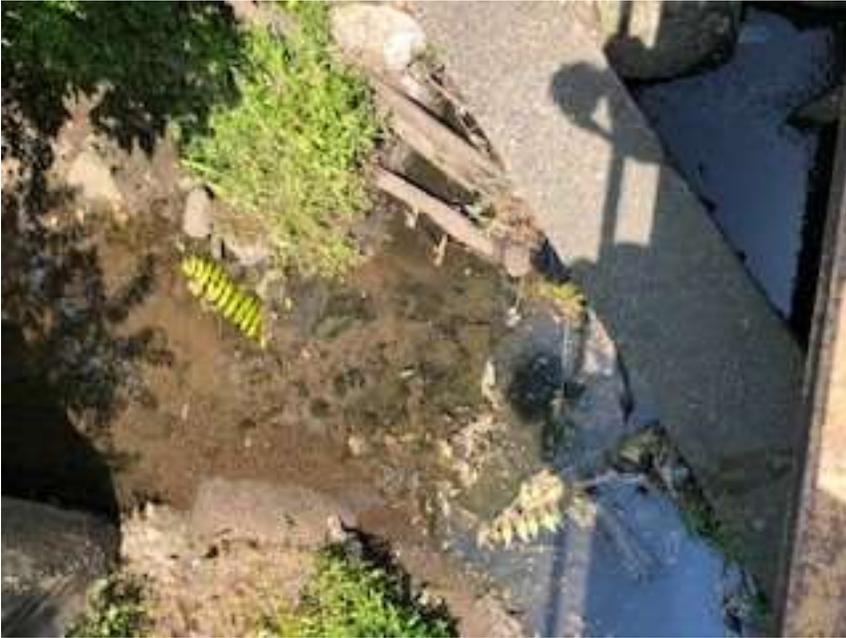
3. Fleischer Brook 4 – This pedestrian crossing would not be problematic except for a large piece of historic concrete infrastructure that blocks stream flow and aquatic connectivity below it. I do not see any purpose to this structure so it would probably be a quick fix.

*3 Fleischer Brook 4 - looking down on blocking structure from crossing*

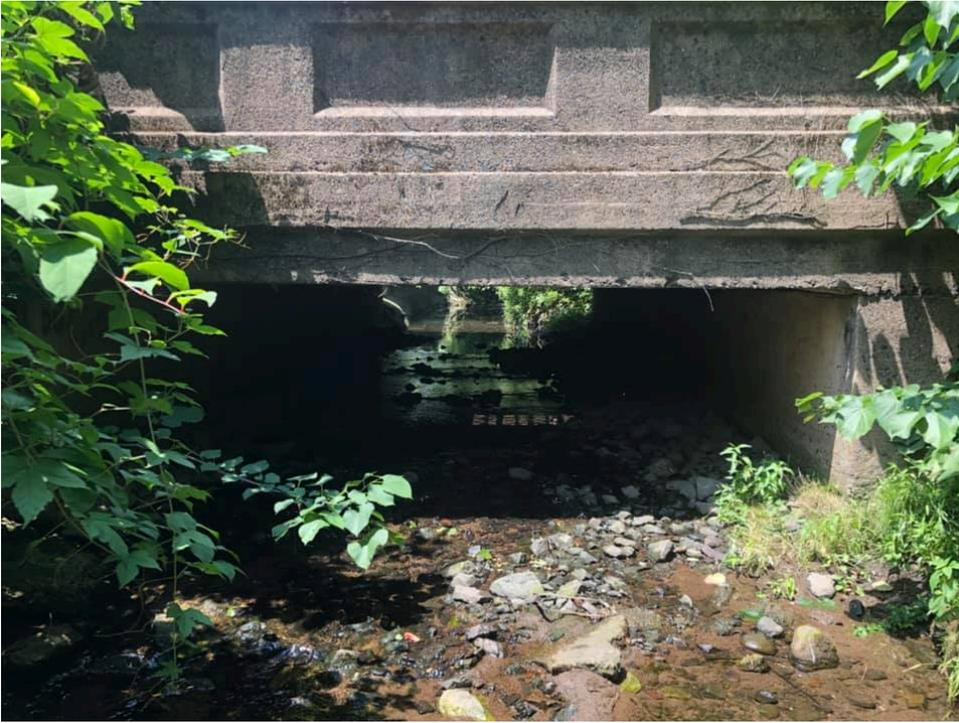
*4 Fleischer Brook 2 outlet*

4. Fleischer Brook 2 and 3 – small bridges that can only accommodate a 1-year storm event and could be replaced with connectivity-friendly new bridges.

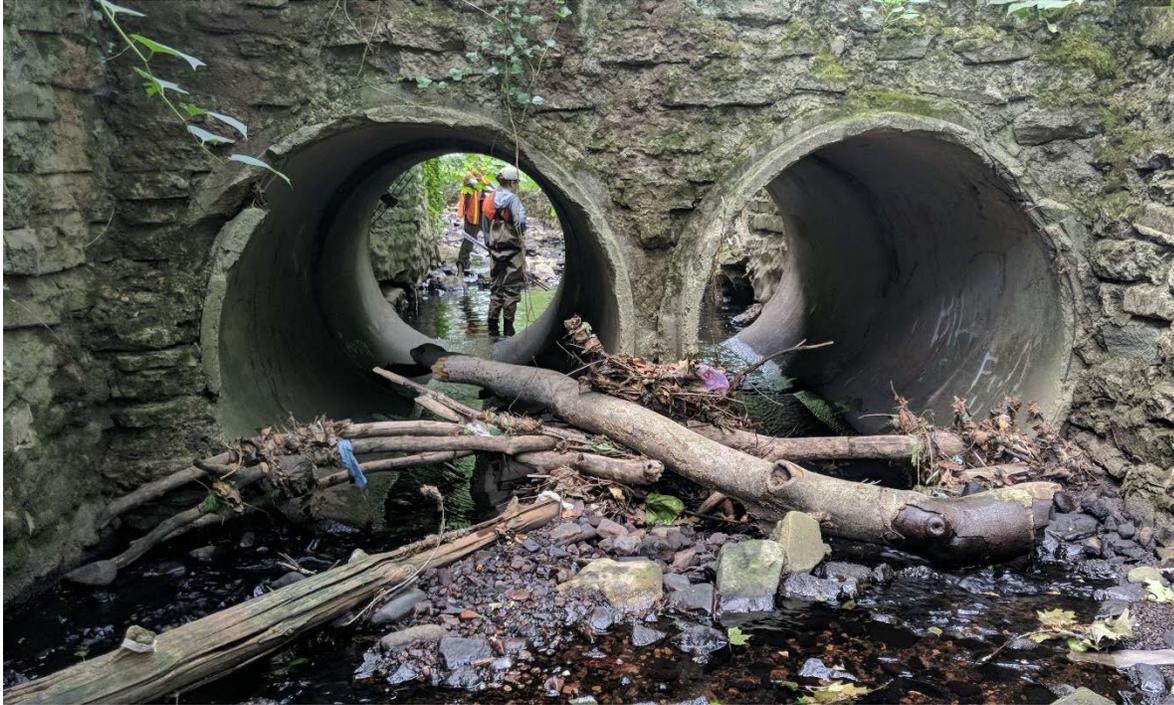
*5 Weasel Brook 42A inlet*

5. Weasel Brook 42a and 42b – these are historic crossing structures in Ravine Park that are no longer in use and could be removed.
