Aquatic Connectivity Through Climate-Ready Infrastructure

Barclay Brook Subwatershed

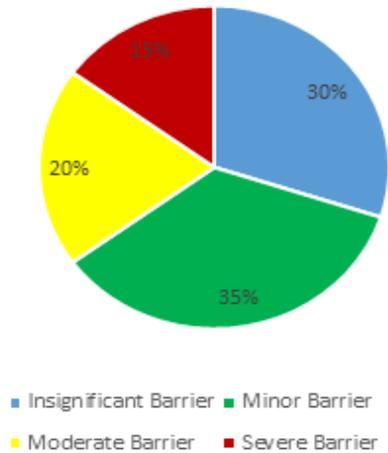
Aquatic Connectivity Results

The Barclay subwatershed is highly dendritic (forking) leading to a good overall connectivity score. The watershed, uniquely, has many minor and moderate barriers. Those two categories tend to lead to good candidates for restoration projects as they are problematic but sometimes can be more feasible than, for example, a part of stream that is buried (a severe barrier).

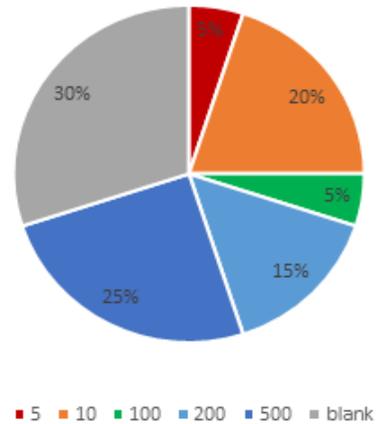
Capacity Model Results

Hydraulic Capacity in this subwatershed was variable with a good portion that are adequately sized (>100). The crossings listed as blank could not be modeled; half were too large to be modeled (likely no capacity issues) and half buried or collapsed (likely capacity issues).

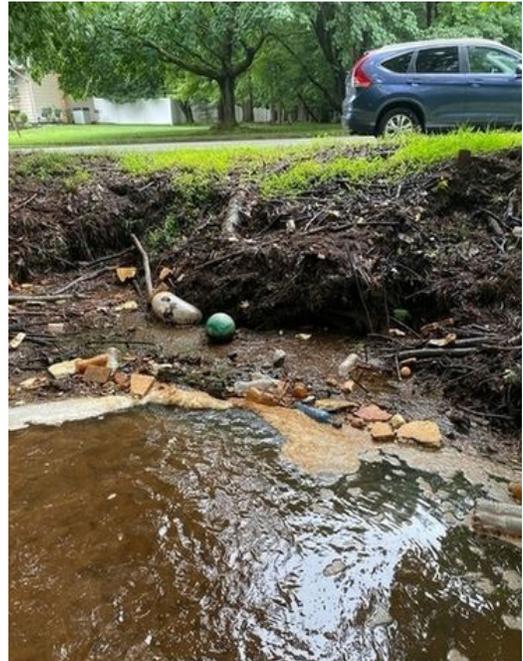
1. Barclay Brook 2 (BB2) is a clogged, submerged, and undersized culvert that is also blocking migration for potadromous fish. Due to these features, the outlet is a collection point for large woody debris and garbage, and the bank is greatly eroding.

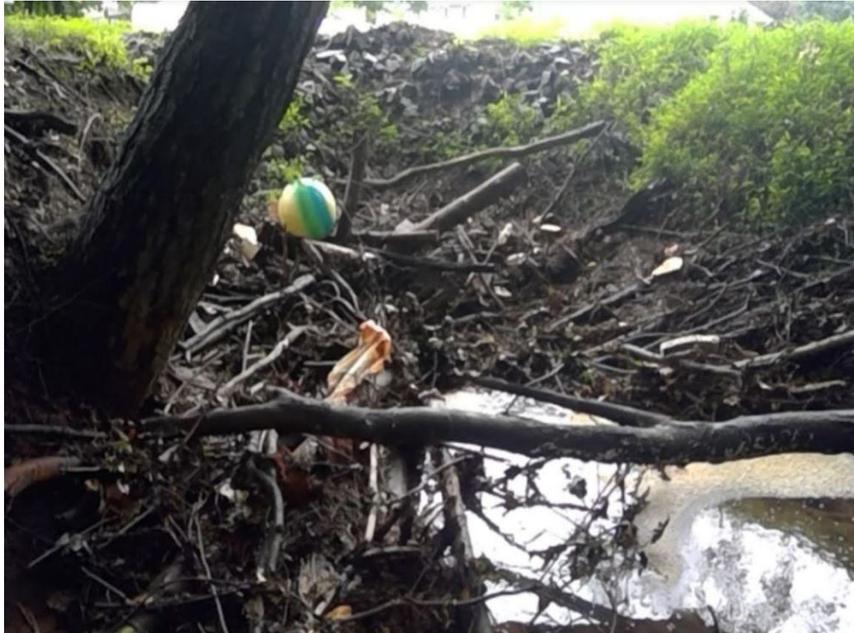
2. Barclay Brook 3 (BB3) is just upstream of BB2 and in similar condition. The crossing is undersized and nearly completely blocked by debris, and the metal culvert itself is misshapen. There is evidence of some stopgap erosion control measures on the bank in the form of large construction cobbles placed on the roadside leading down to the culvert top.

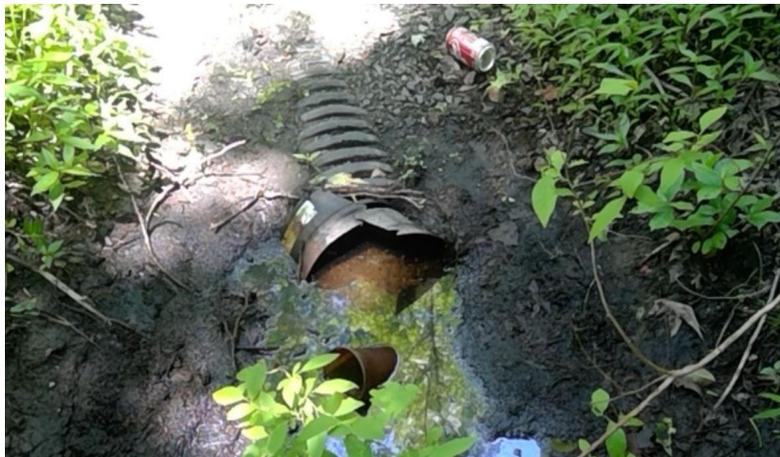
3. Barclay Brook Tributary B3 (BBBT3) is a small culvert that is completely filled in, allowing for no flow. The culvert is nearly at road-height, which likely leads to frequent flooding events. This culvert may need maintenance or replacement.

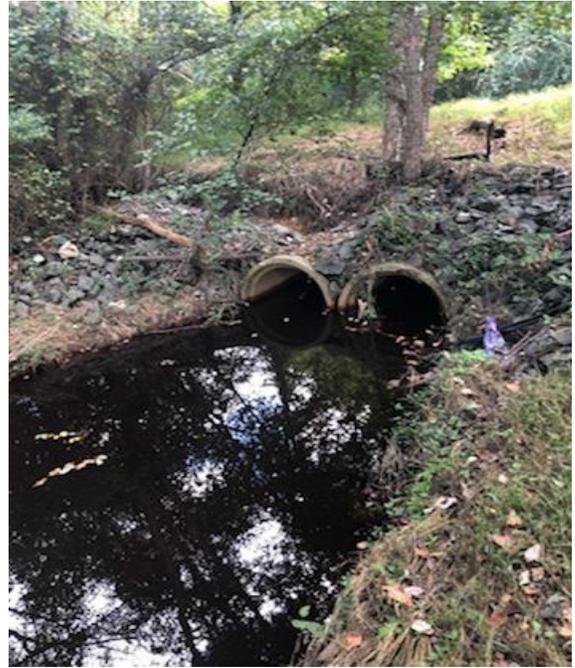
4. Barclay Brook Tributary B1 (BBB1) is a double culvert that can only accommodate a 5-year flooding event. There is evidence of heavy erosion on the outlet side and the culverts both have a small diameter and long length, which may deter some fish from entering.

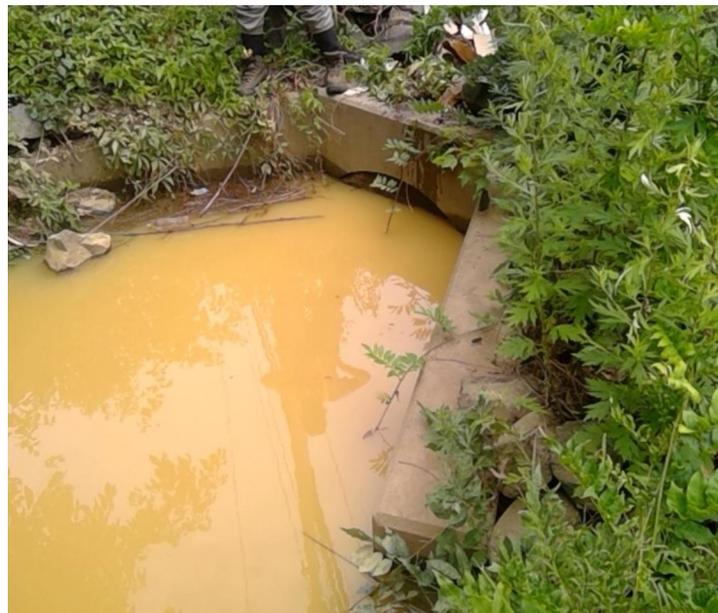
5. Barclay Brook Tributary A1 (BBA1) is a small, undersized culvert with a submerged outlet. The inlet is mostly blocked by debris and it is likely a deterrent to fish passage.
