Aquatic Connectivity Through Climate-Ready Infrastructure

Iresick Brook Subwatershed

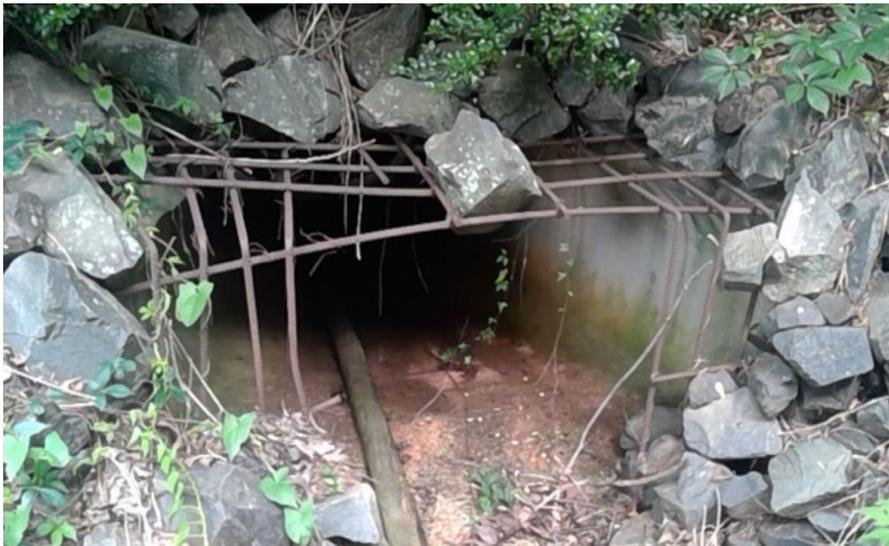
1. Duhernal Lake 3 (DL3) is an overly long (~240 ft.) and undersized culvert on an ephemeral stream. Though the stream was dry during the assessment period, the dendritic connectivity assessment placed this as the most critical barrier for fish passage in the watershed. It can only accommodate a 5-year storm event.

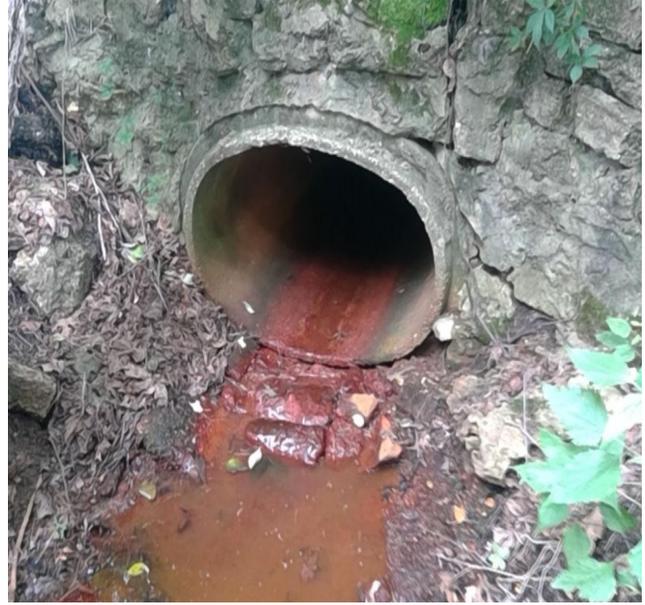
2. Veterans Brook 5 (VB5) is a very long and undersized culvert. This small diameter and length (>300 ft.) of this culvert likely deters most fish, and it can only accommodate a 2-year storm event.

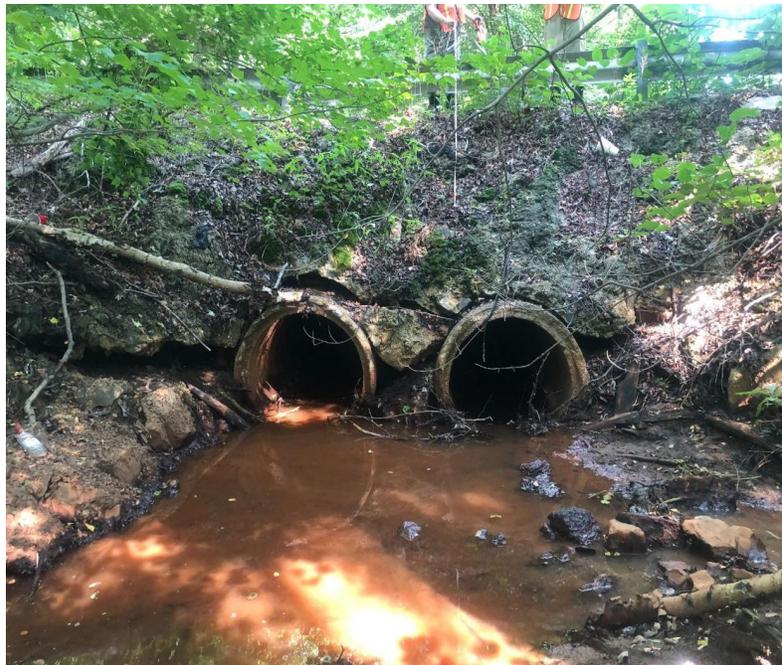
4. Iresick Brook 5 (IB5) is an undersized double culvert that is in poor condition with an eroding bank. It can only accommodate at 50-year storm event and may block fish passage.

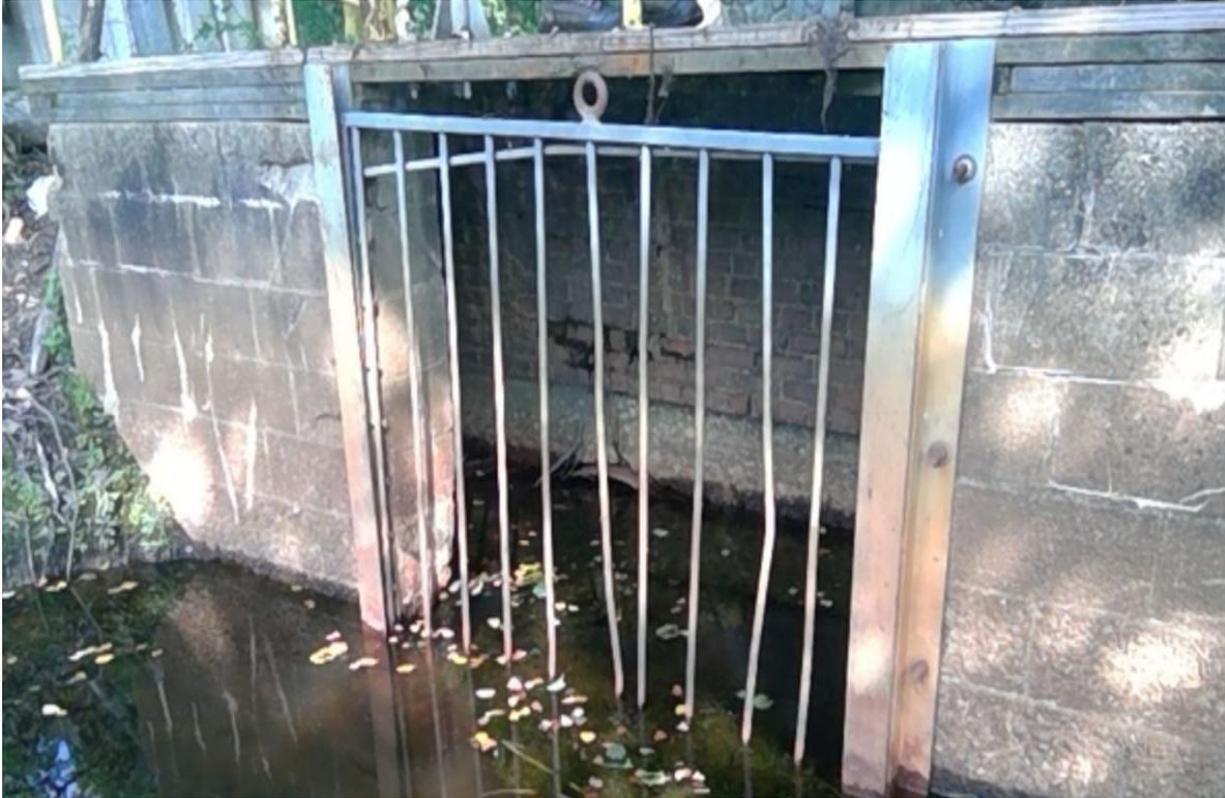
5. Iresick Brook 1 (IB1) is an oddly structured bridge with culverts that run under it. Access prevented an assessment for either connectivity or capacity. However, the culverts were submerged under low flow conditions which likely indicates a capacity issue and the grate and concrete dead-ends likely do not support easy fish passage.
