Aquatic Connectivity Through Climate-Ready Infrastructure

Mill Brook Subwatershed

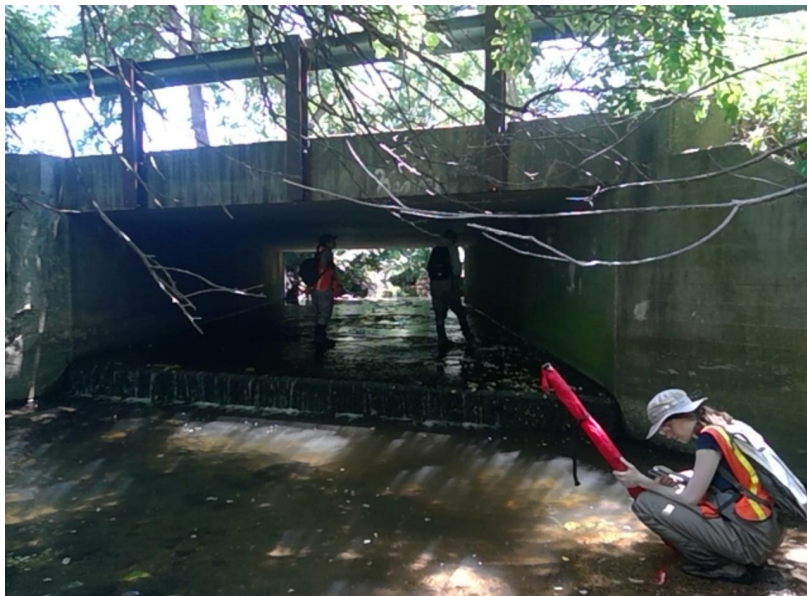
1. Mill Brook 23 (@ Dorothy Ave.) is the most important barrier to fish migration in the watershed and affects both potadromous and diadromous fish. This bridge has an outlet drop of over a foot, followed by a cascade, that effectively stop all aquatic passage. The bridge is also showing signs of wear including exposed metal and crumbling concrete.

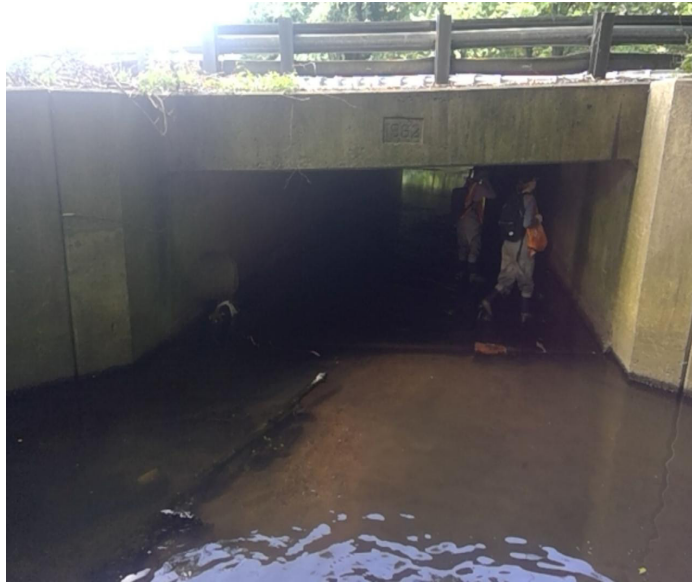
2. Mill Brook Tributary D11 (@ Rt. 1 exit ramp) is an undersized bridge that has a concrete bottom where the streambed has eroded on both the inlet and outlet sides, thus the crossing is slightly perched, has a slight outlet drop, and large pools at both the inlet and outlet side. This erosion may be due to the undersized nature of the structure. All of these factors contribute to less likelihood of fish passage for potadromous fish.

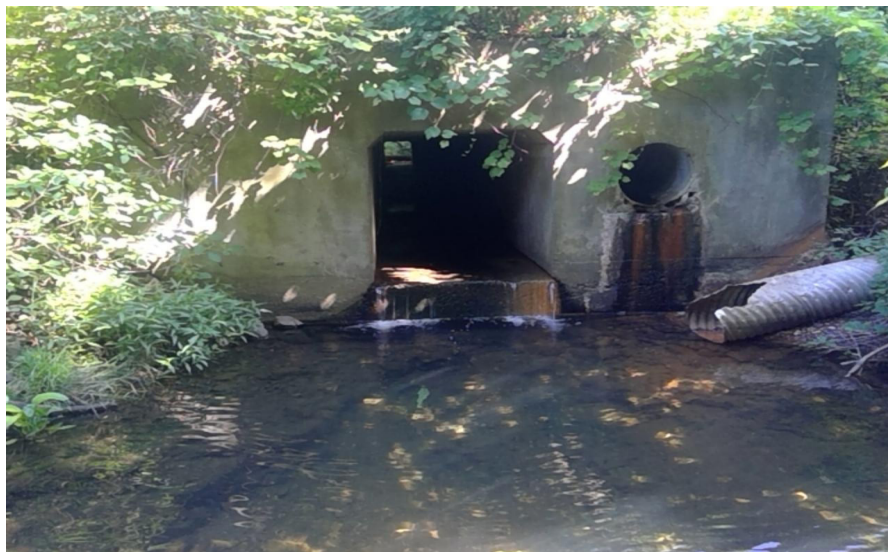
3. Mill Brook Tributary A4 (@ Hwy. 1) is a small culvert on a small tributary of Mill Brook. It has a large outlet drop that is a full barrier for aquatic passage for both anadromous and potadromous fish.

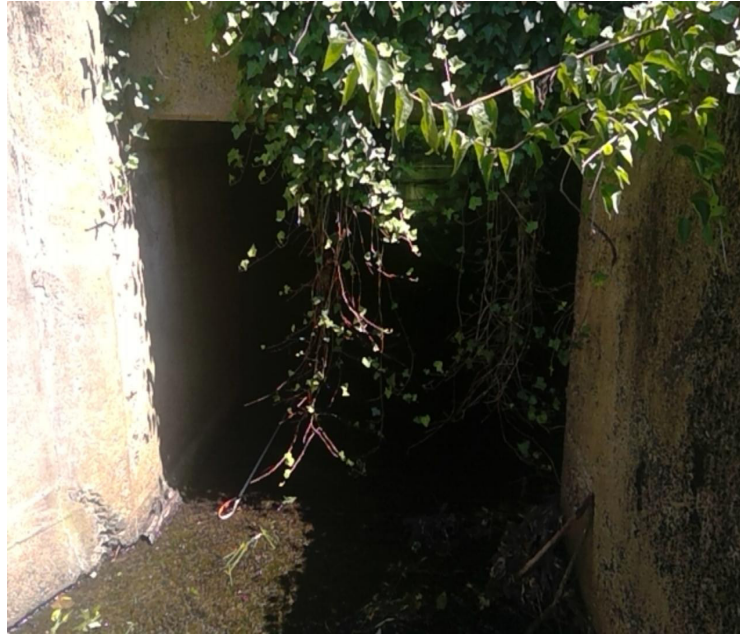
4. Mill Brook Tributary D5 (@Rt. 1 exit ramp) has similar issues to MBD11 just upstream, though not quite as severe. This crossing is undersized and can only accommodate a 10-year storm event. The concrete bottom of this box bridge is slightly higher than the surrounding riverbed leading the inside of the structure to be shallow and with faster velocities, which is problematic for fish.

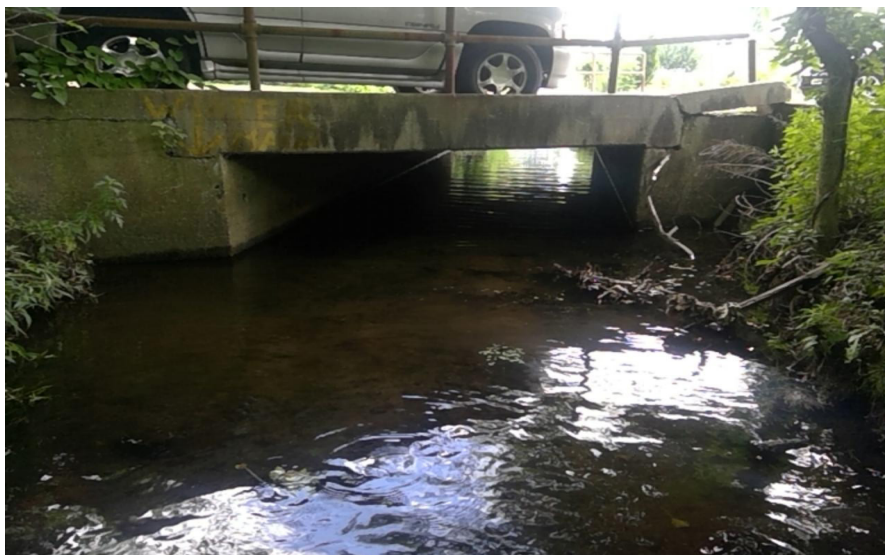
5. Mill Brook Tributary D14 (@ Orchard Ave.) is a small bridge further up in the watershed. It is fine for fish passage but is severely undersized and is falling apart.
