# Beach Restoration at Southern Seven-Mile Island, New Jersey

Project Lead: NJ Audubon  
Partners: LJ Niles & Associates  
The Wetlands Institute  
Stockton University  
Conserve Wildlife Foundation  
NJ Division of Fish & Wildlife  
US Fish & Wildlife Service  
Borough of Stone Harbor

# Goals and Objectives

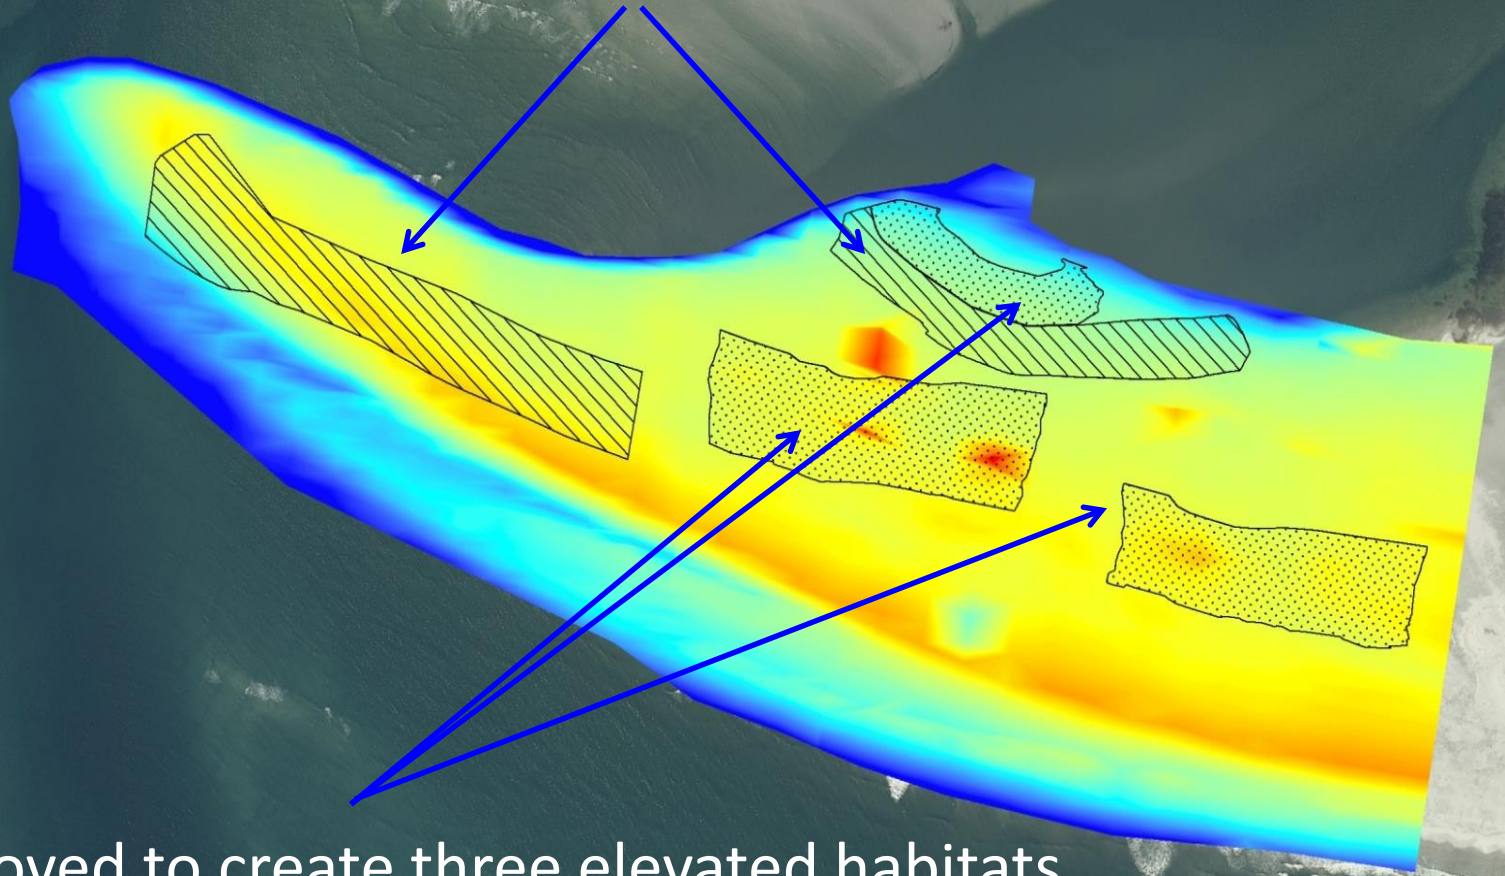
Sand harvested from two areas

Sand moved to create three elevated habitats

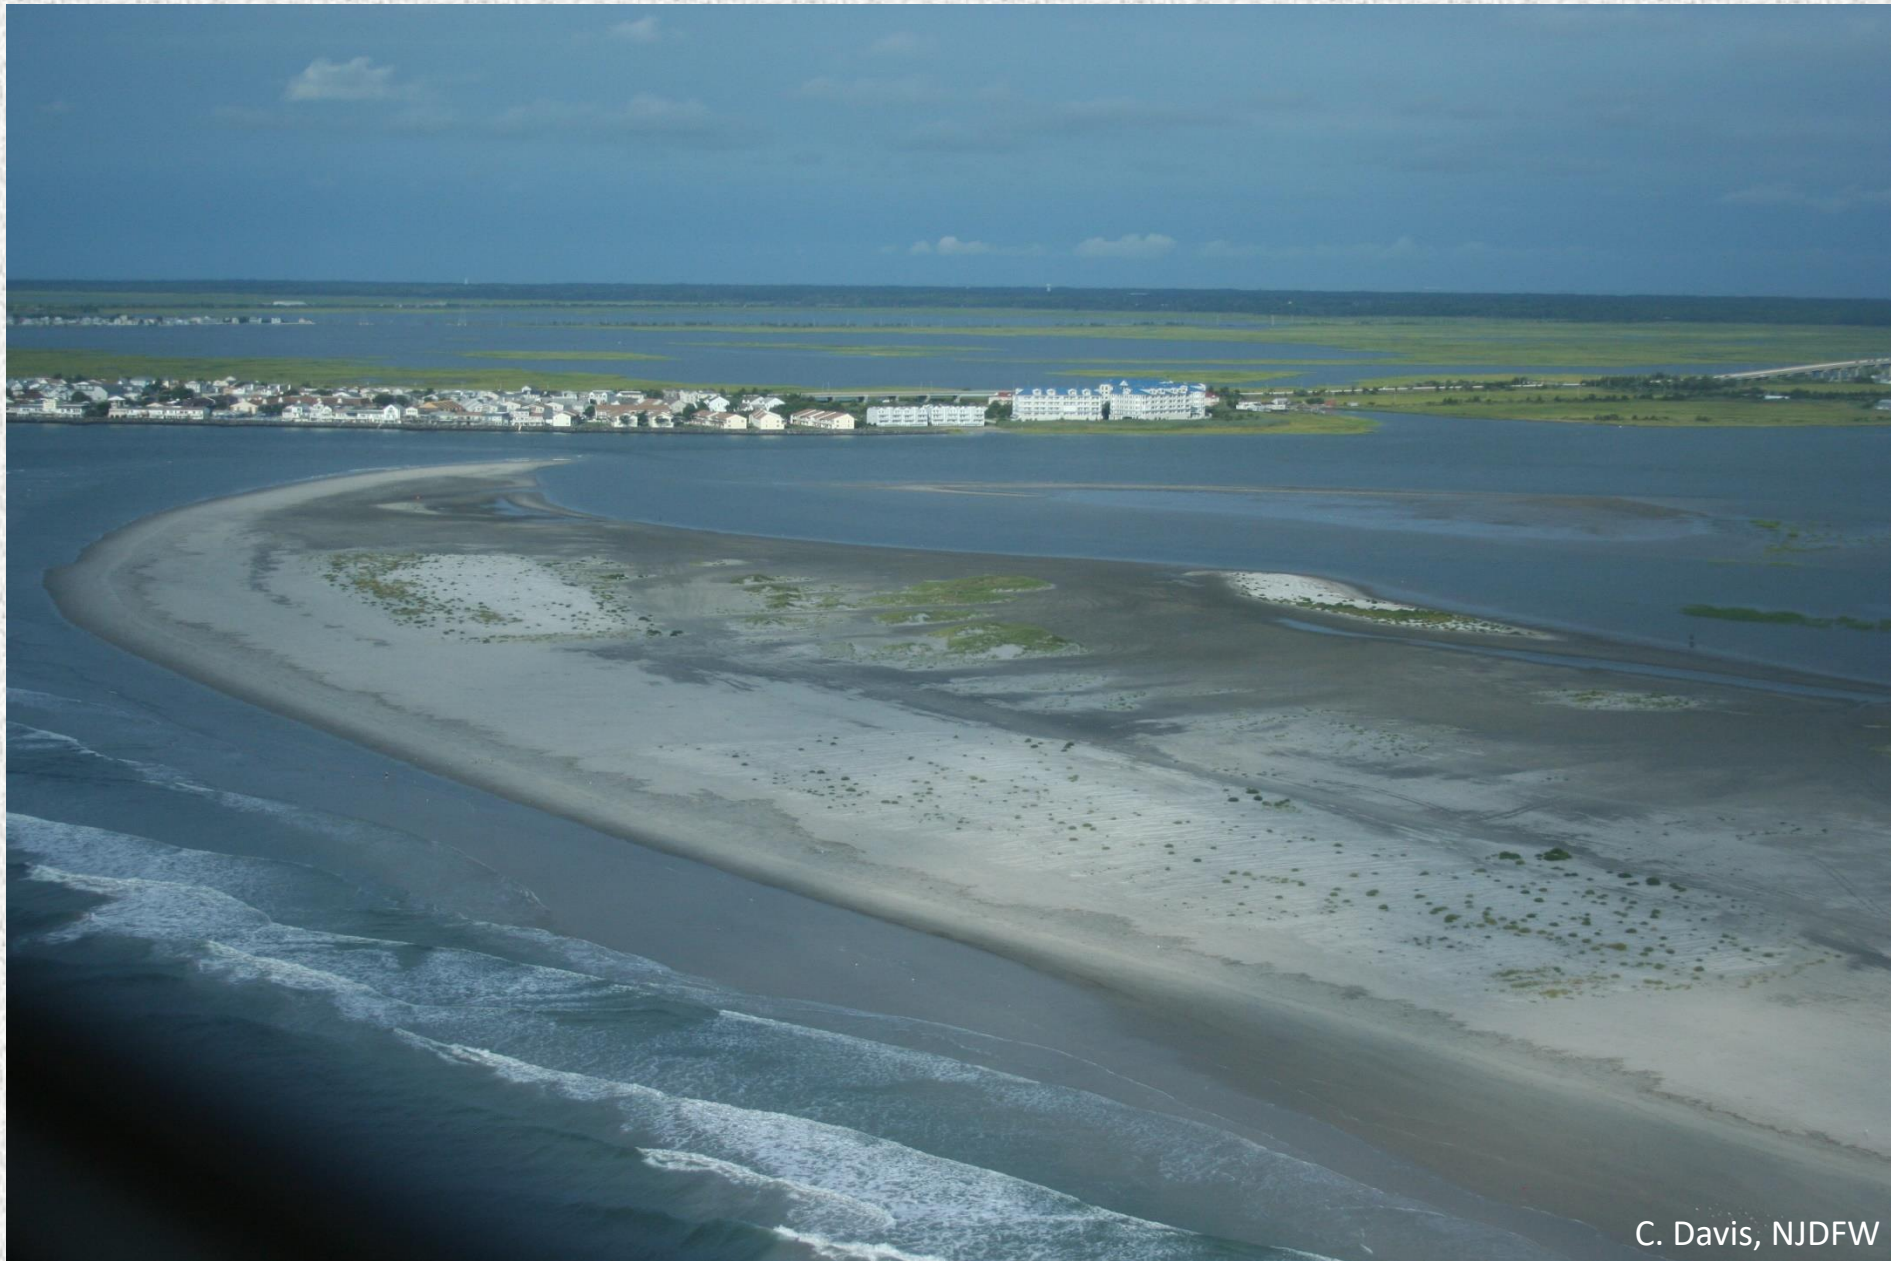
**Stone Harbor Point, NJ:  
Habitat Restoration Areas  
Elevation Change Map  
February 2016 to March 2016**

The Stone Harbor Point Elevation Change Map was created by comparing February 2016 pre-construction survey data and March 2016 post-construction survey data collected by the Stockton University Coastal Research Center.

The total volume placed in all habitat restoration areas were estimated to be 9,500 cubic yards.

The total volume harvested from all transfer zones were estimated to be -12,200 cubic yards.

Restoration Sites	Volume yd <sup>3</sup>
Southern Habitat	7,100
Landward Habitat	2,400
<b>Total Estimated Volume</b>	<b>9,500</b>

Transfer Zones	Volume yd <sup>3</sup>
Runnel	-3,600
Transfer Zone	-8,600
<b>Total Estimated Volume</b>	<b>-12,200</b>

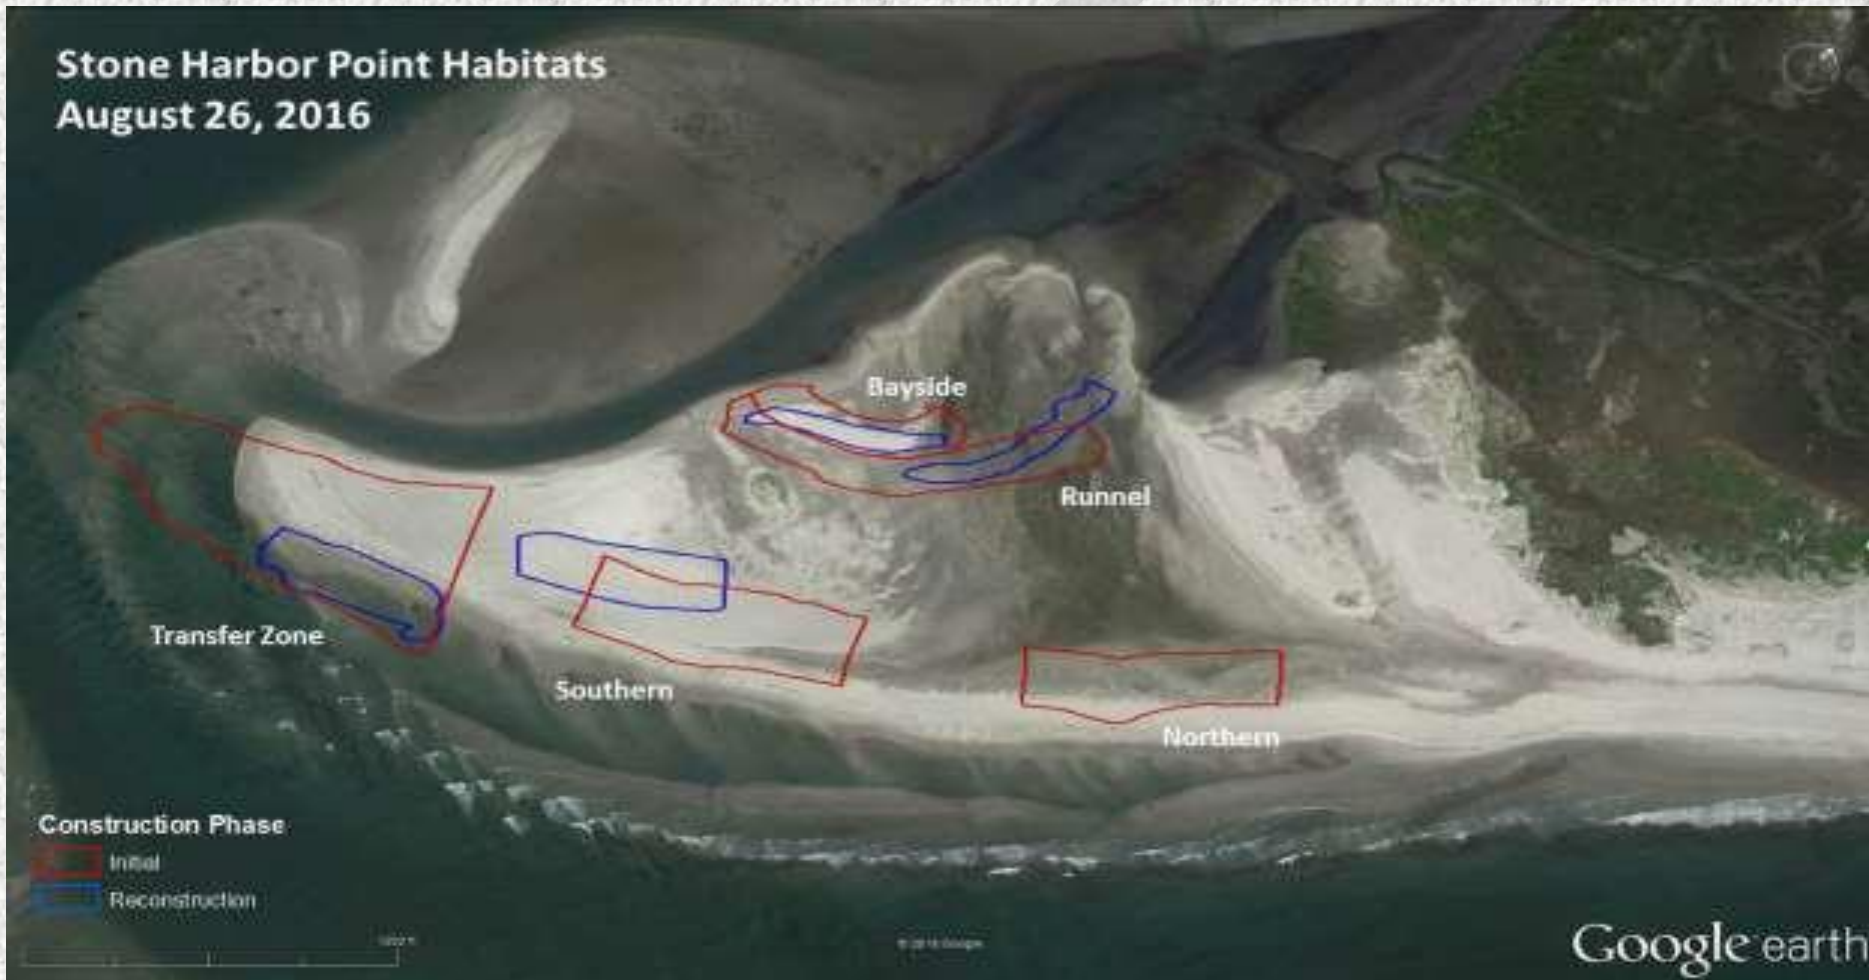
**Stone Harbor Point Habitats  
August 26, 2016**

**The aerial image above shows conditions at the point on August 26, 2016, approximately 18 months following initial construction. Red colored areas are the project feature created in 2015, blue those features constructed in 2016.**
