Developing a Self-Sustaining  
Oyster Population in  
Jamaica Bay, New York City

Final Report and Project Deliverables

October 2020

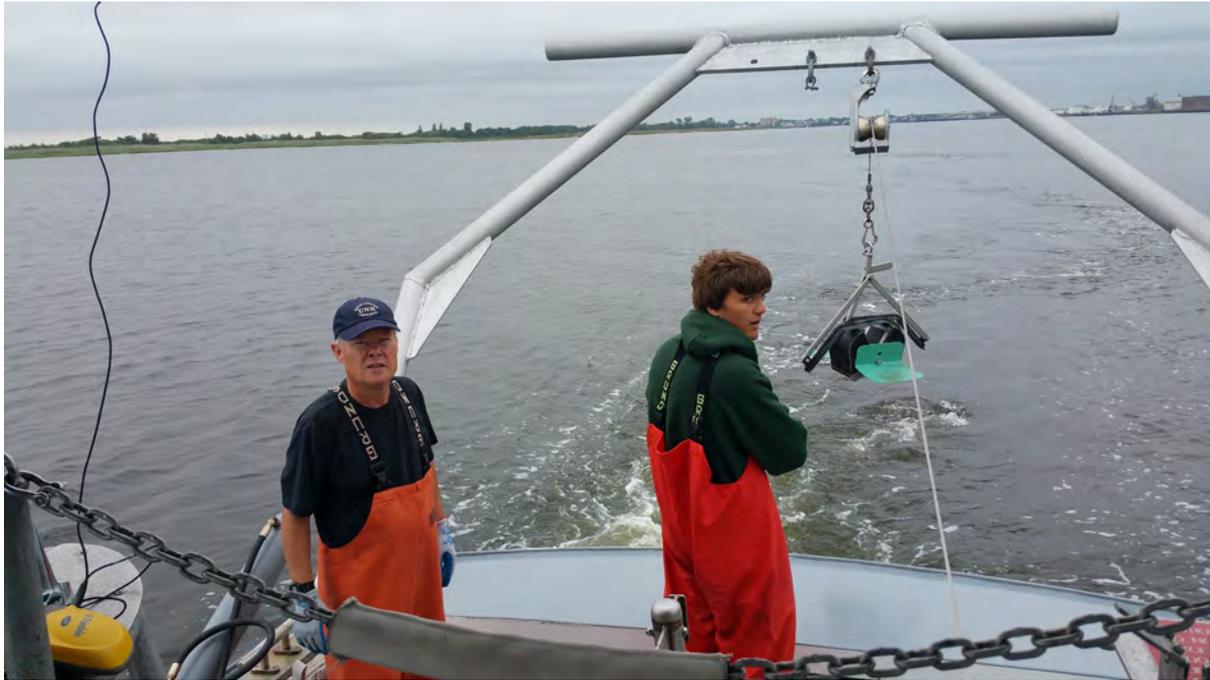
Figure 4.1 Deployment of Van Veen grab used to take pre-construction sediment and benthos samples at project site.

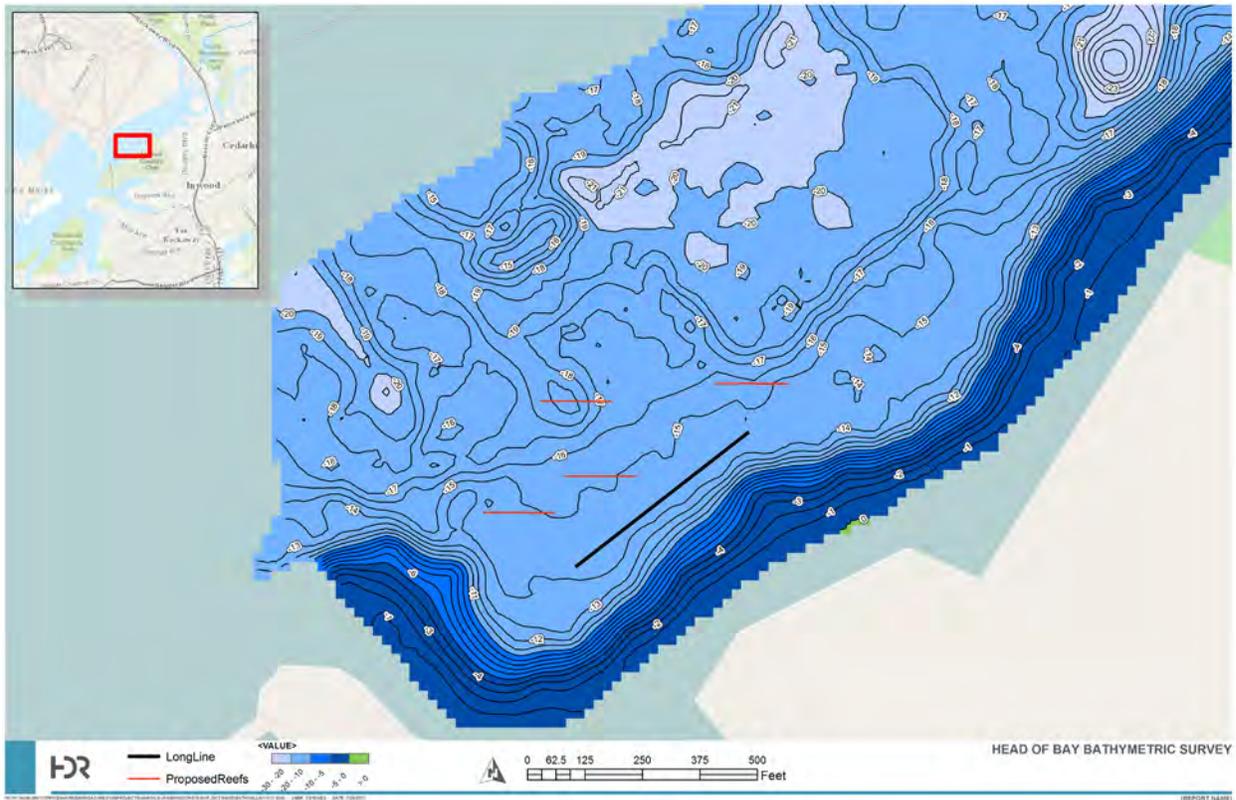
Figure 4.2 Bathymetric profile.

The bathymetry of the study site was mapped to provide information on project depths and slopes. The bathymetry data aided decisions for locating the receiver reefs and logistical considerations for reef construction (Figure 4.2 and Appendix B3).

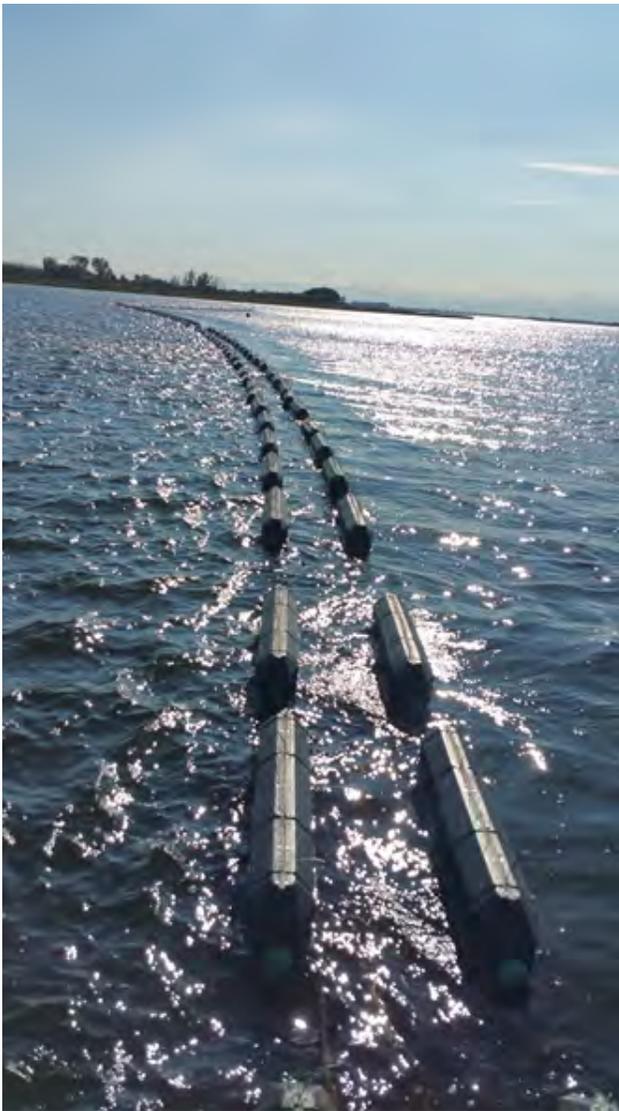
Figure 4.3 The OysterGro Donor Reef.

The donor reef consisted of a 650-foot longline (Figure 4.3). Four 400-lb mushroom style mooring anchors were selected as the ground tackle after sediment characterization revealed soft sediment throughout much of the project site. Each anchor was followed with 30 feet of 1/2-inch, galvanized chain. The weight of chain served to soften shocks on the anchor system caused by waves or currents and to increase the holding power of the ground tackle system. From the chain, 1/2-inch, polypropylene line was used as an anchor rode. This line ran to floats at the extreme ends of the longline. The longline itself was constructed of 1/2-inch, sinking, polypropylene line.

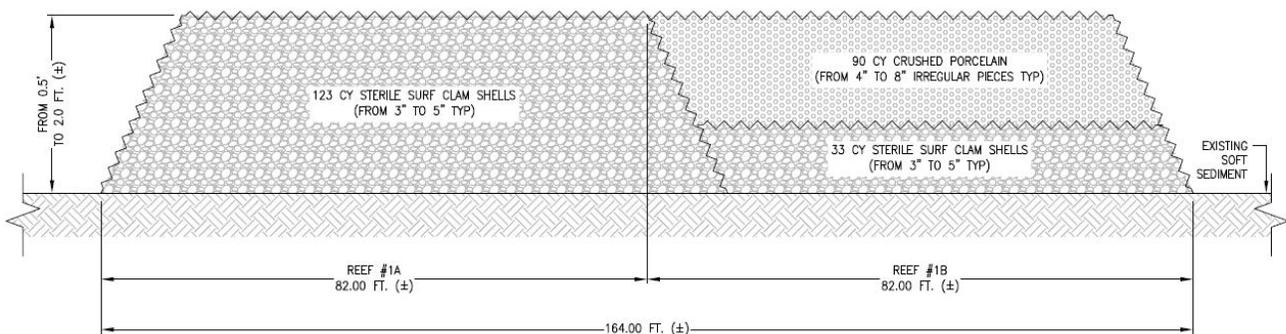
Figure 4.4 Side profile view of receiver reef bed #1 illustrating material composition of one of the reef beds.

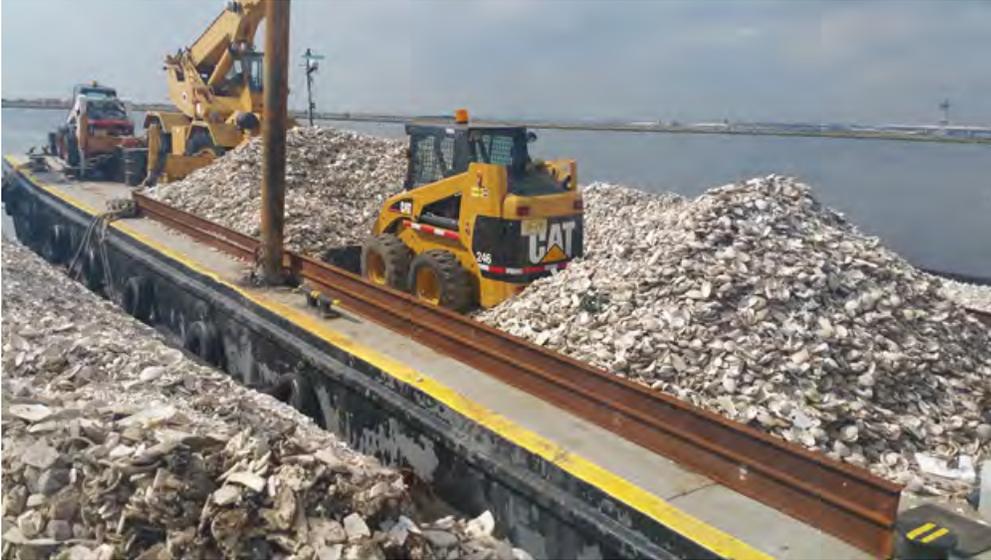
Figure 4.5 Receiver reef materials: seasoned clam shells, oyster shells and crushed porcelain

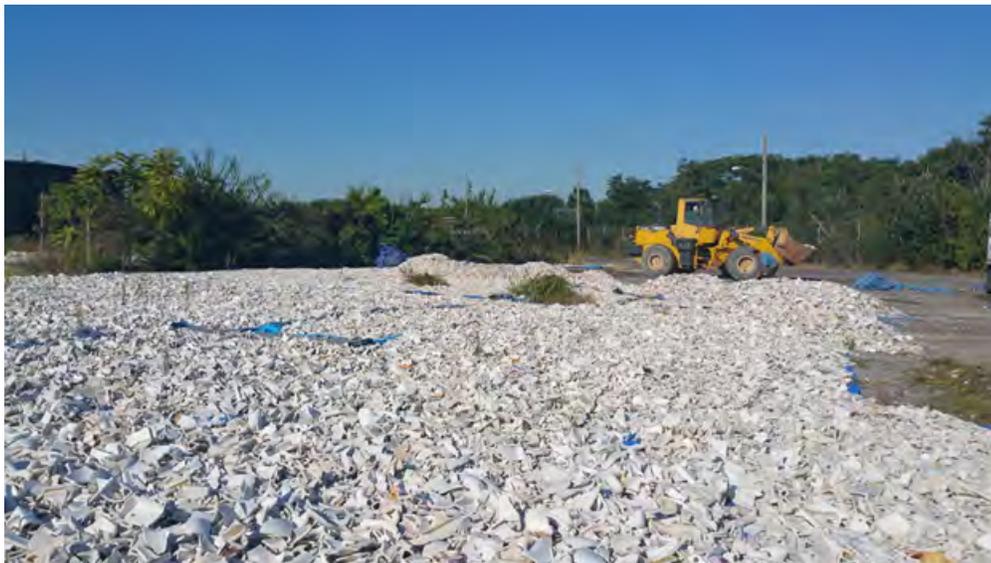
Figure 4.6 Porcelain Material "curing" prior to placement

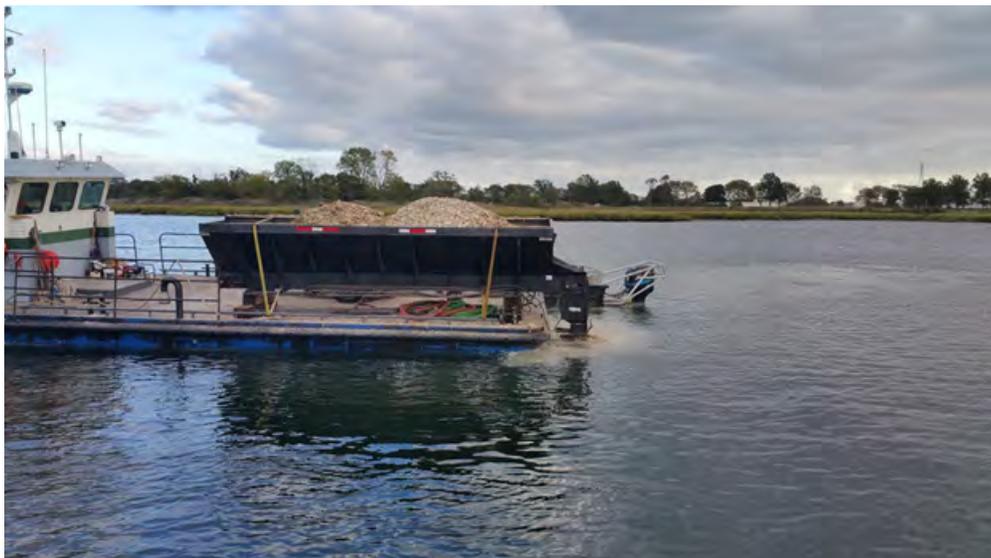
Figure 4.7 Picture of placement materials by the spreader.

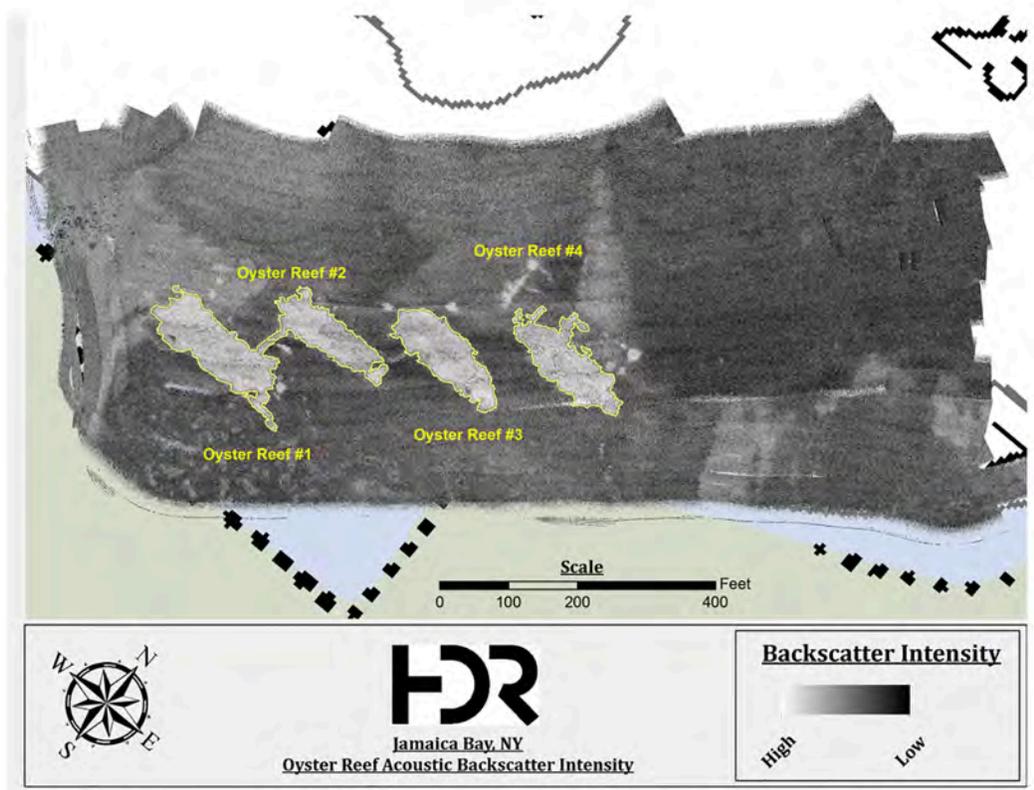
Figure 4.8  
Materials  
placement within  
defined  
parameters

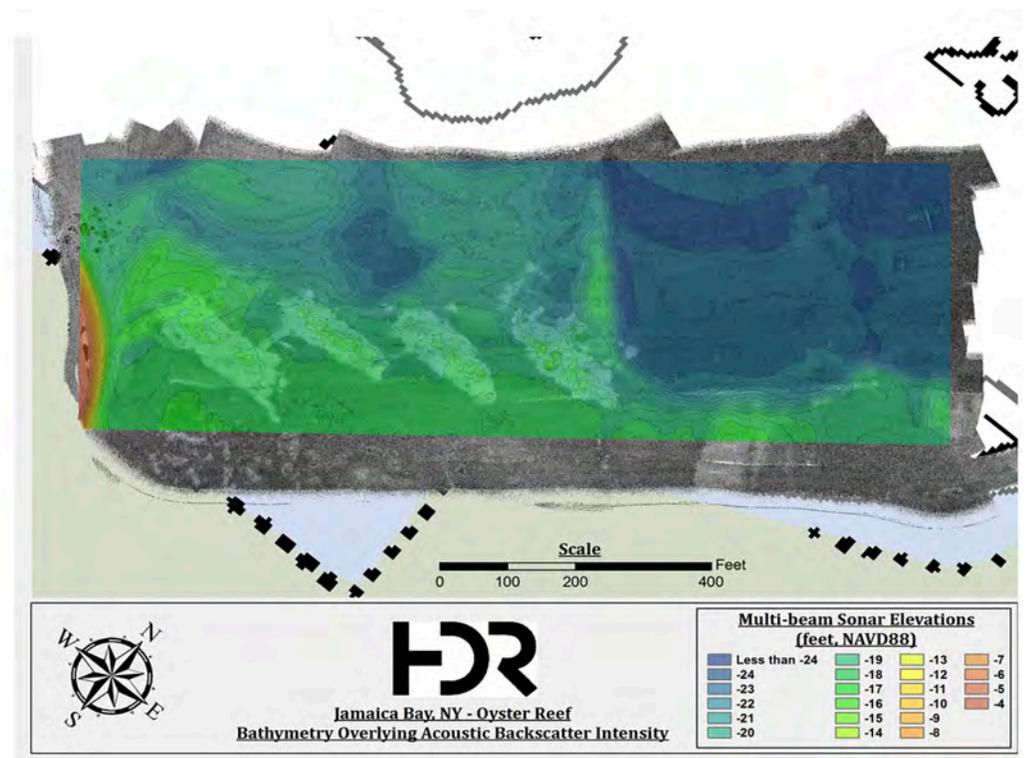
Figure 4.9 HDR  
image from  
post-construction  
bathymetry.

Following the construction of the receiver reef, a high-resolution hydrographic survey was completed in November 2016 and then repeated in October 2018 using a multi-beam echosounder (MBES) to measure the oyster reef elevations (bathymetry) and acoustic backscattered intensity (side-scan sonar) of the reef and surrounding seabed (Appendix B3). The post-construction hydrographic surveys yielded a full-surface, high-resolution dataset with a vertical accuracy within 0.1 to 0.2 feet for comparison between surveys and for comparison of as-built conditions to specified design criteria.

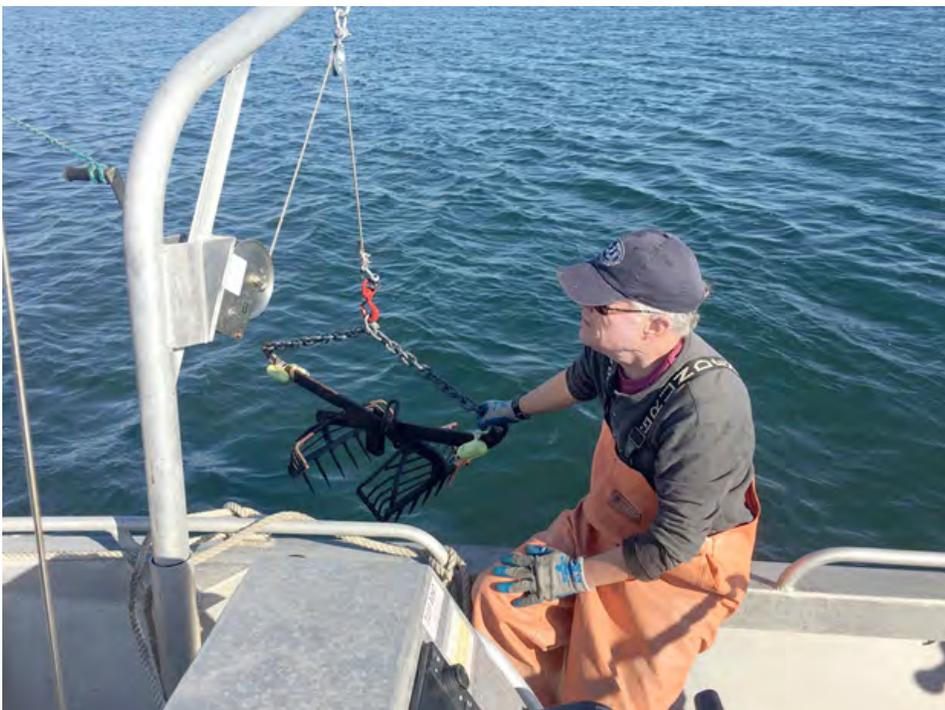
Figure 4.10. Patent tongs used in 2017 to take quantitative samples of the constructed reef bases.

Six replicate patent tong (0.1 m<sup>2</sup>) samples were collected per reef (24 samples total) on October 19, 2017 (Figure 4.10). All substrate material (shell and porcelain) collected was examined in the field for live oysters and returned to the water after examination. This sampling methodology was discontinued after 2017 and replaced by the diver-based excavations and video transects.

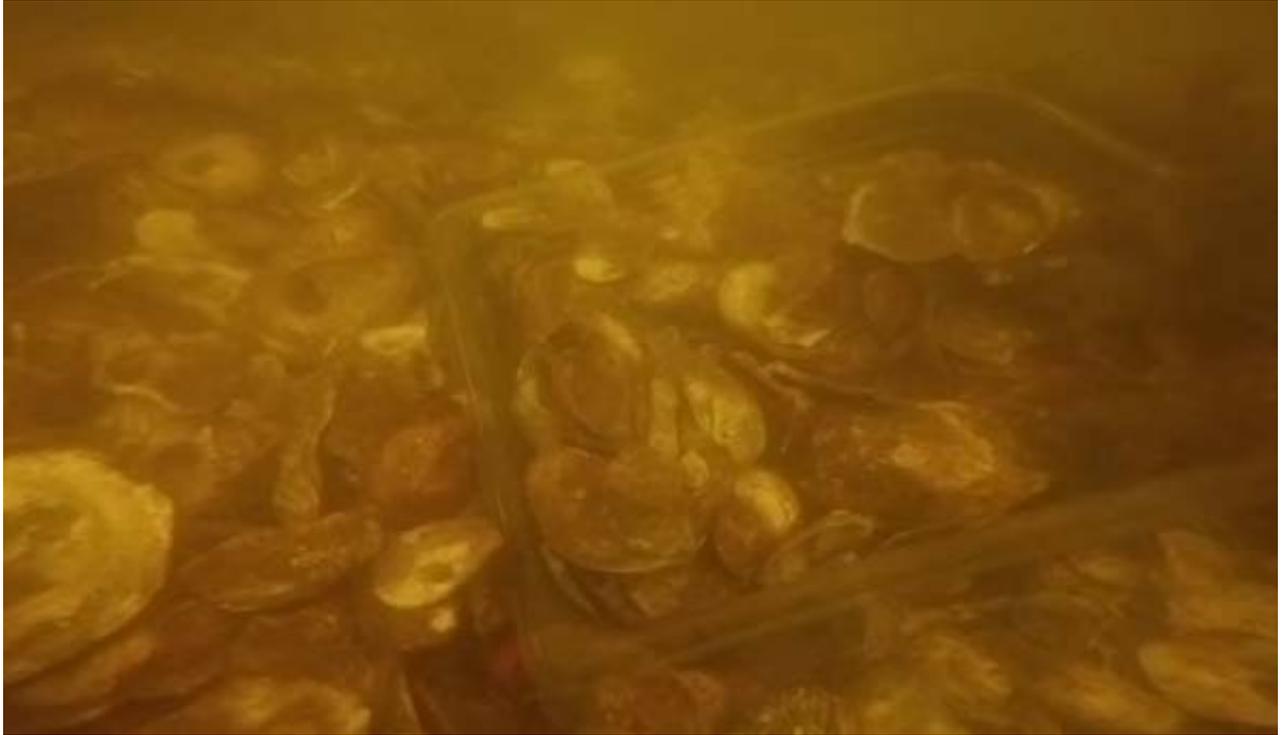
Figure 4.11 Underwater picture of benthic trays on a clam shell reef bed.

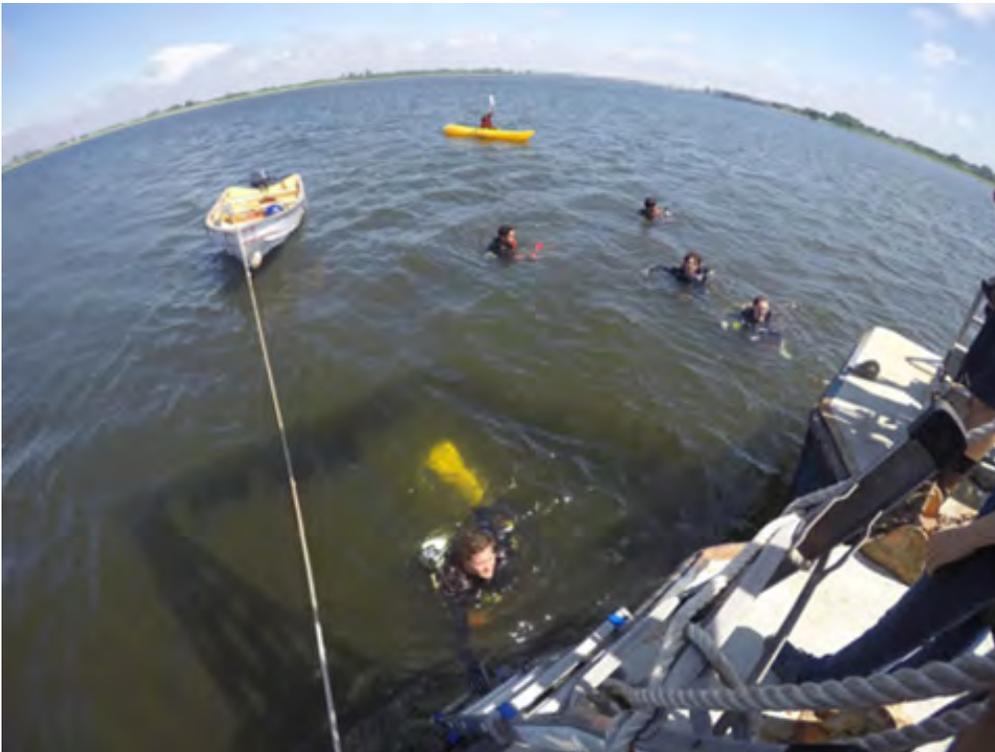
Figure 4.12 Divers retrieving trays containing materials used to construct reef bases and used to characterize biotic communities that developed on the constructed oyster reefs.

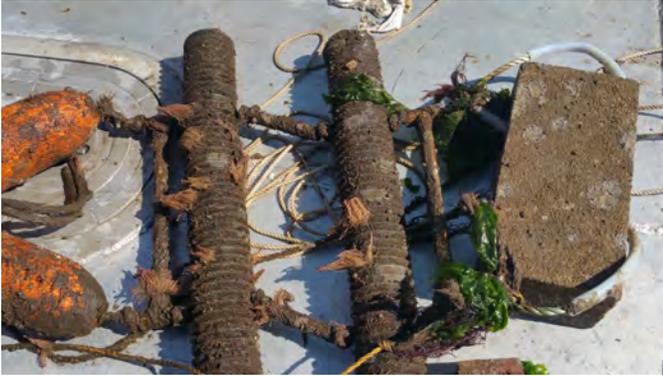
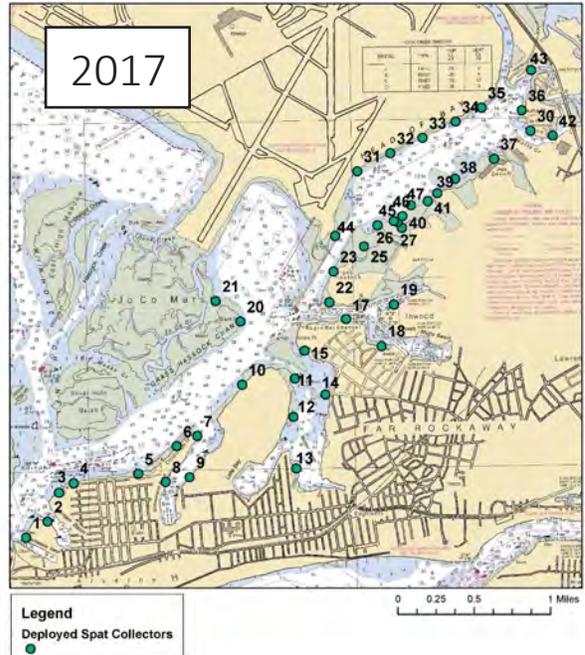
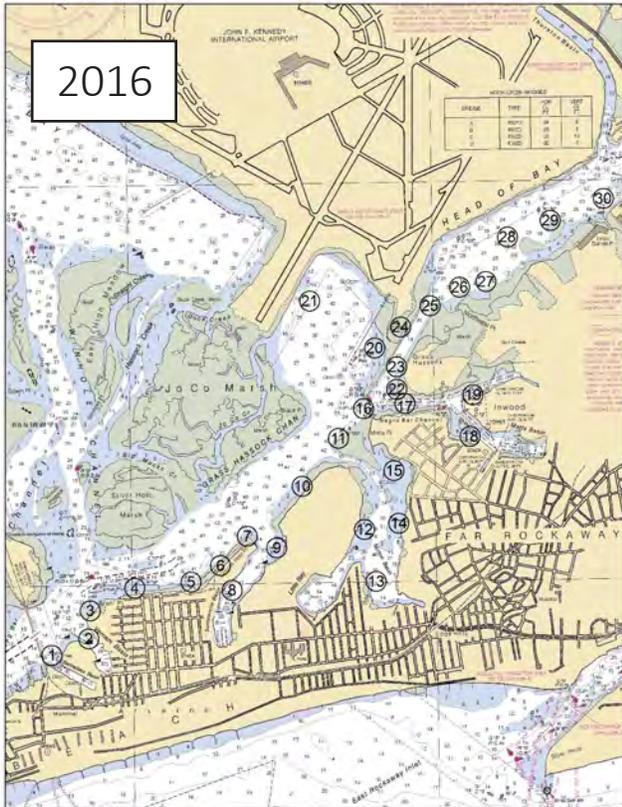
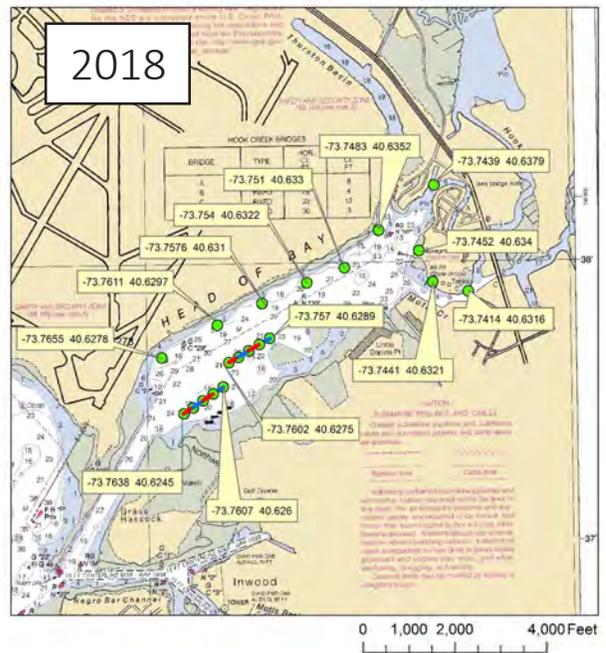
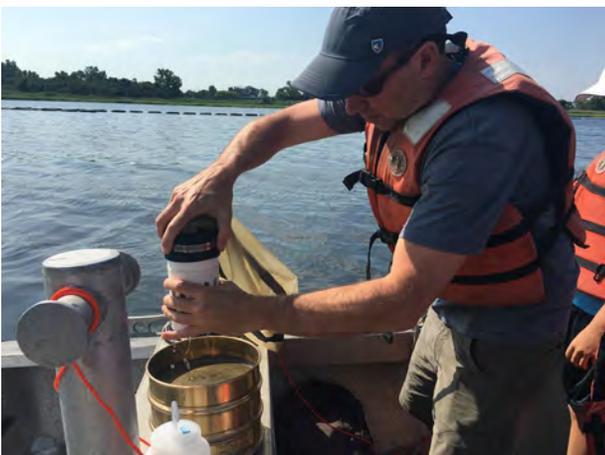
Figure 4.13 (Above) Spat Collector and Sampling Locations

Figure 4.14 (Left) Plankton Sampling near Oyster Donor Reef

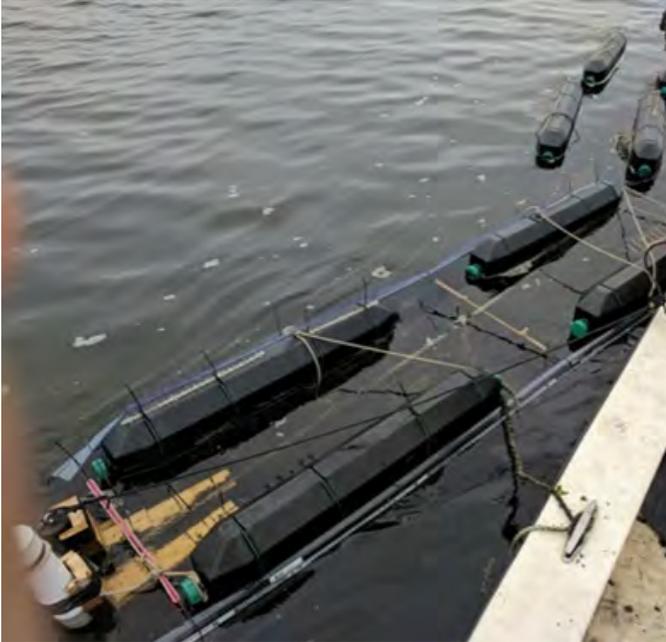
Figure 4.15. Temporary field flume to measure long-term (~40 hours) water filtration by oysters in eight bags on the long line. Note Sontek ADV current meter and Manta datasonde mounted vertically on left end of flume.

Long-term deployment of datasondes and the ADV during 2017 yielded a total of ~160 separate measurements (~40 hours total; readings at 15-min intervals) of CHL concentrations, water quality parameters, and water flow speed deployed on the field flume apparatus. Initial inspection of the overall dataset clearly indicated that the “upstream” CHL concentrations were usually greater than “downstream” (Figure 5.9); the overall means were 24.0 µg/L upstream and 18.7 µg/L downstream, indicating an average 32.1% CHL removal (uptake) over the 40-hour measurement period. However, there were several periods lasting up to a few hours when downstream CHL was greater than upstream (indicating CHL export).

The ADV measurements of water flow during the 40-hour period showed wide variability in speed and direction. All three sensors were fixed so that “upstream” could be determined regardless of instrument orientation, and only one had a net flow that was positive: 1.3 cm/s from an oblique angle entering the flume. The other two indicated average negative (“downstream”) flows of ~3 cm/s. These data confirm the minimal flow speeds and variable direction for water currents in the general area, but also the probable effects of wind waves that persisted during most of the 40-hour measurement period.

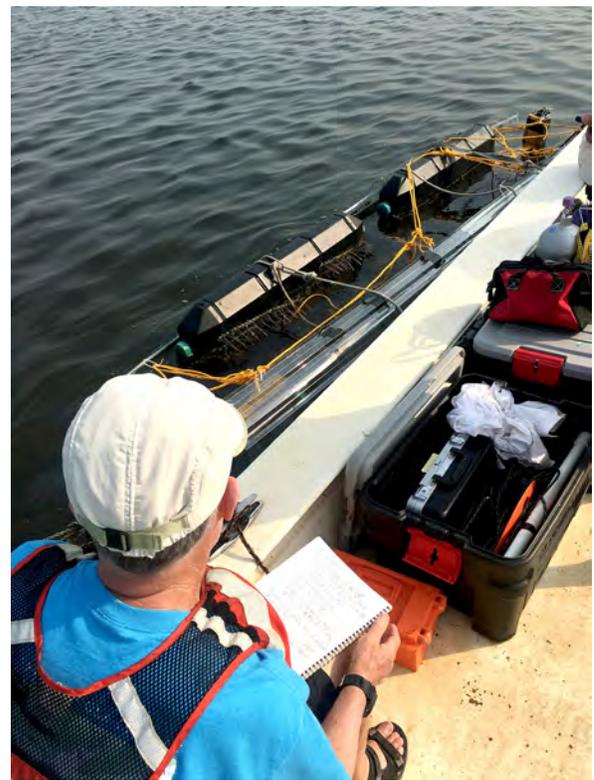
Figure 4.16. Left: Constructing temporary field flume (August 15, 2018) used to measure water filtration by oysters in bags. Right: Field flume anchored in position near channel; note one of two Manta datasondes mounted vertically on each end of flume is visible.

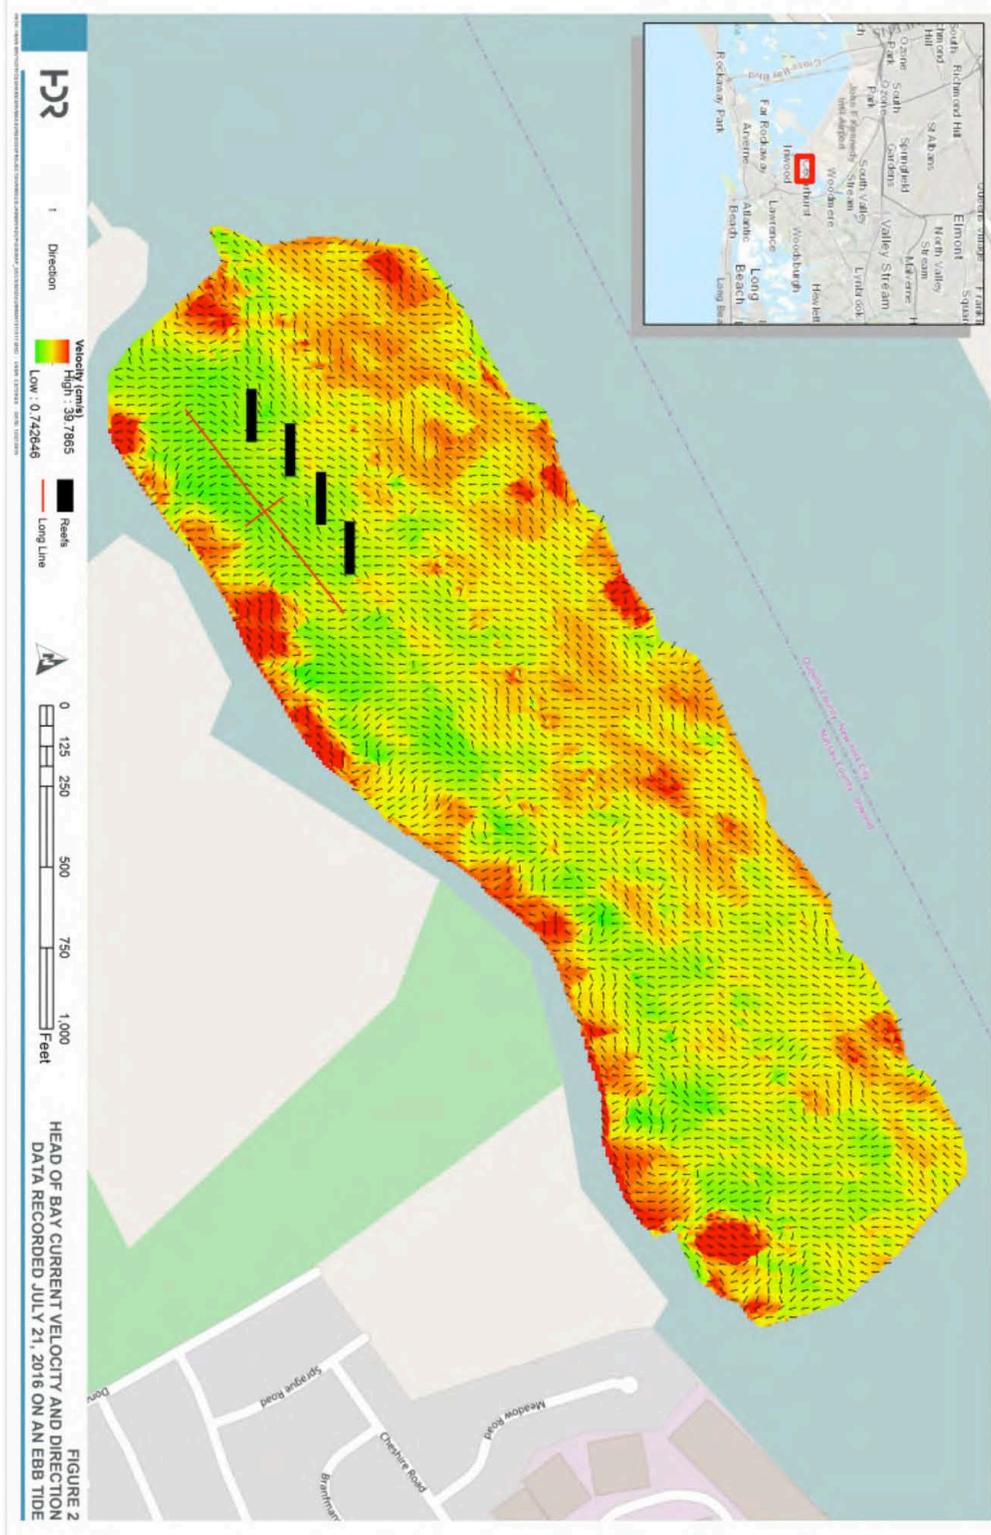
Figure 5.1. ADCP measurements of current velocity and direction.

In order to characterize baseline conditions at the potential donor reef and receiver reef locations, a hydrodynamic survey using a bottom-mounted Acoustic Doppler Current Profiler (ADCP) was conducted at two locations in the Head of Bay between 7 July 2016 and 5 August 2016. The first deployment (7 July through 21 July) was located in the middle of the study area, while the second deployment (21 July through 5 August) was conducted in the southwest portion of the study area. During both deployments, the ADCP was set to record current profiles in 20 cm depth increments every 20 minutes (Appendix B2).

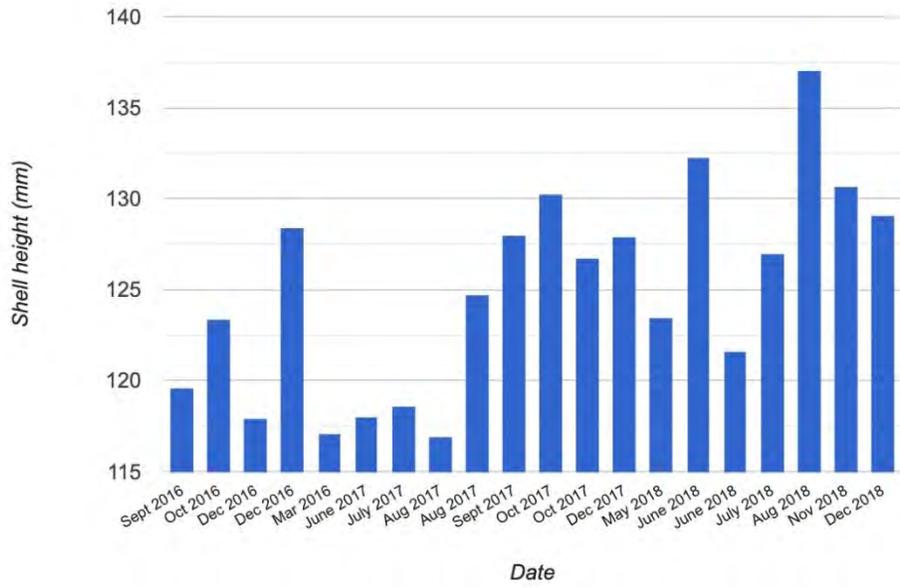
Figure 5.2 Shell height, Island Creek cohort.

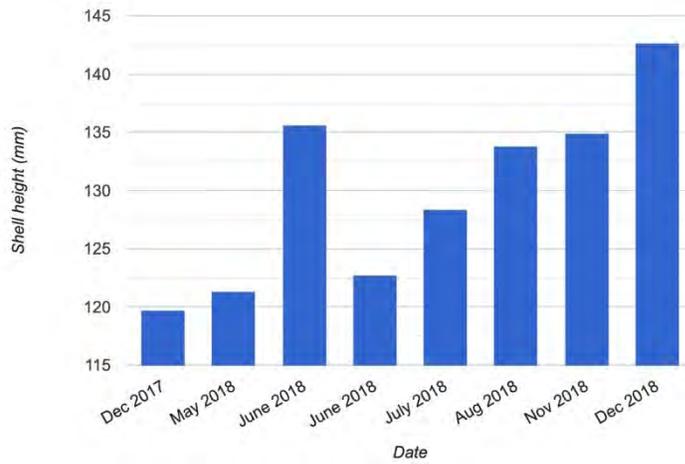
Figure 5.3 Shell height, Merry Island cohort.

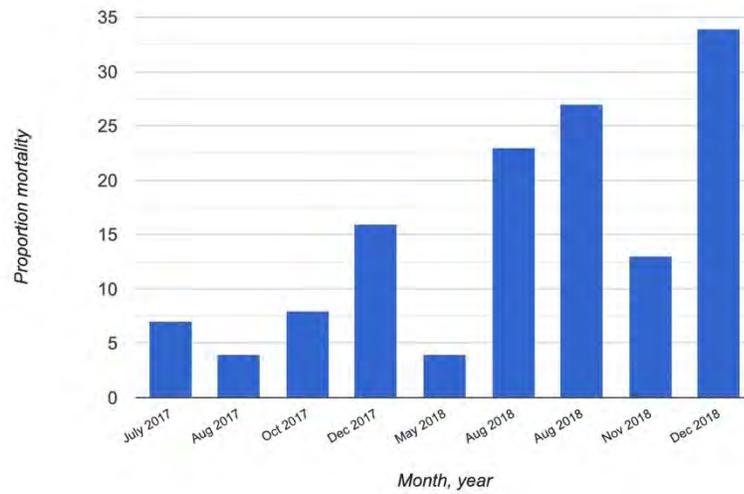
Figure 5.5 Proportion mortality of Island Creek cohort over time. Note: oysters were sampled both during the first and last weeks of August.

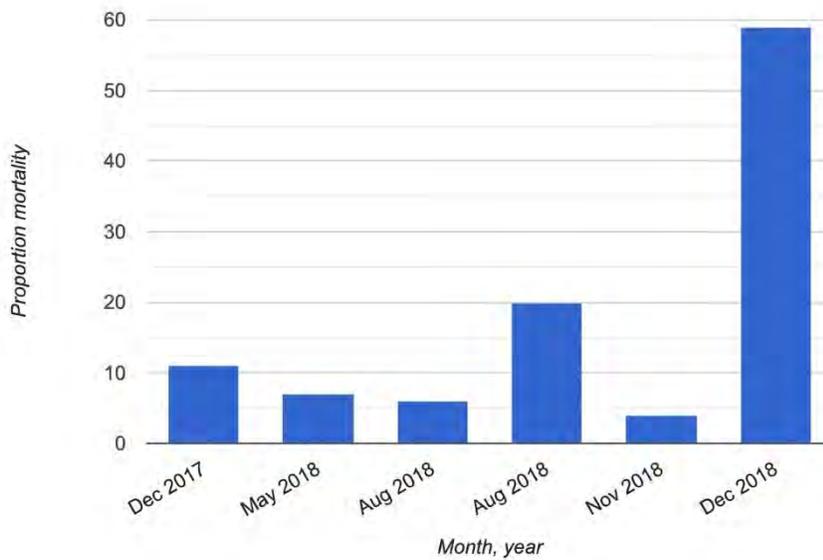
Figure 5.6 Proportion mortality of Merry Oysters cohort over time

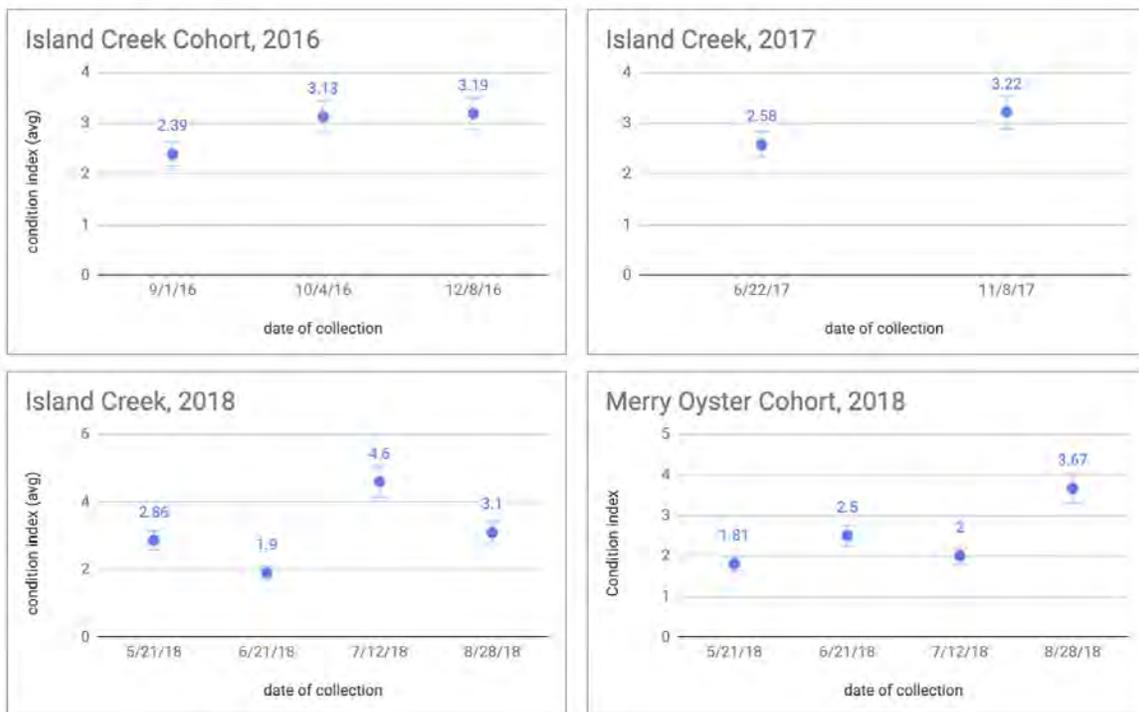
Figure 5.8. Condition Index (avg ± 1 SE) of Oysters

The condition index was calculated following the method of Filgueira et al. (2013) method ( $CI = (\text{dry meat weight} / \text{dry shell weight}) \times 100$ ). The condition index of oysters was measured in spring and fall of each year. Condition index was calculated as  $(\text{dry mean weight} / \text{dry shell weight}) \times 100$ . In 2018, the condition index was measured each month from May through August to track changes in results that may be triggered by spawning events.

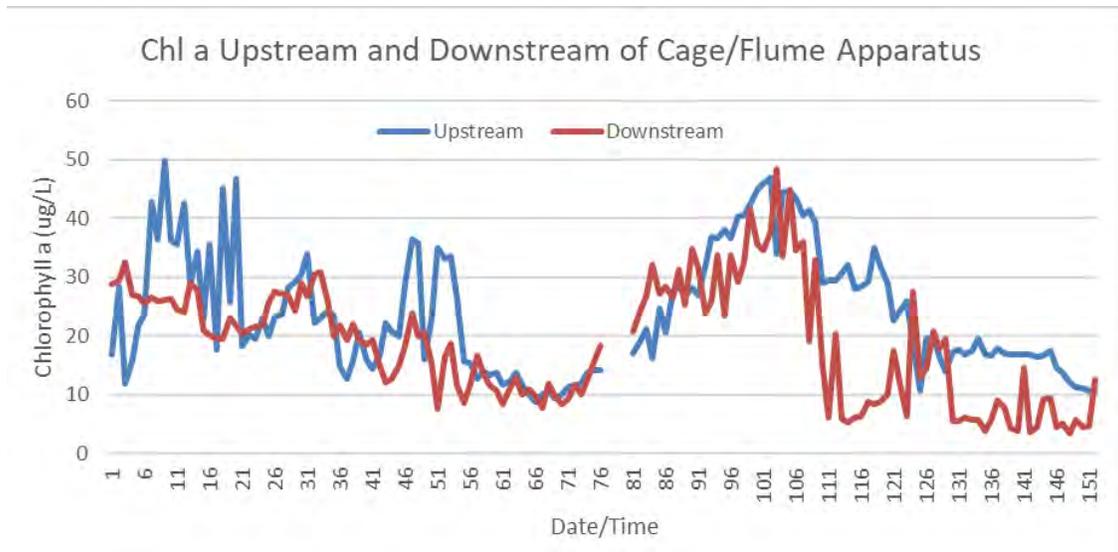
Figure 5.9 Time series (~40 hours total) of CHL measurements by two datasondes at 15-min intervals deployed on field flume.

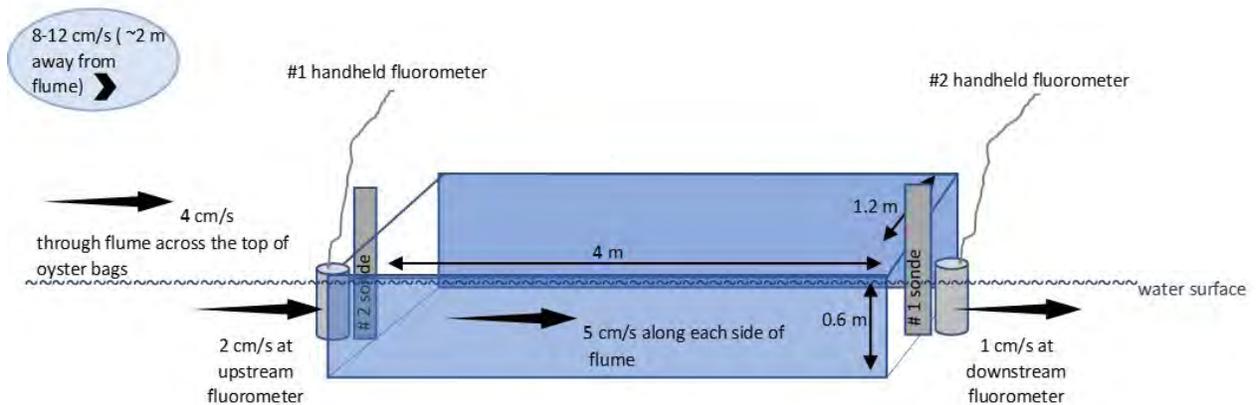
Figure 5.10 Schematic illustrating water flow speed patterns in and around the flume based on measurements made from 2:30 – 2:50 pm on August 16, 2018 (see Table 5.6).

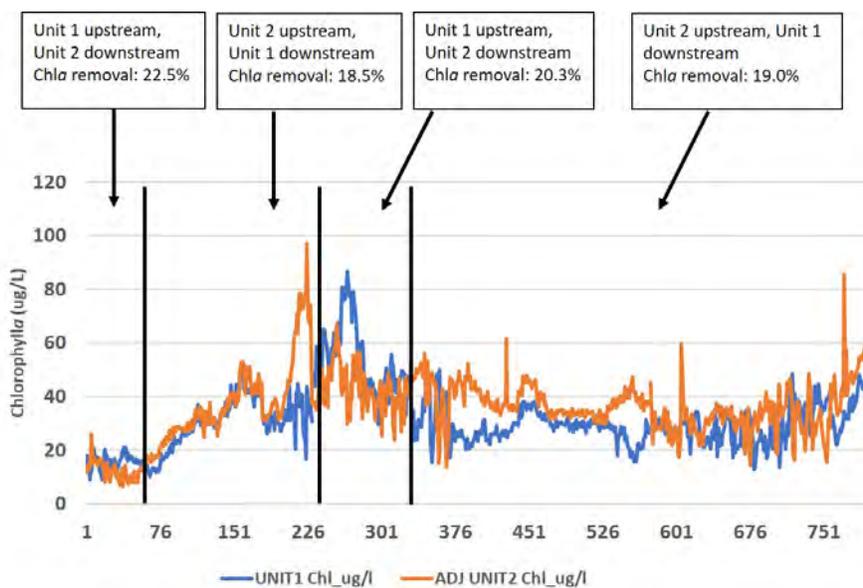
Figure 5.11 Time series (28 hours) of CHL measurements by two datasondes at 2-minute intervals deployed on the field flume during August 15 – 16, 2018.

During 2018, 28-hour deployment of datasondes yielded a total of ~800 separate measurements of CHL concentrations upstream and downstream of the oyster bags in the field flume (Figure 5.11). The overall dataset could be divided into four separate measurement intervals based on observed (or likely) changes in flow direction associated with tidal flows, as discussed above (Figure 5.9). CHL removal rates ranged from 18.5% to 22.5% when calculated on a per interval basis. However, inspection of the data plots (Figure 5.11) indicates substantial variability in CHL removal rates within each interval. Water quality parameters measured by the datasondes ranged from

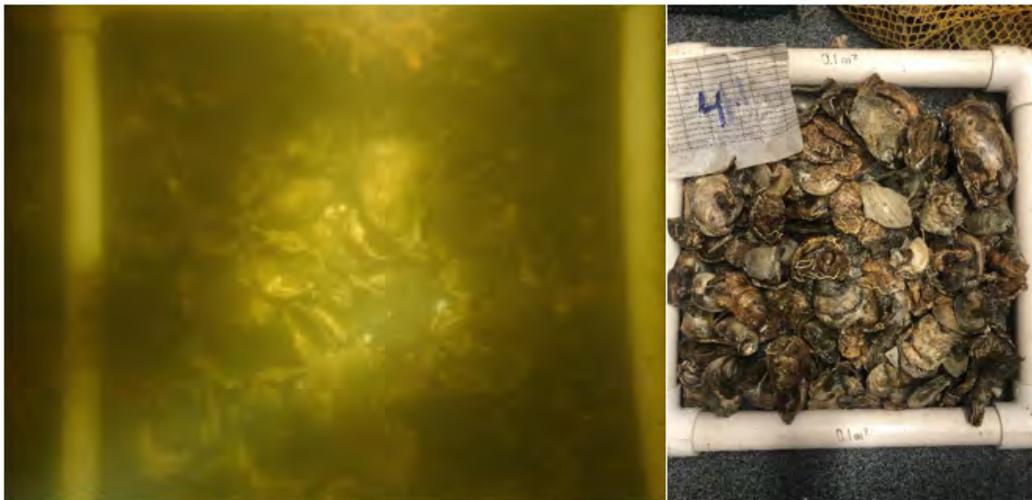
Figure 5.13 Underwater photo of quadrat prior to excavation (left) and after (right).

In October 2018, diver excavation quadrat sampling and video transects were used to monitor the four receiver oyster reef beds for oyster spat recruitment. At each of the four reef beds, eight haphazardly tossed 0.25-meter quadrat samples were collected and brought to the surface for examination. For the video transects, divers swam along east-west transect lines and recorded high-resolution video. The video files were reviewed in the lab to identify and measure any oysters found.
