2020 POST-CONSTRUCTION OYSTER MONITORING FINAL REPORT

The Governor Mario M. Cuomo/New NY Bridge Project at Tappan Zee Oyster Substrate and Water Quality Monitoring

April 5, 2021

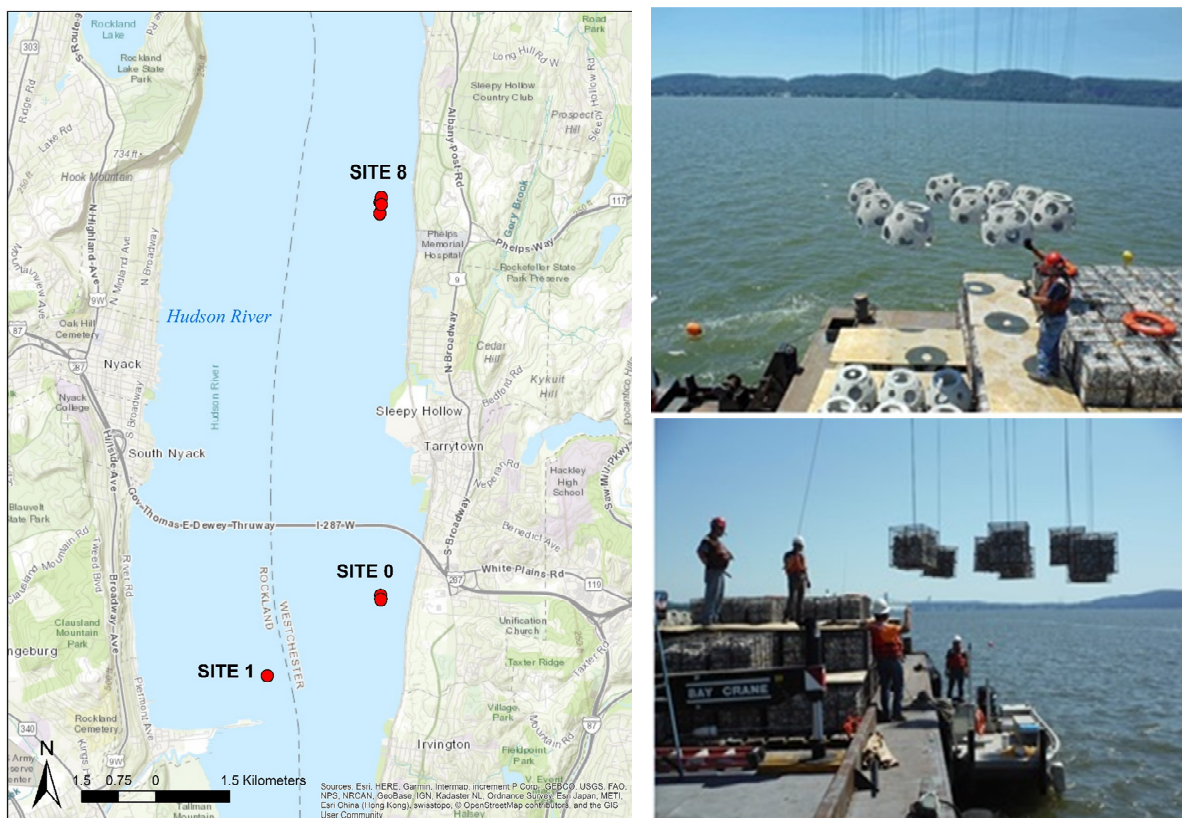
Figure. 1. Locations of the three oyster reef mitigation sites and deployment of the two substrate types in July 2018.

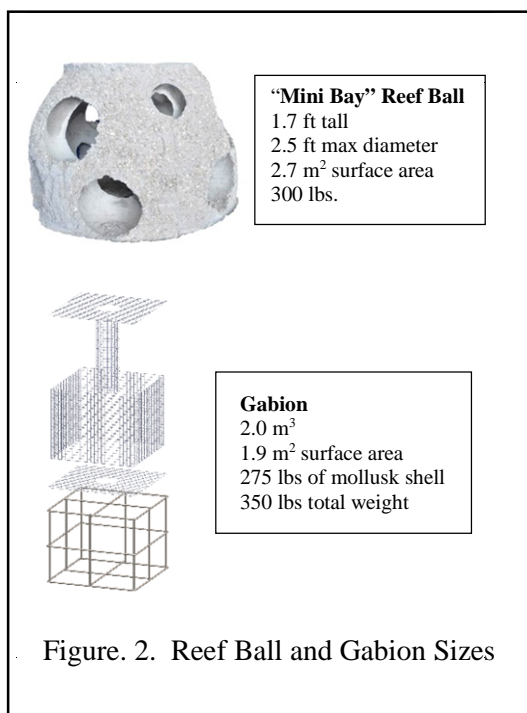
Figure 2. Reef Ball and Gabion Sizes

The three sites for full-scale mitigation (oyster reef restoration) were chosen based on earlier studies that characterized the occurrence of natural reefs with live oysters (Princeton Hydro 2015) and were among the sites recommended for further study based on overall environmental characteristics (AKRF 2016a, b). These initial studies were followed by a 3-year (2015-2017) pilot study that assessed the performance of three potential restoration substrates at several potential restoration sites (Lodge et al. 2020). The performance metrics included attracting (recruiting) oysters, supporting oyster growth and survival, and the longevity and sustainability of the three different substrates and construction techniques: 1) metal gabion cages containing oyster shells; 2) small Reef Balls (“Lo-Pro”); and 3) larger Reef Balls (“Mini-Bay”). The pilot study determined that Mini-Bay reef balls and shell-filled gabions provided effective substrates, and were chosen for the full-scale reef restoration efforts. The reef balls are 1.7 feet tall, 2.5 ft wide at the base, and weigh approximately 300 lbs. The gabions were

fabricated using ½” steel rod and 12.5 gauge wire stainless steel 1" mesh. The gabions are 2³ feet and weigh approximately 350 lbs. (Figures 2 and 3). The gabions were filled with approximately 5 cubic feet of cured mollusk shell (approximately 85% oyster, 15% hard clam). Installation of the substrates occurred in July 2018.

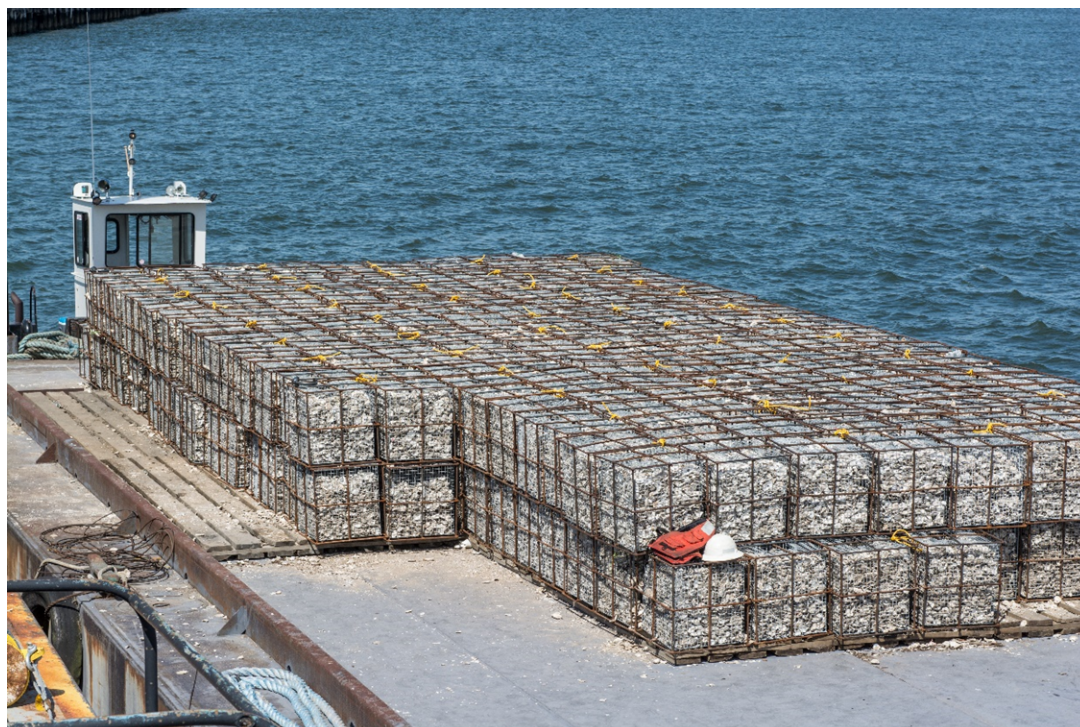
Figure 3. 422 Gabions pre-deployment.

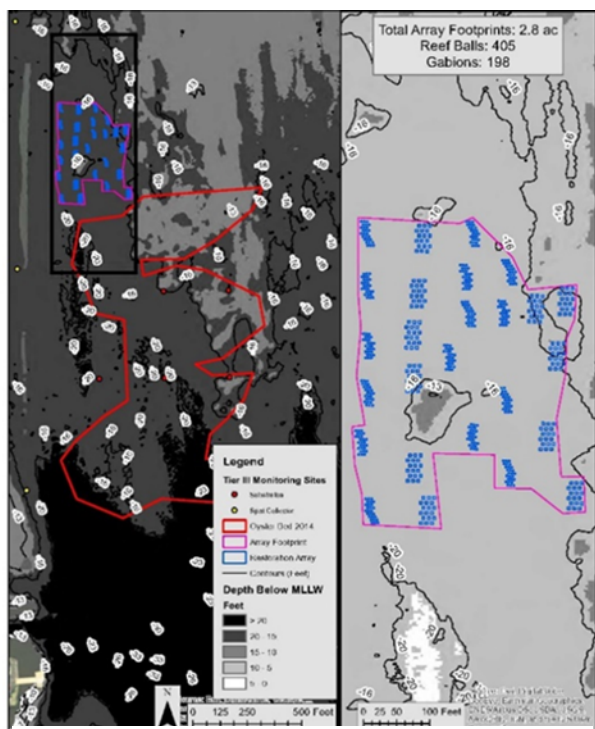
Figure 4. Site 1 Locations of reef balls and gabions

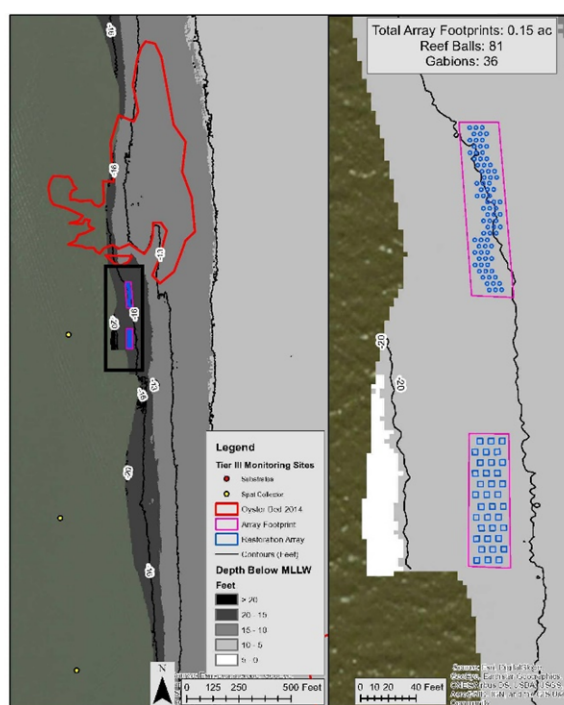
Figure 6. Site 0 “The Glove”

Site 0. Site 0 “The Glove” encompasses an area of 0.07 acres and consists of 54 reef balls and 36 gabions, each in a single cluster (Figure. 6).

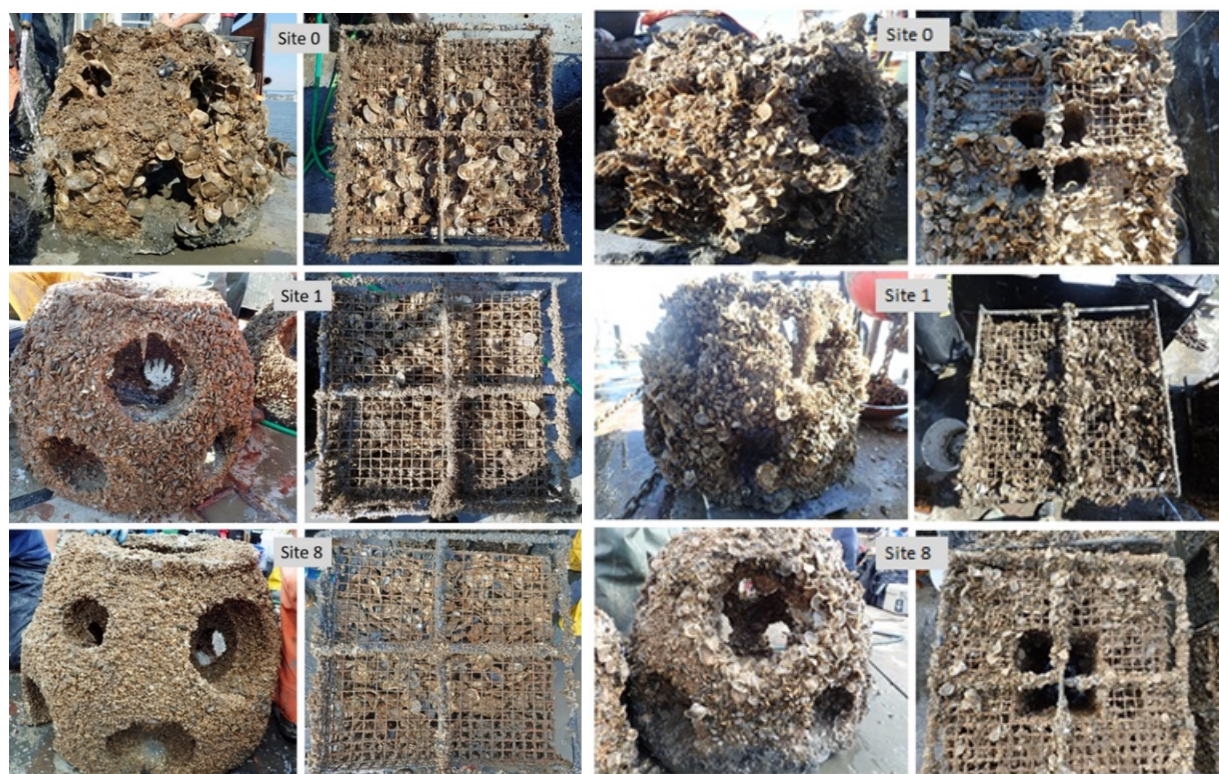
Figure. 7. Photos of typical substrates retrieved from the three mitigation sites during 2019 (left) and 2020 (right).

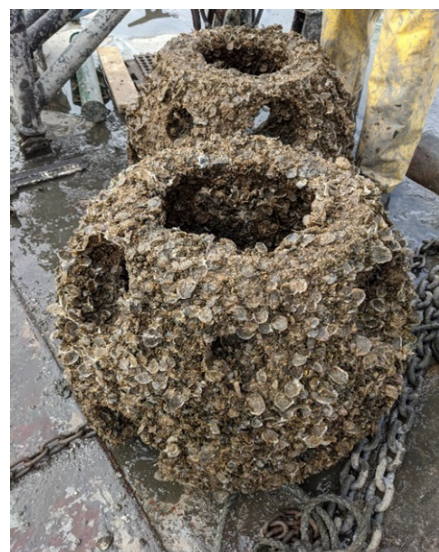
Figure 8. Reef Balls from Site 0

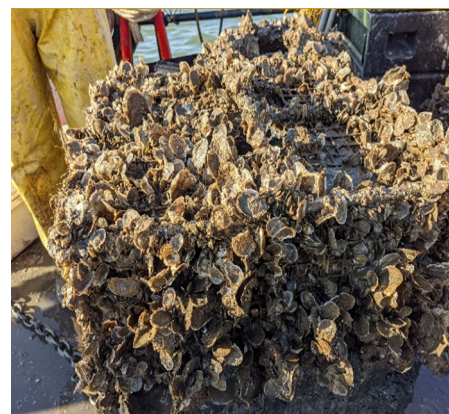
Figure 9. Gabion from site 0

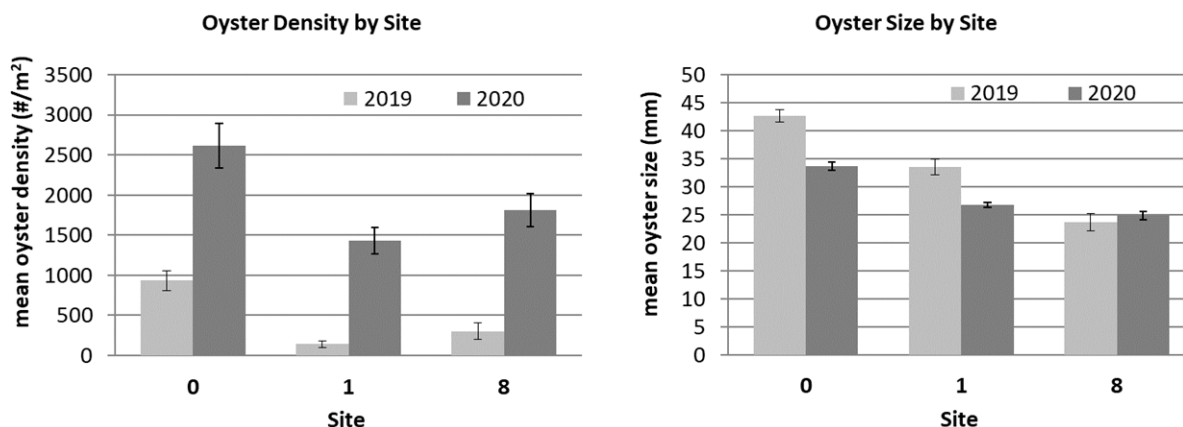
Among-site differences in oyster metrics: There were marked differences in oyster density and mean size among the sites for both years of the study. Both annual datasets (2019 and 2020) showed the same by-site (data from both substrate types combined at each site) trends for live oyster density: Site 0 > Site 8 > Site 1 (Figure. 10). Two-way analysis of variance (ANOVA) of the 2020 dataset indicated significant differences ($p < 0.0001$) among the three sites for both density and size. For both density and size, t-tests indicated Site 0 was significantly ($p < 0.05$) greater than Sites 1 and 8. These data suggest better conditions for individual oyster growth and perhaps survival at Site 0. It should also be noted that mean oyster density increased from 2019 to 2020 at all three sites but mean oyster size did not show a similar increase; rather a decrease in size was observed at two of the three sites.

Figure. 10. Mean (± 1 SE) live oyster densities (left) and live oyster shell height (right) by site when data from both substrate types (gabions and Reef Balls) were combined.

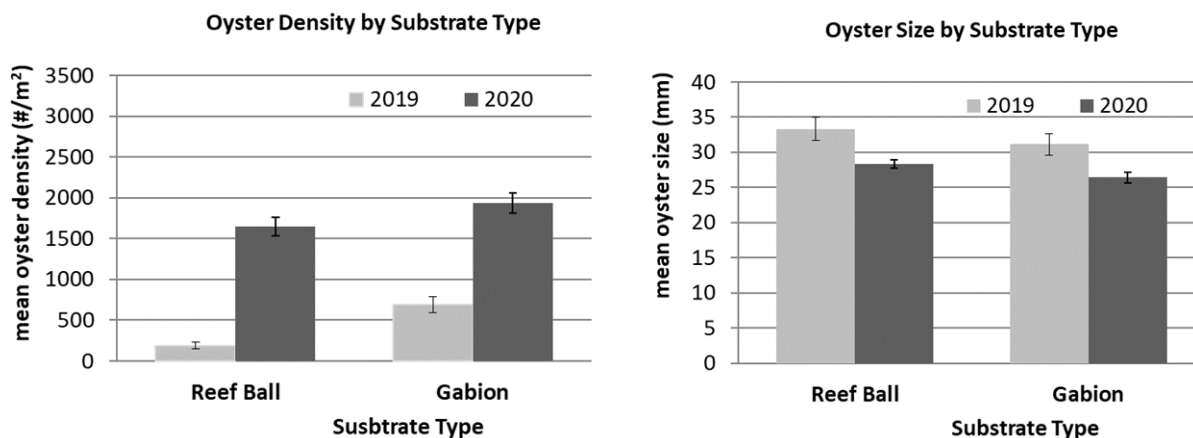
Substrate type and oyster metrics: The effect of substrate type on oyster metrics was assessed on an overall basis after combining the data from all three sites (Figure. 11). The same relative trends were observed in 2019 and 2020. T-tests on the 2020 data indicated no significant ($p > 0.05$) differences in density or size on the two substrates. It should be noted that the greater densities on the gabions compared to the Reef Balls in 2019 – which represented initial recruitment – may indicate that the magnitude of the differences between the two substrates decreased as the reef develops. Longer-term studies are needed to assess this as well as other aspects of reef development.

Figure. 11. Mean (± 1 SE) oyster densities (left) and oyster shell height (right) by substrate type when data from all three sites were combined.

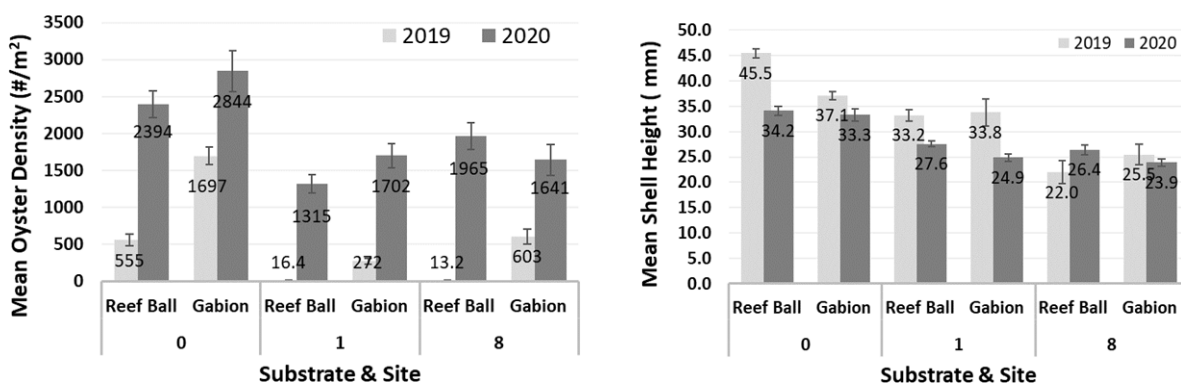
Potential interactions between site and substrate: This assessment provided information on how oyster metrics on the two substrates may have varied among the three sites. Two-way analysis of variance (ANOVA) of the 2020 dataset on oyster density and size indicated no significant interaction ($p > 0.05$) between sites and substrate types (Figure. 12).

Figure. 12. Mean ($\pm 1SE$) oyster densities (left) and oyster shell height (right) by site and substrate.

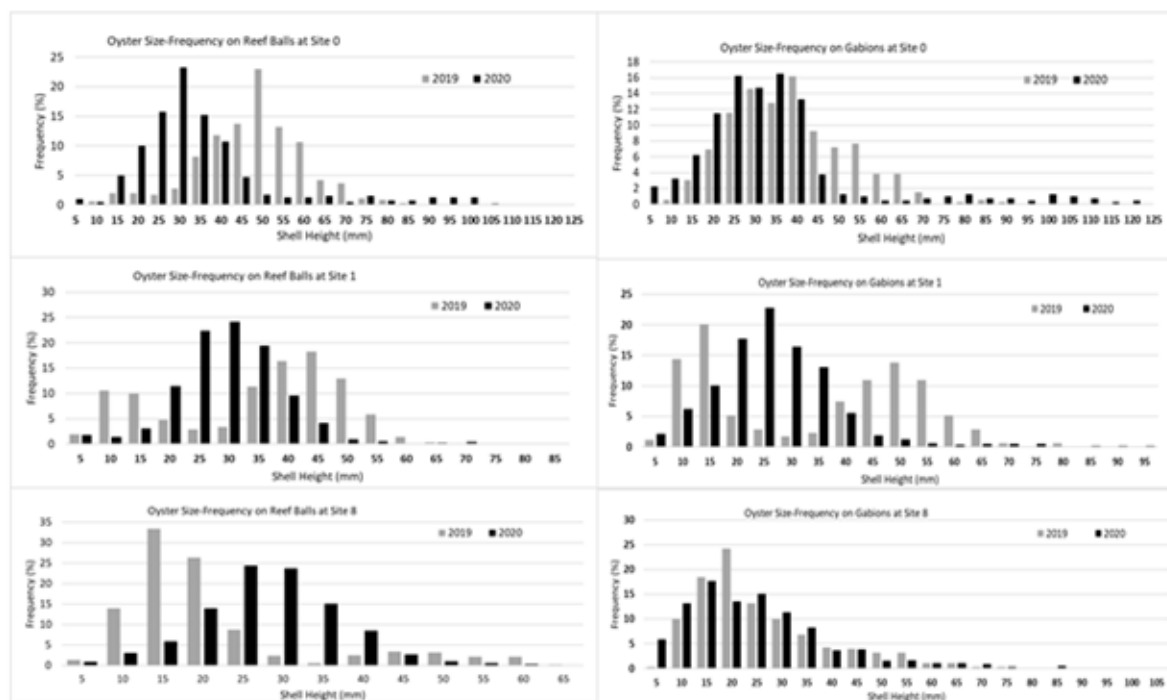
Oyster size distributions by site and substrate: Three size/year classes of oysters were expected on the substrates sampled in October 2020 because their deployment in July 2018 allowed for three summer reproduction periods. Size-frequency plots of the 2019 data indicated two size/year classes and the 2020 data clearly indicated three classes at Site 0, where the largest oysters in 2020 exceeded 120 mm shell height (Figures 13 and 14). Because of variability in oyster growth, it is unclear whether some of the larger oysters (range of 70-85 mm shell height) collected at Site 1 and Site 8 were representative of two (2018-2019) or three (2018-2020) size/year classes. Higher mortality losses at Sites 1 and 8 could potentially explain the lack of larger oysters at those sites in 2020.

Figure. 13. Size-frequency distributions by site and substrate type for fall 2020 oyster data.

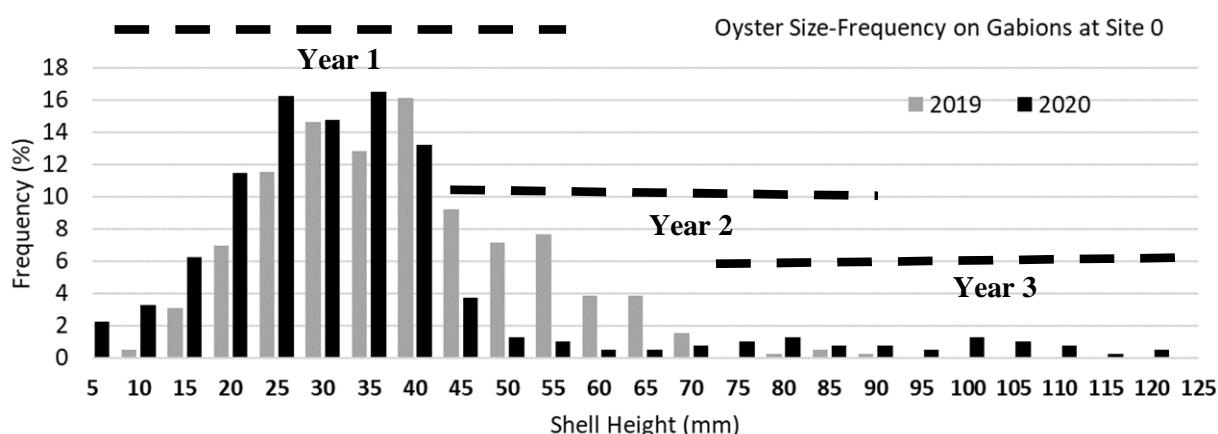
Growth rates of 25 to 40 mm/year for the first few years have been reported in earlier studies in the region (Cerrato 2006; Medley 2010; Levinton and Doall 2011; Grizzle et al. 2013, 2016; Levinton et al. 2013). Although growth rates can vary widely from site to site, using 35 mm/year as an approximate mean value, the size-frequency data from Site 0 for both years indicates two-year classes in 2019 and three in 2020. Data from the other sites and substrates were more variable, which may indicate variations in growth and/or survival rates among the sites and between the substrates. Therefore, as stated above, it is unclear whether some of the larger oysters collected at Sites 1 and 8 are representative of the two or three year classes. One major difference in patterns between the two years was strong small size classes (10 – 15 mm) at Sites 1 and 8 in 2019 but not 2020. Since there already was a relatively dense oyster population of various sizes at Site 0 prior to the restoration effort, it's possible that environmental conditions there are better for oyster recruitment, but additional years of data would be needed to test this.

Figure. 14. Size-frequency distributions for gabions only at Site 0 in 2019 and 2020. Dashed lines denote probable size/age classes based on previous studies in the region (see text).

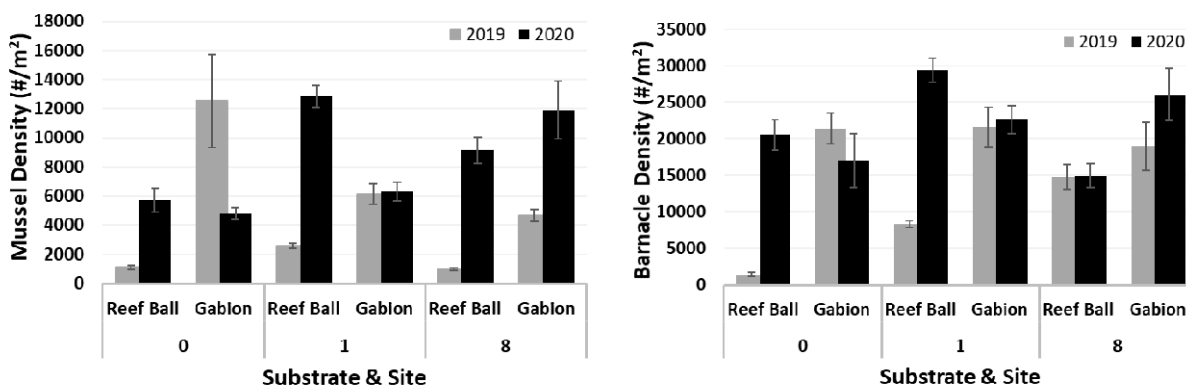
reef development patterns. Overall there appears to be an increase in mussel and barnacle densities between 2019 and 2020 but the increase was not always consistent among sites or between substrates.

Figure. 15. Non-oyster invertebrate densities by substrate type and year.

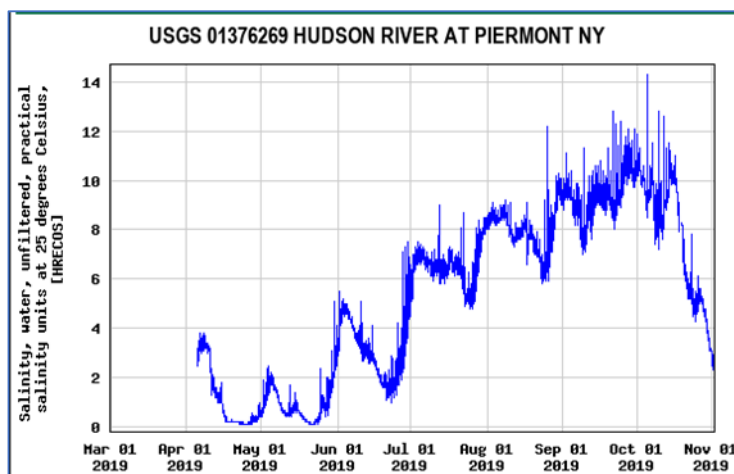
The present project also provides additional data on surprisingly robust oyster performance in waters of very low salinity. During the 5-year study period, spring and early summer (April – July) salinity measurement were typically less than 5 PSU and sometimes zero for several days to weeks (Figure 16 and Attachment B). Strong oyster performance despite these apparently extreme conditions has implications for restoration practitioners utilizing habitat suitability models and suggests careful consideration be given to using data and models from outside of this region.

Figure. 16. Salinity data from Piermont HRECOS station near Site 1, May-November 2019 (<https://hrecos.org/>).

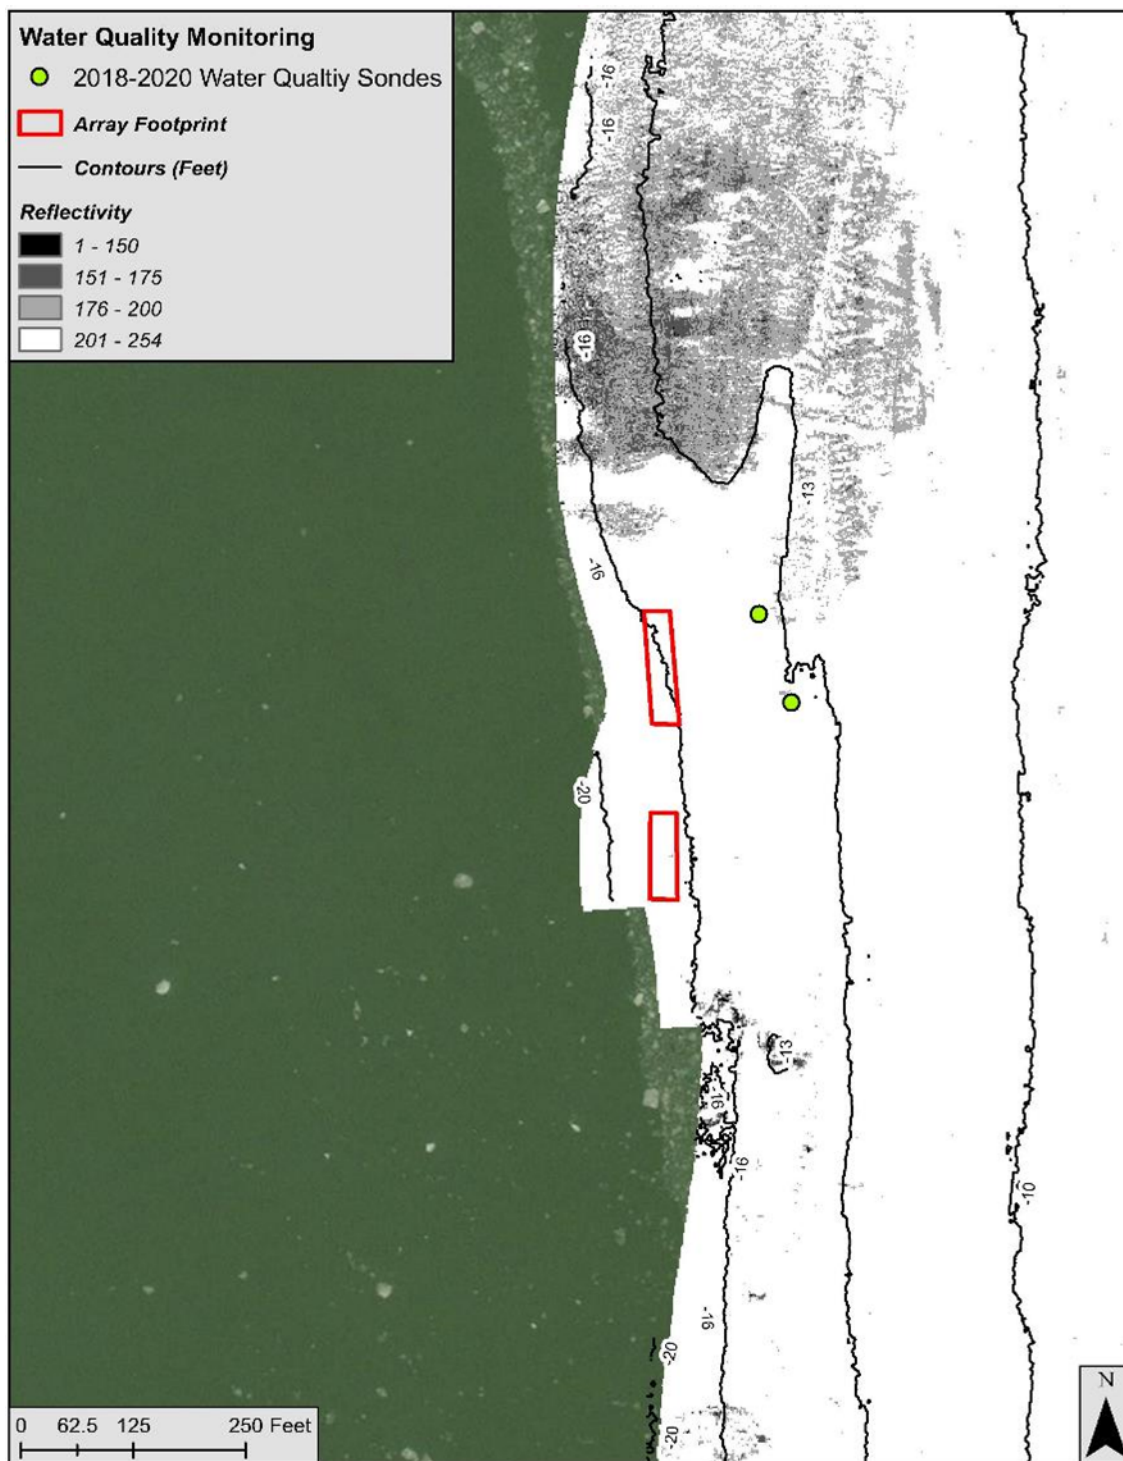
Figure 2: Site 0 Oyster Monitoring and Restoration Array Locations

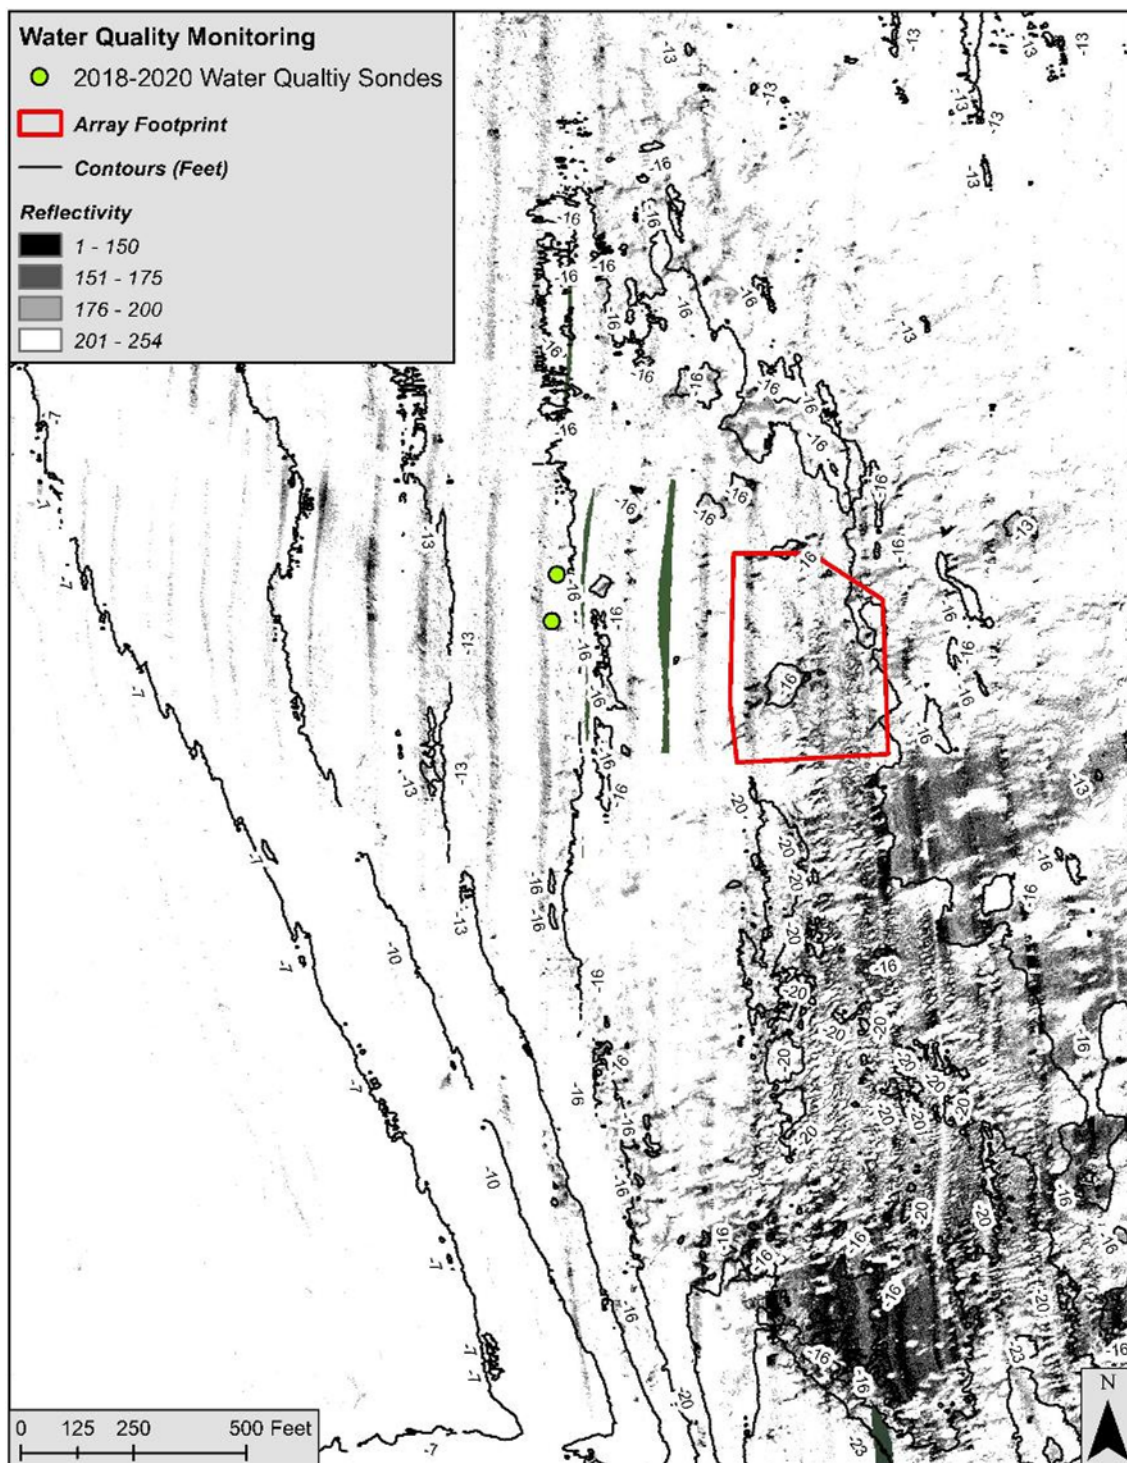
Figure 3: Site 1 Oyster Monitoring and Restoration Array Locations

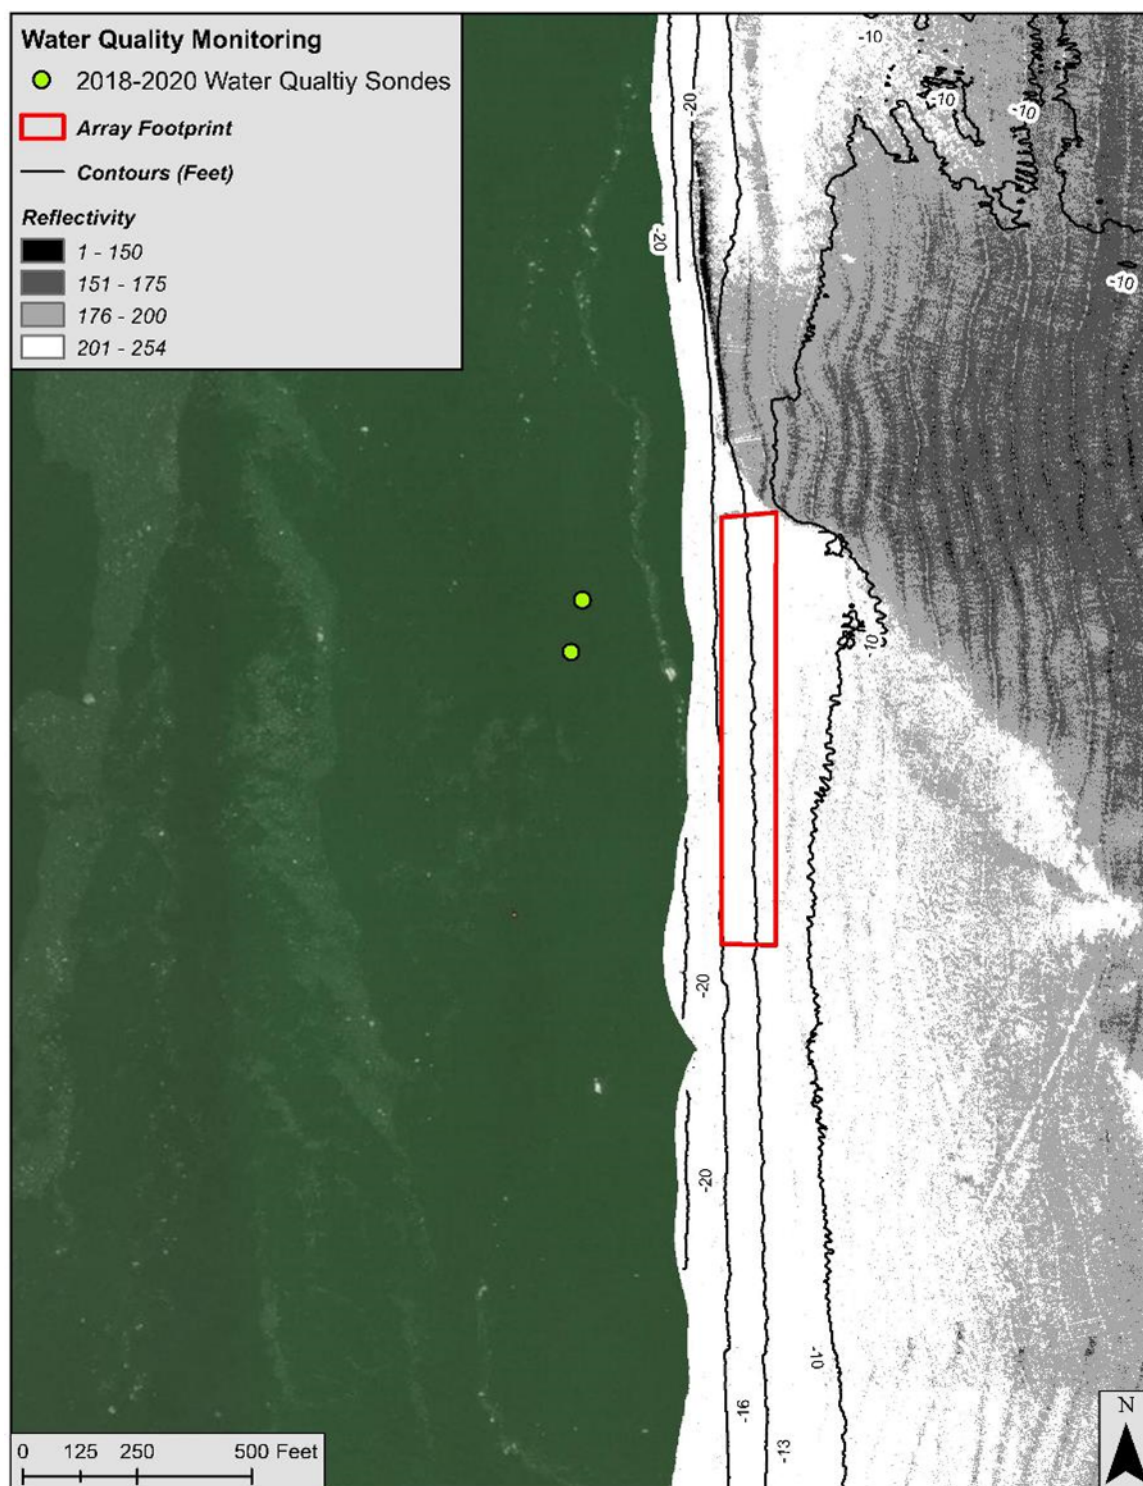
Figure 4: Site 8 Oyster Monitoring and Restoration Array Locations

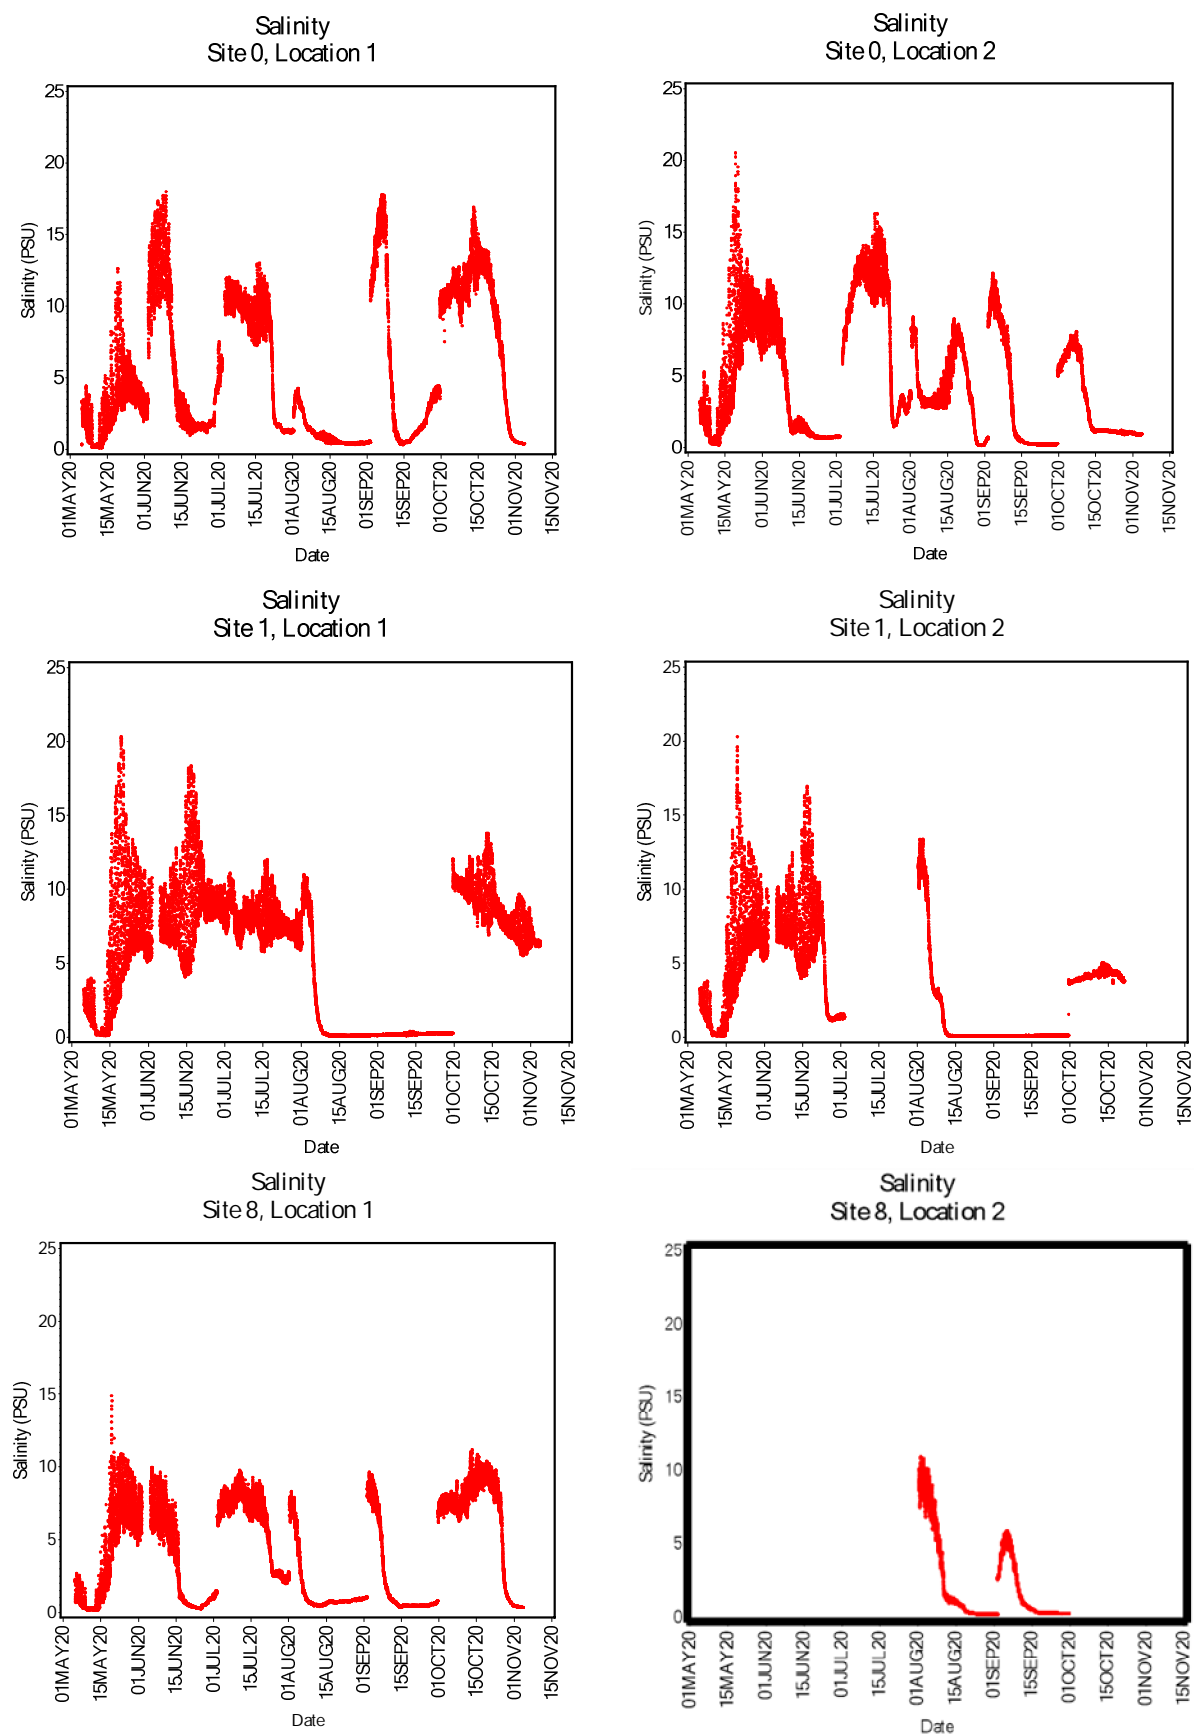
Figure A-1. Temporal trends in salinity at locations 1 (left) and 2 (right) at Sites 0, 1, and 8.

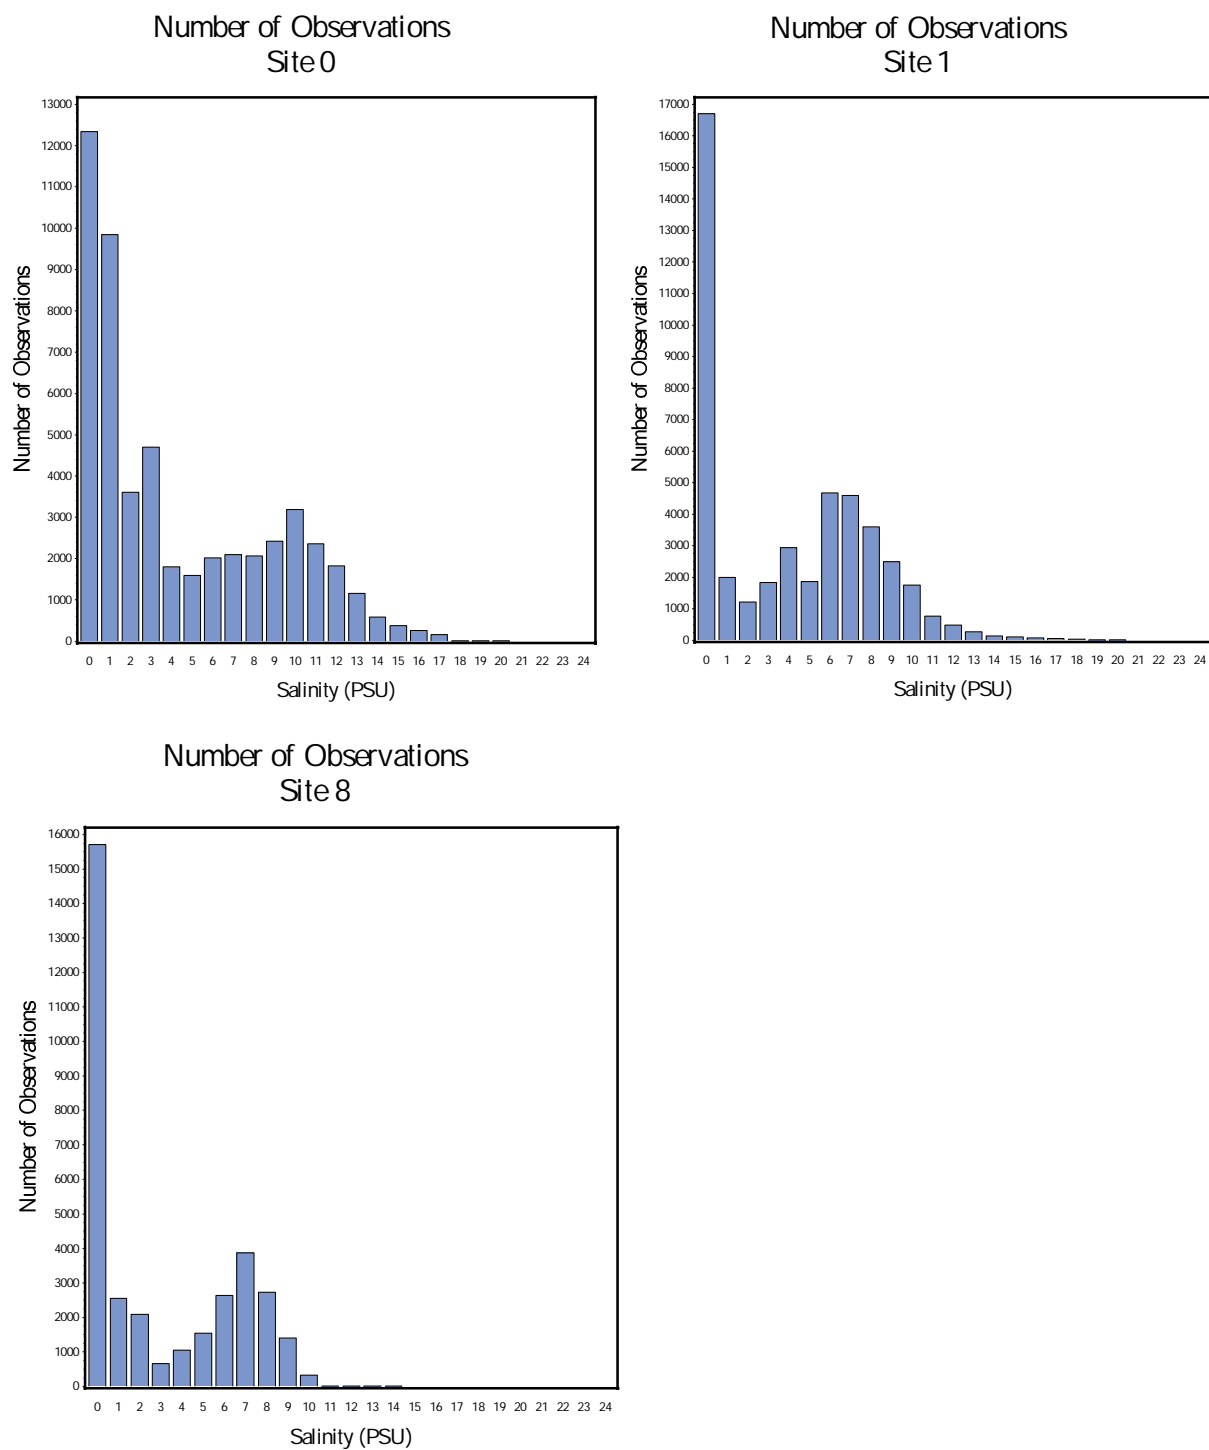
Figure A-2. Salinity frequency distribution at Sites 0, 1, and 8 (locations 1 and 2 combined)

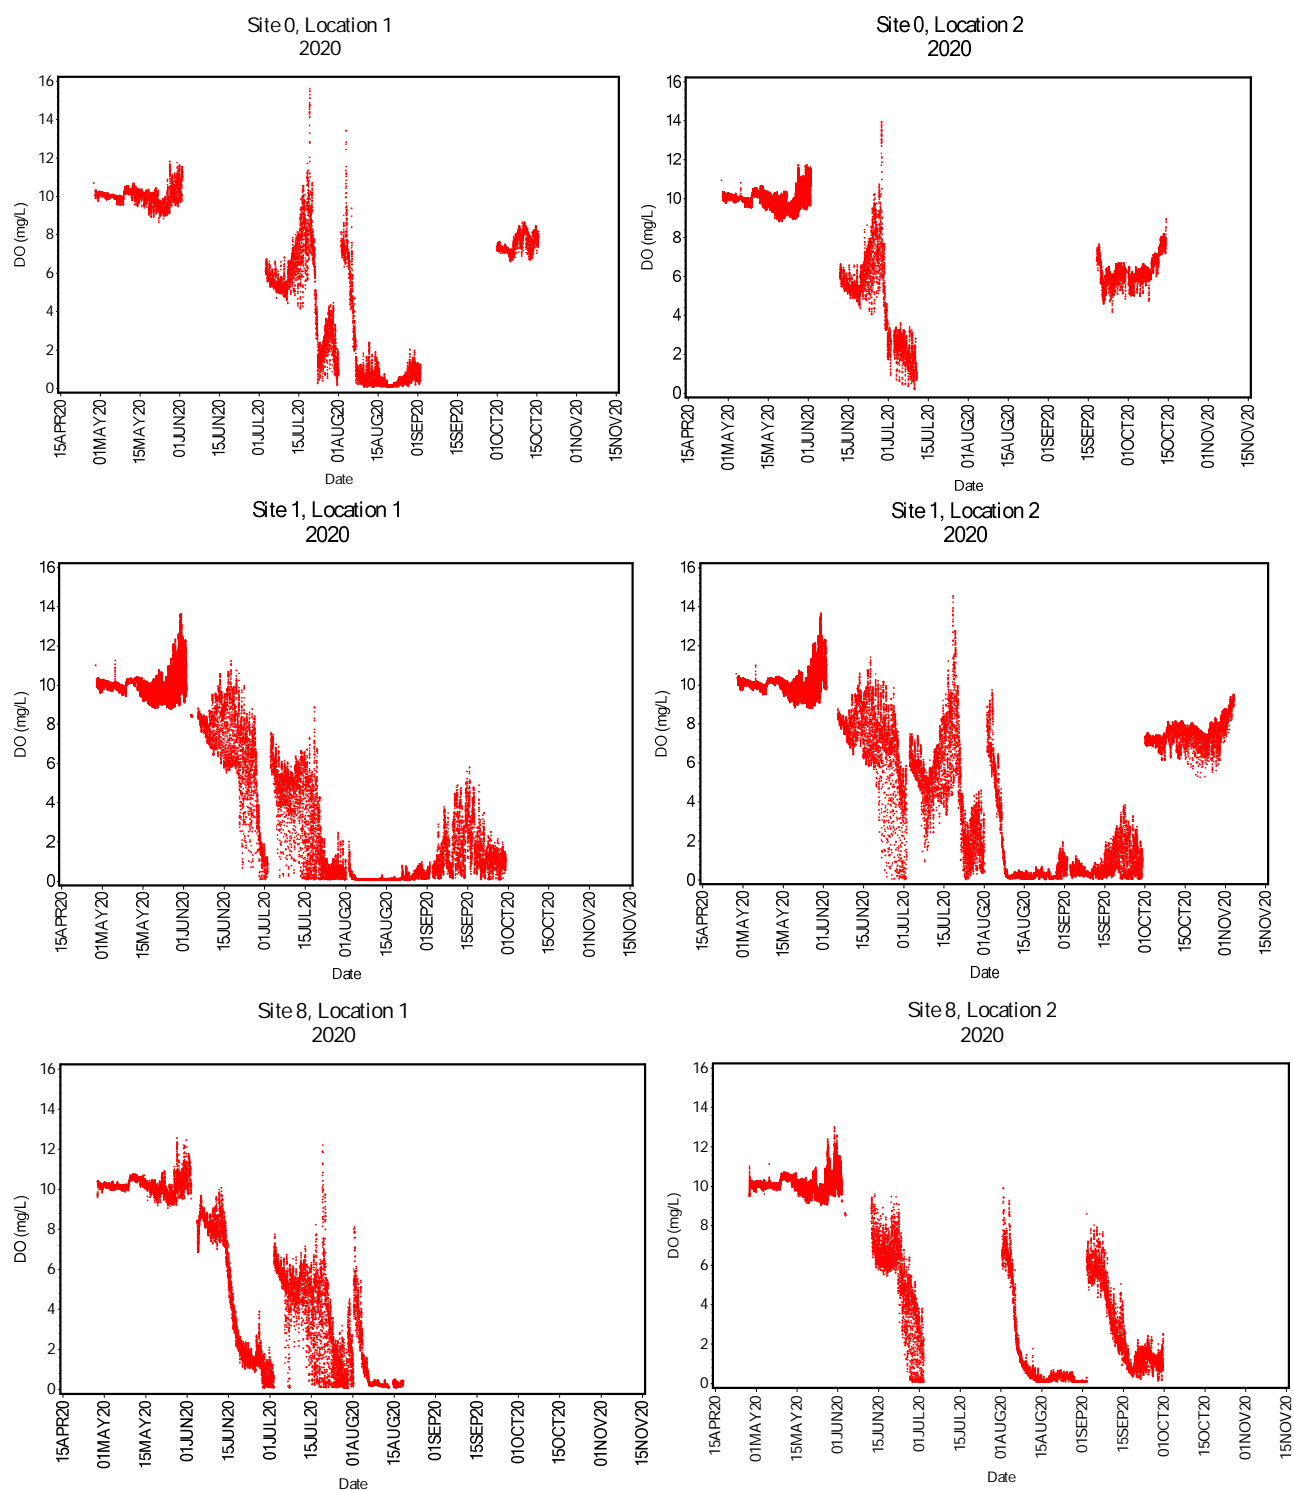
Figure B-1. Temporal trends in dissolved oxygen at locations 1 (left) and 2 (right) at Sites 0, 1, and 8

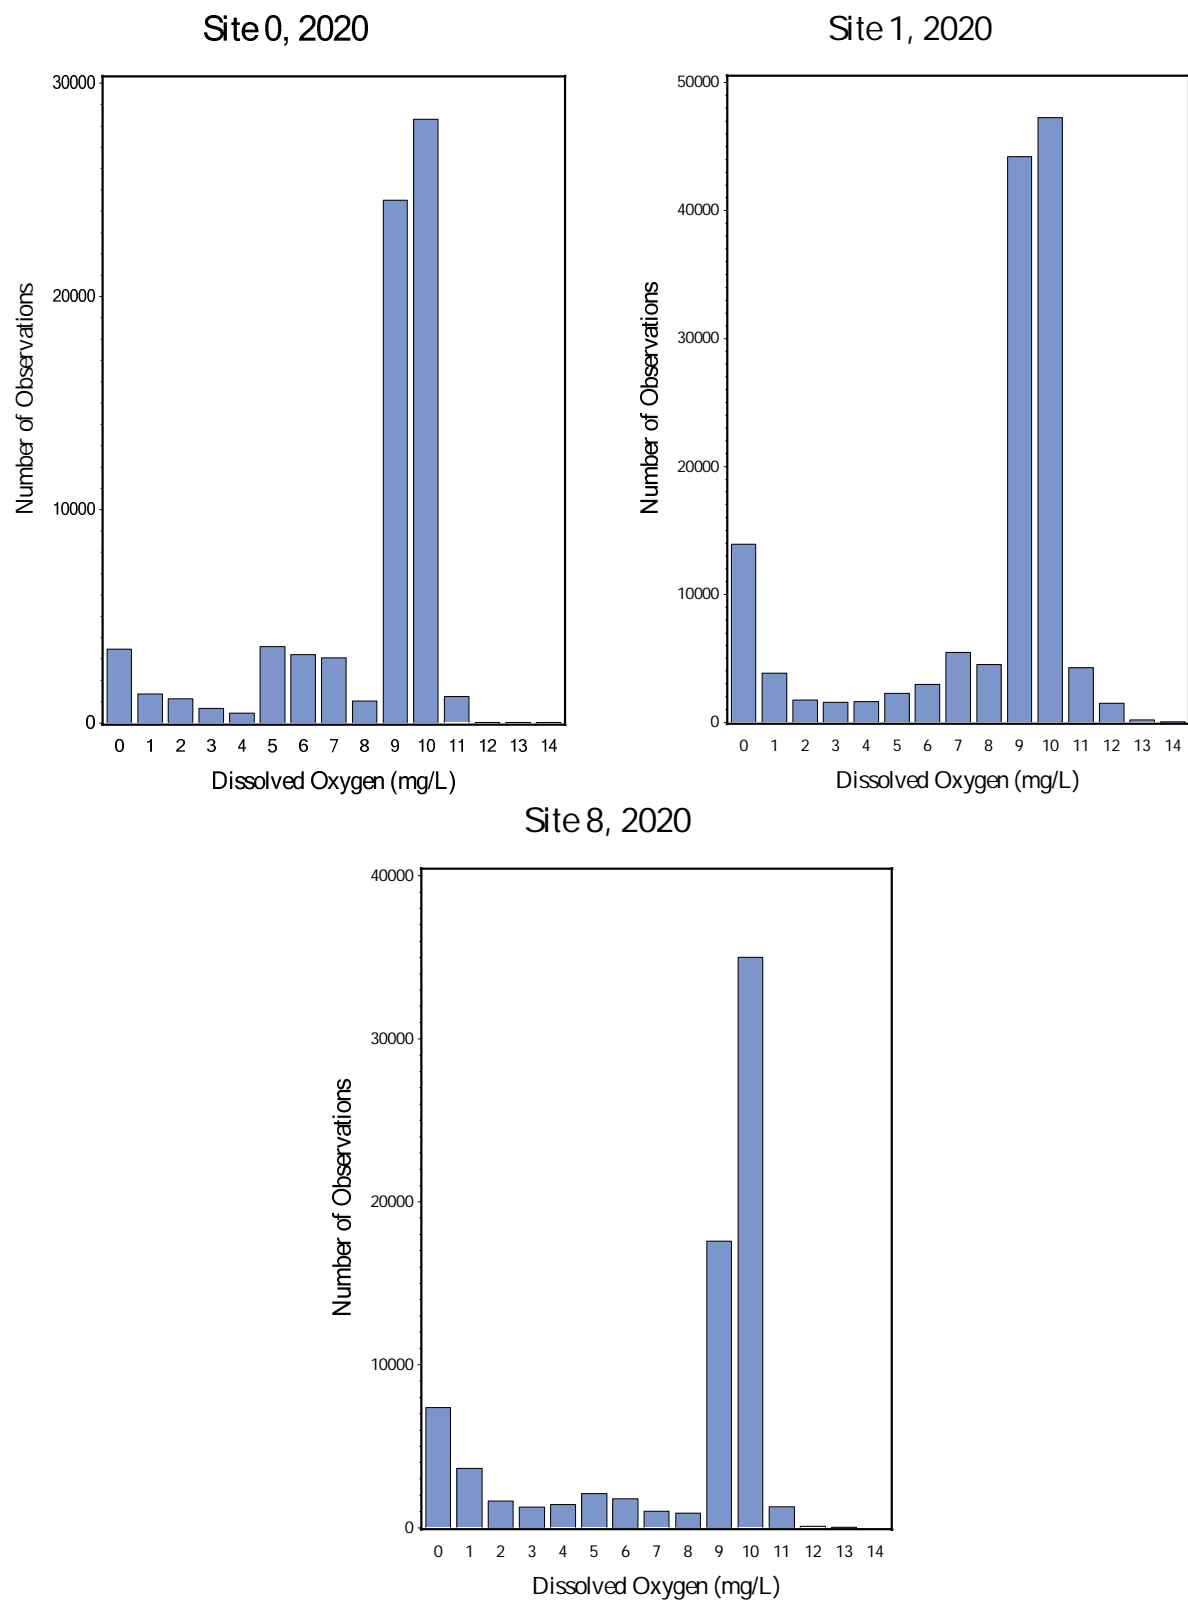
Figure B-2. Dissolved oxygen frequency distribution at Sites 0, 1, and 8 (locations 1 and 2 combined).
