2020 POST-CONSTRUCTION OYSTER MONITORING FINAL REPORT

The Governor Mario M. Cuomo/New NY Bridge Project at Tappan Zee Oyster Substrate and Water Quality Monitoring

April 5, 2021

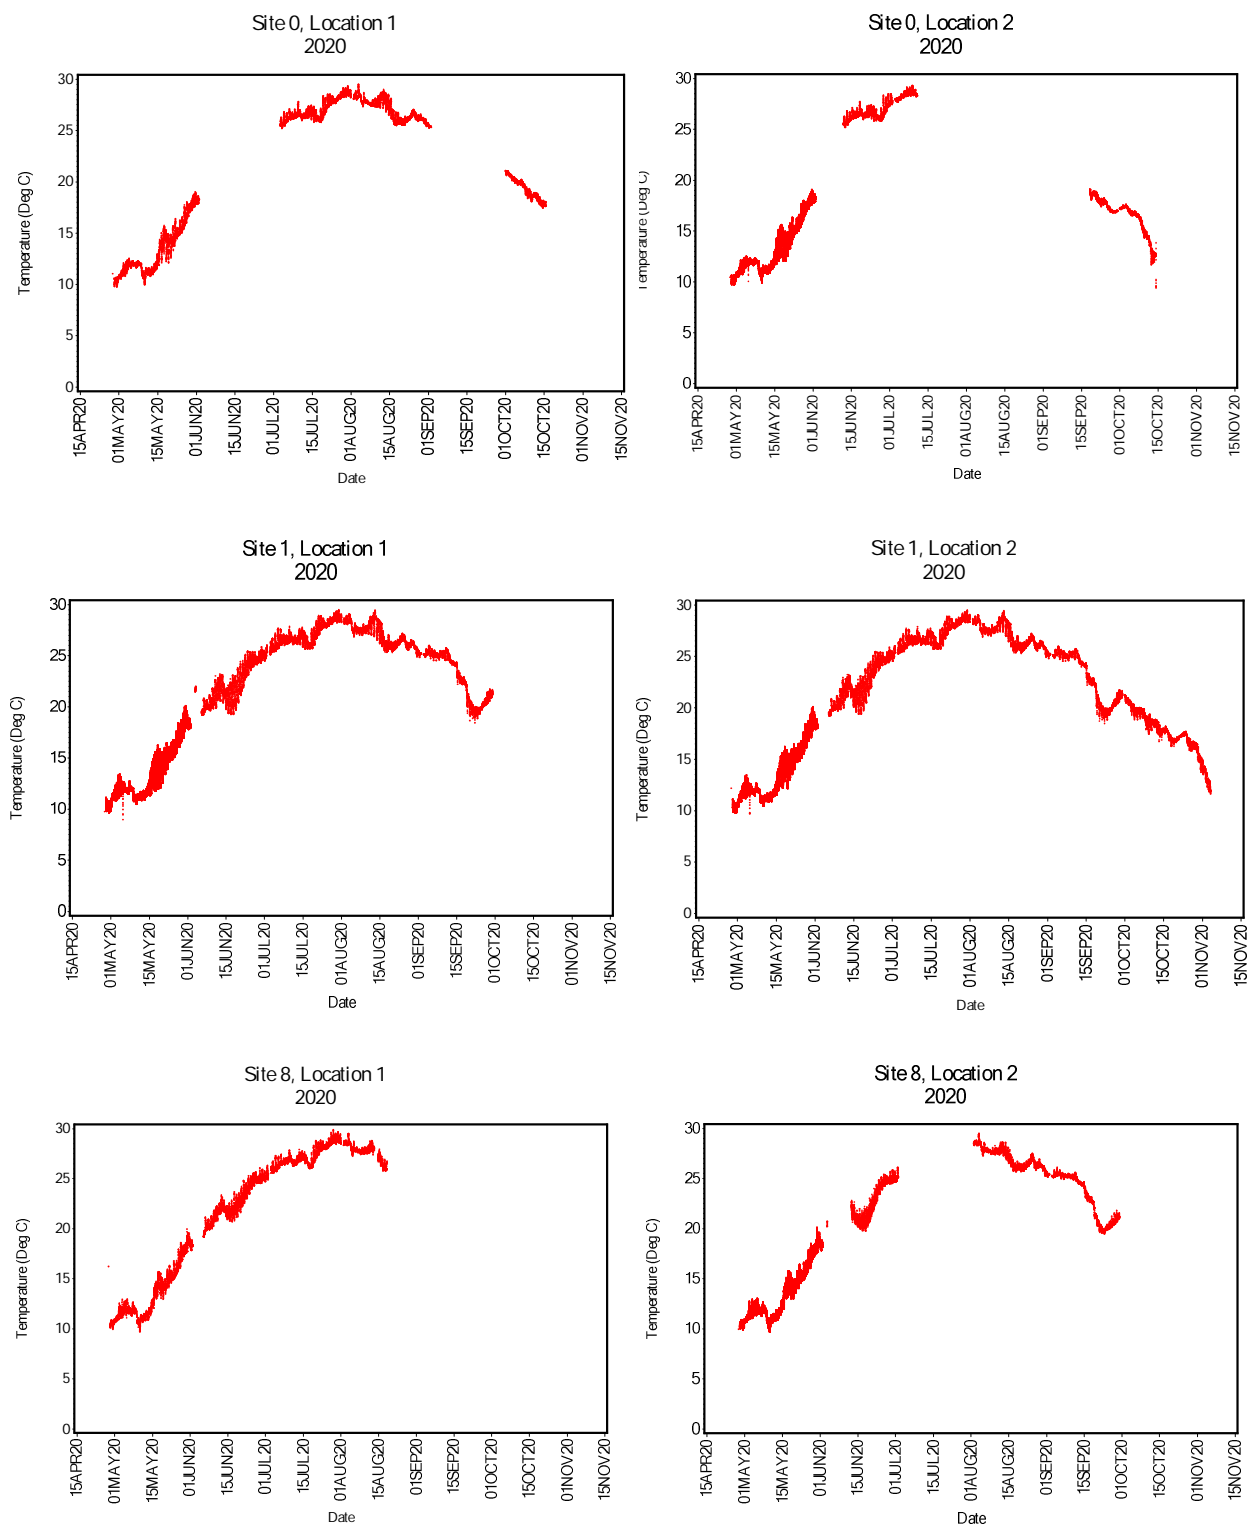
Figure C-1. Temporal trends in temperature (°C) at locations 1 (left) and 2 (right) at Sites 0, 1, and 8.

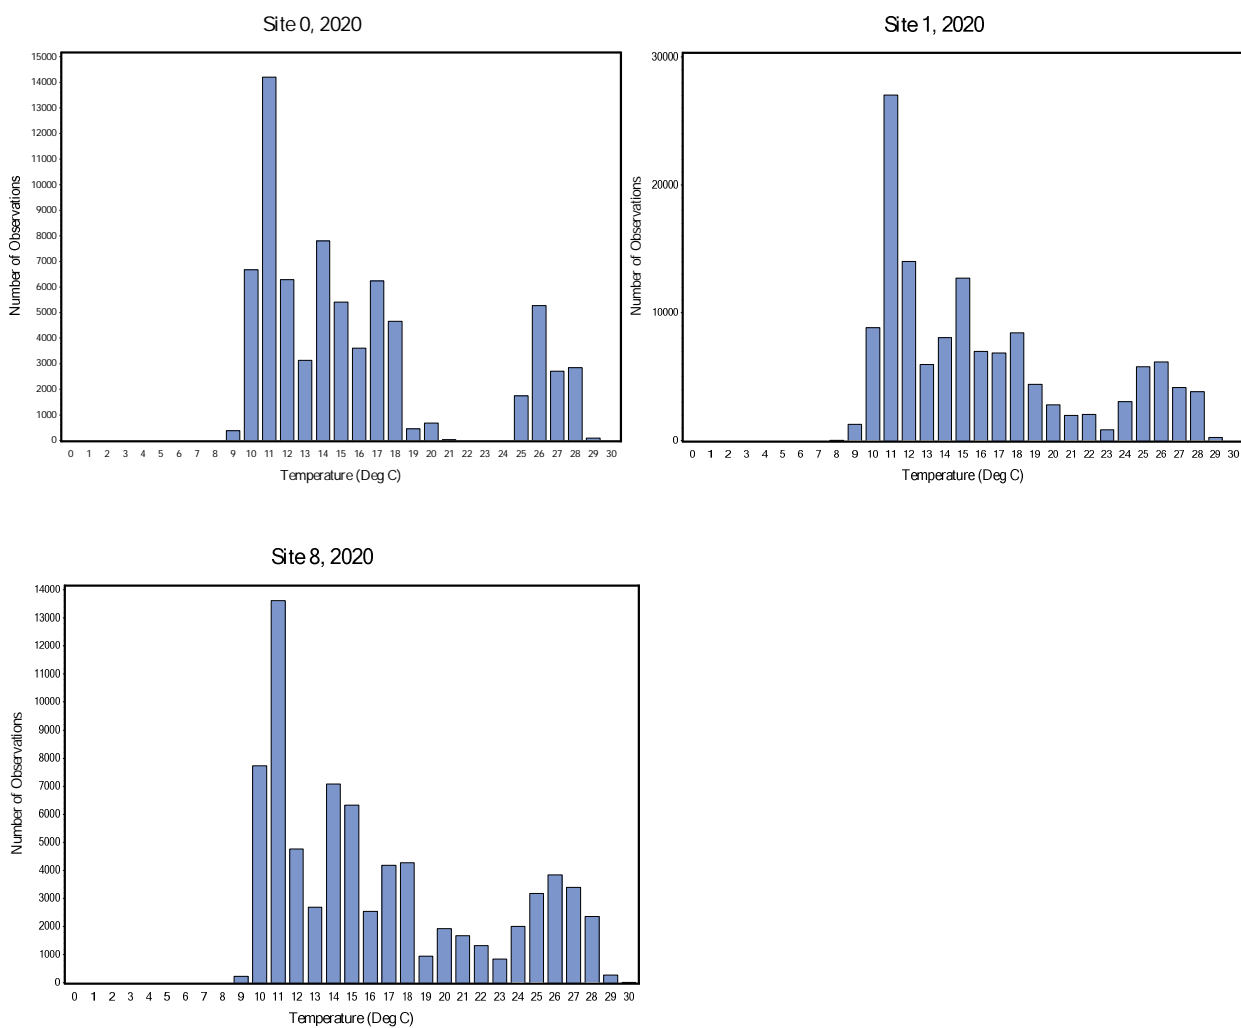
Figure C-2. Temperature frequency distribution at Sites 0, 1, and 8 (locations 1 and 2 combined).

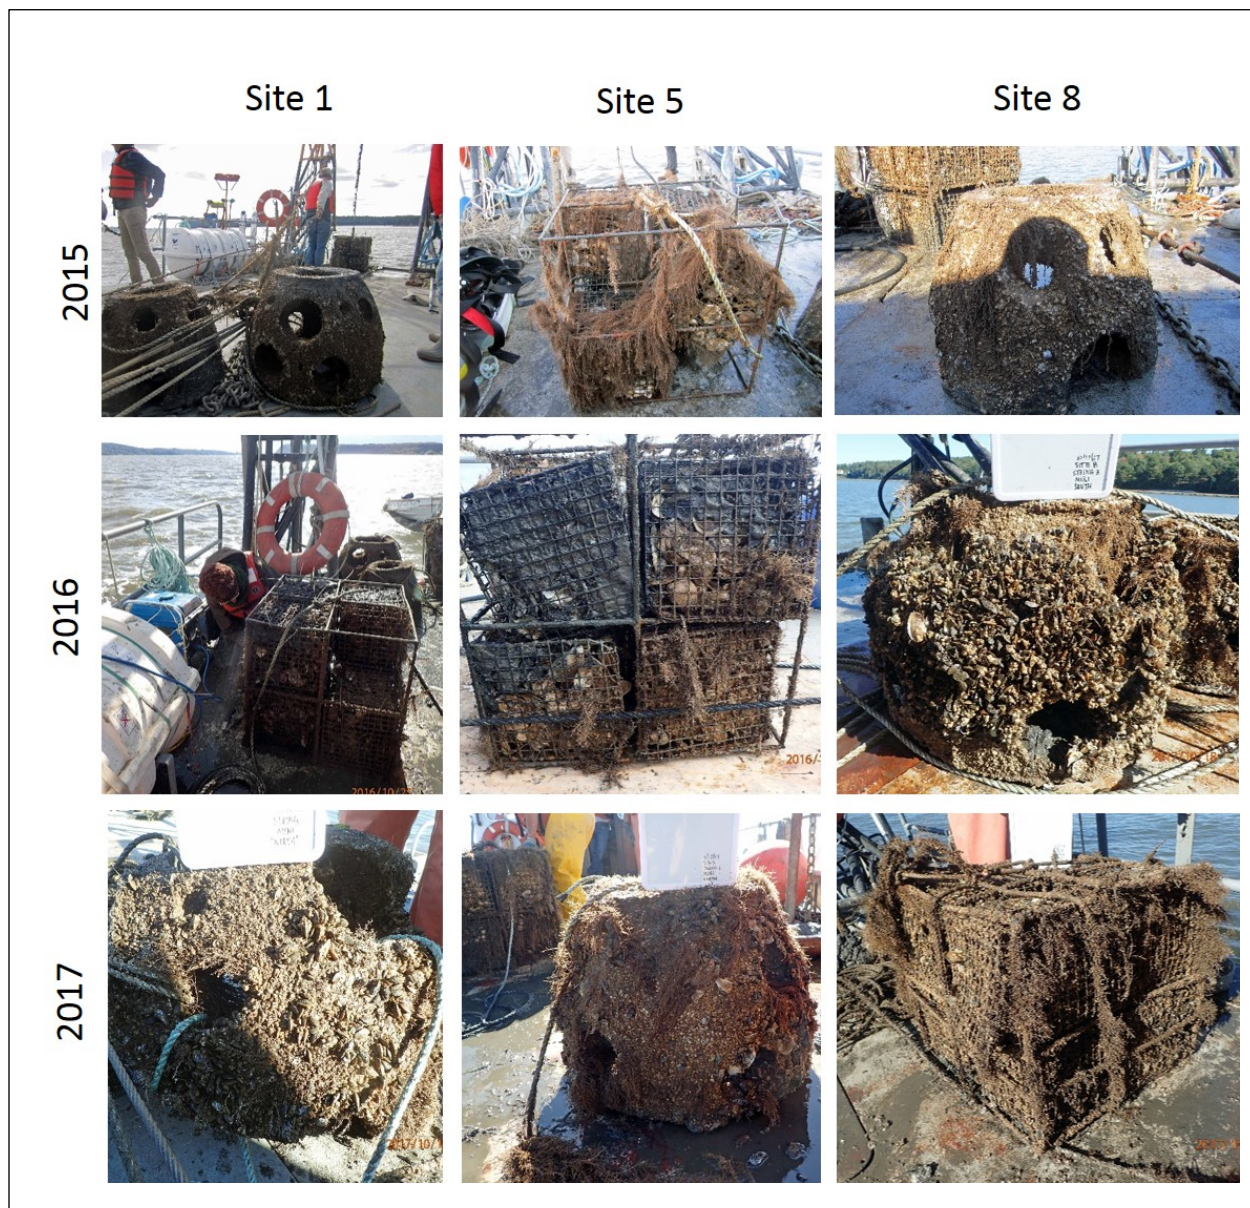
One replicate (with all three substrate types) was retrieved from Site 8 on October 15, 2015 and from Sites 1 and 5 on October 16, 2015 (Table 1; Fig. 2). These samples represented 4 months of development of the invertebrate communities on the test substrates. All three substrates from all three sites were in good condition. The major issue was in locating and connecting with the substrate lines, resulting in only one complete set of substrates being retrieved from each site. The gabion at Site 5 was also damaged.

One replicate (with all three substrate types) was retrieved from Site 8 on October 24, 2016 and from Sites 1 and 5 on October 25, 2016 (Table 1; Fig. 2). These samples represented 16 months of development of the invertebrate communities on the test substrates. All of the substrates were in good condition, except two of the mini-gabions had been lost from one of the gabions at Site 5 and the rebar used for framing the gabions showed signs of deterioration (Fig. 2).

Two complete replicates from Site 8 and one complete replicate from Site 5 were retrieved on October 17, 2017. One replicate was retrieved from Site 1 on October 18 but the gabion was missing (Table 1; Fig. 2). Most of the Reef Balls were in good condition, except some that may have been damaged in the sampling process. In contrast, most of the gabions showed signs of deterioration that in large measure appeared to be the result of failure of the rebar framing from broken welds.

Fig. 2. Retrieval of test substrates by year and site. Note damaged gabions all three years.

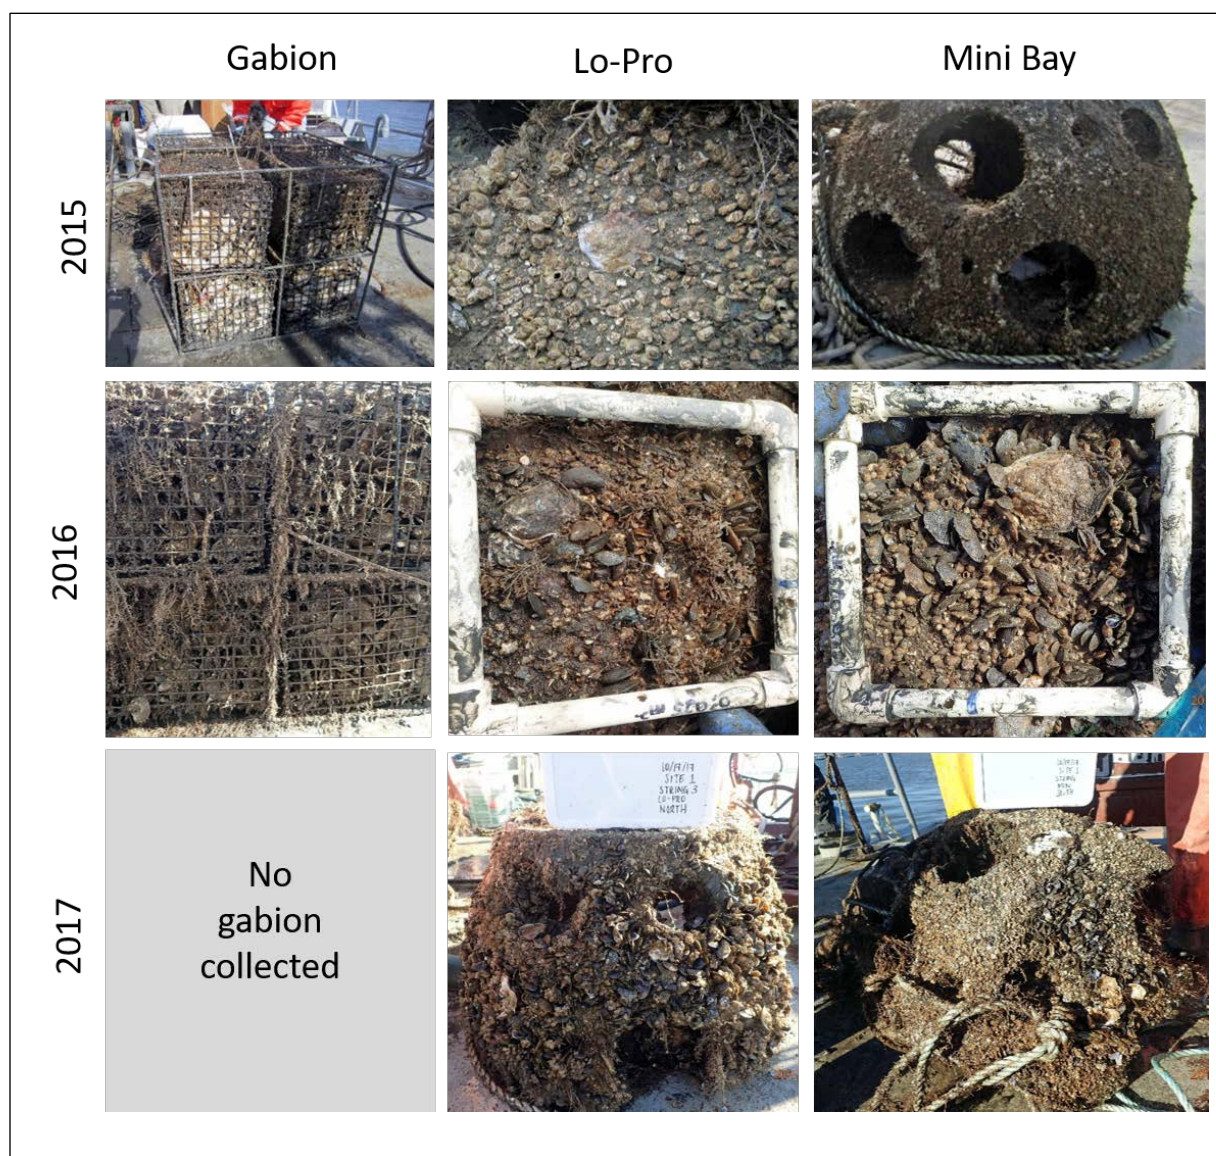
Fig. 3. Example photos of the oyster reef community on three substrate types each of the three years from Site 1.

Figures 3 – 5 below provide photographic documentation of the overall 3-year development of oyster reef communities (oyster populations and other fouling organisms) on the test substrates at each of the three study sites. Although substantial quantitative differences were evident (as discussed below), there was good oyster reef development on all three substrates and at all three sites.

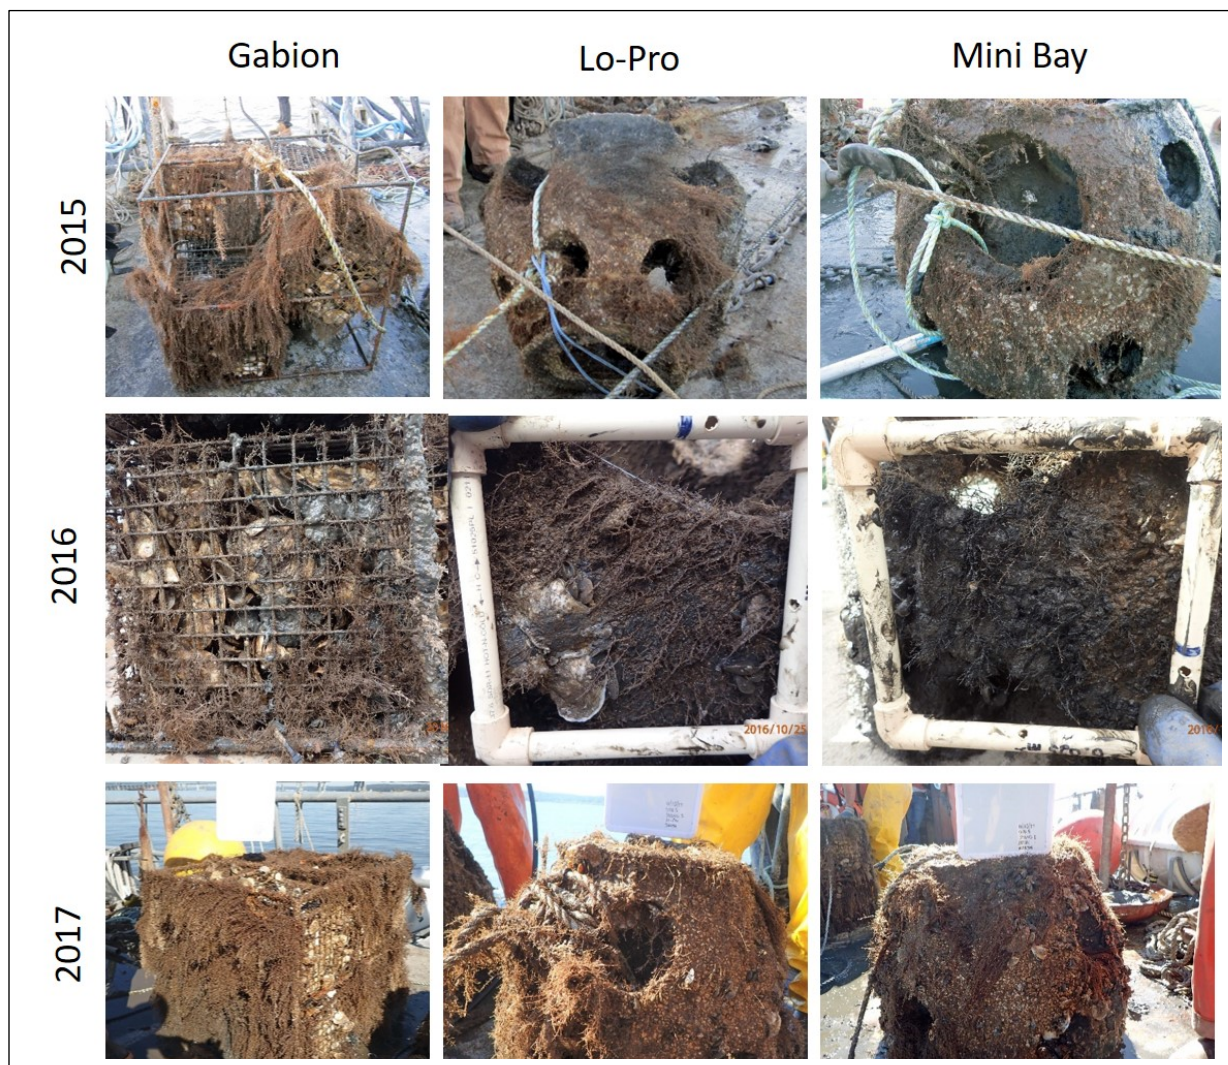
Fig. 4. Example photos of the oyster reef community on three substrate types each of the three years from Site 5.

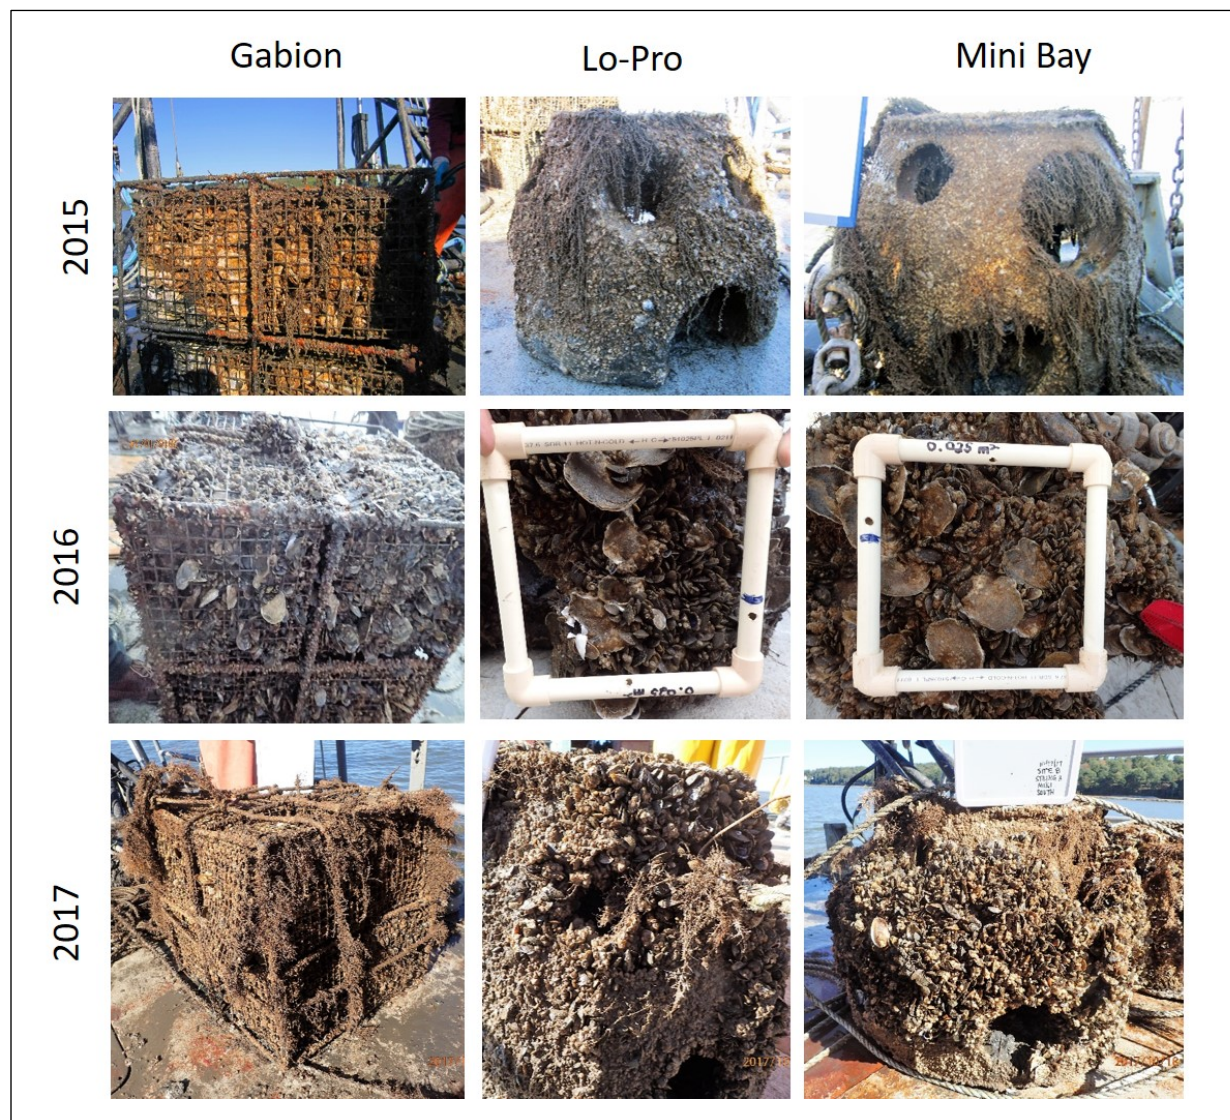
Fig. 5. Example photos of the oyster reef community on three substrate types each of the three years from Site 8.

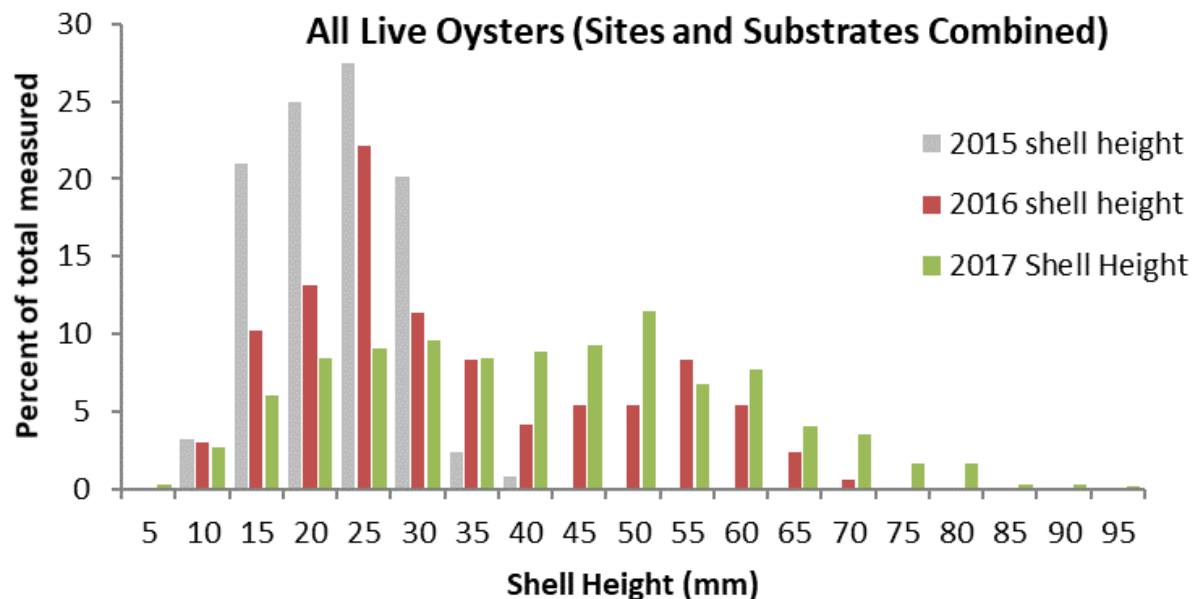
Fig. 6. Size-frequency histogram for all oysters measured on all three substrates and from all three sites.

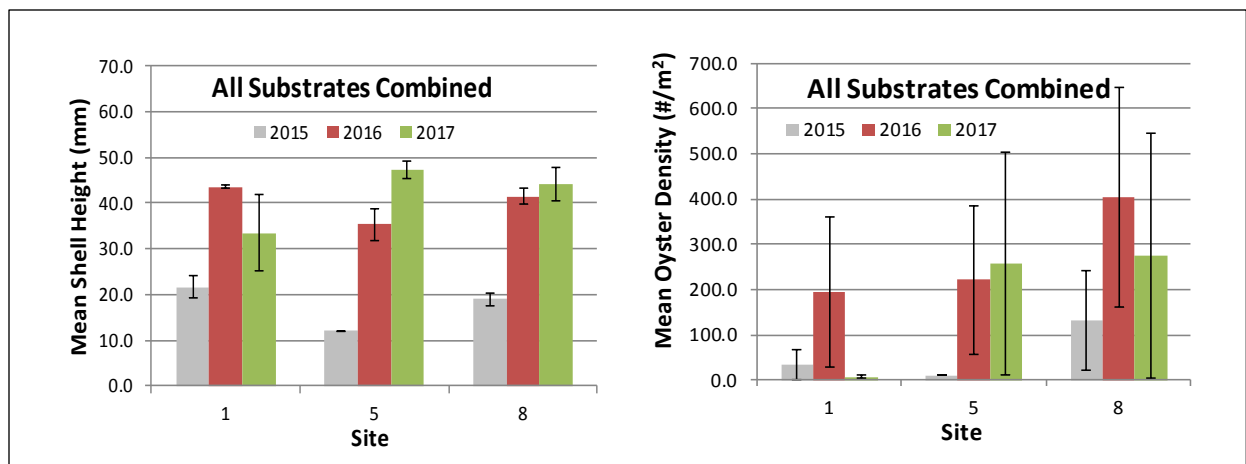
Assessment of the oyster size data by site and year (combining all three substrates) indicates similar mean shell heights were at all three sites, suggesting similar environmental characteristics among the three sites that affect oyster growth (Fig. 7). Focusing on the 2017 data, ANOVA test indicated no significant differences in mean shell heights ($P = 0.314$) among the three sites. Mean oyster density differences were also non-significant ($P = 0.637$) among the three sites, though small sample sizes at some sites (Table 1) resulted in very high variances around each mean.

Fig. 7. Oyster mean size and mean density (± 1 SE) by site and year (all substrates combined).

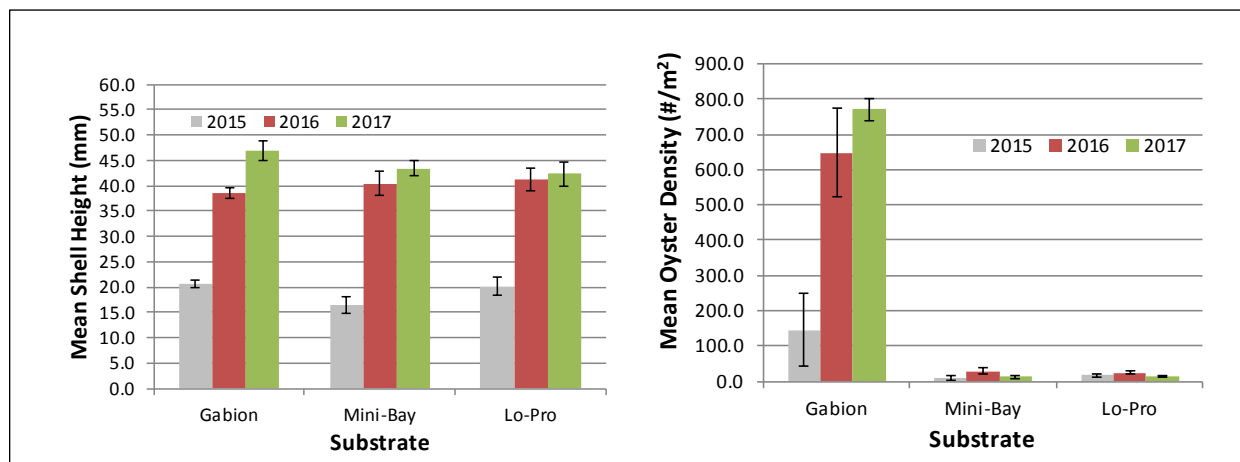
Assessment of oyster size by substrate (all sites combined) and year showed very similar mean sizes all three years on all three substrates, indicating the three substrates provide similar conditions for oyster recruitment and growth (Fig. 8). Focusing on the 2017 data, there were no significant differences in mean shell height among the three sites. In contrast, there were substantial differences among the three substrates with oysters occurring at much higher densities on the gabions. We emphasize, however, that the two substrate types (Reef Balls and gabions) differ substantially with respect to surface area potentially available for larval recruitment and subsequent reef development. Live oysters of a wide range of sizes were found on shell cultch material deep within each gabion, whereas only the surfaces of the Reef Balls were available as potential substrate. Thus, gabions provide a third dimension for reef development although the long-term survival of oysters deep within the gabions is unknown.

Fig. 8. Oyster size and density (± 1 SE) by substrate and year, combining the data from all three sites.

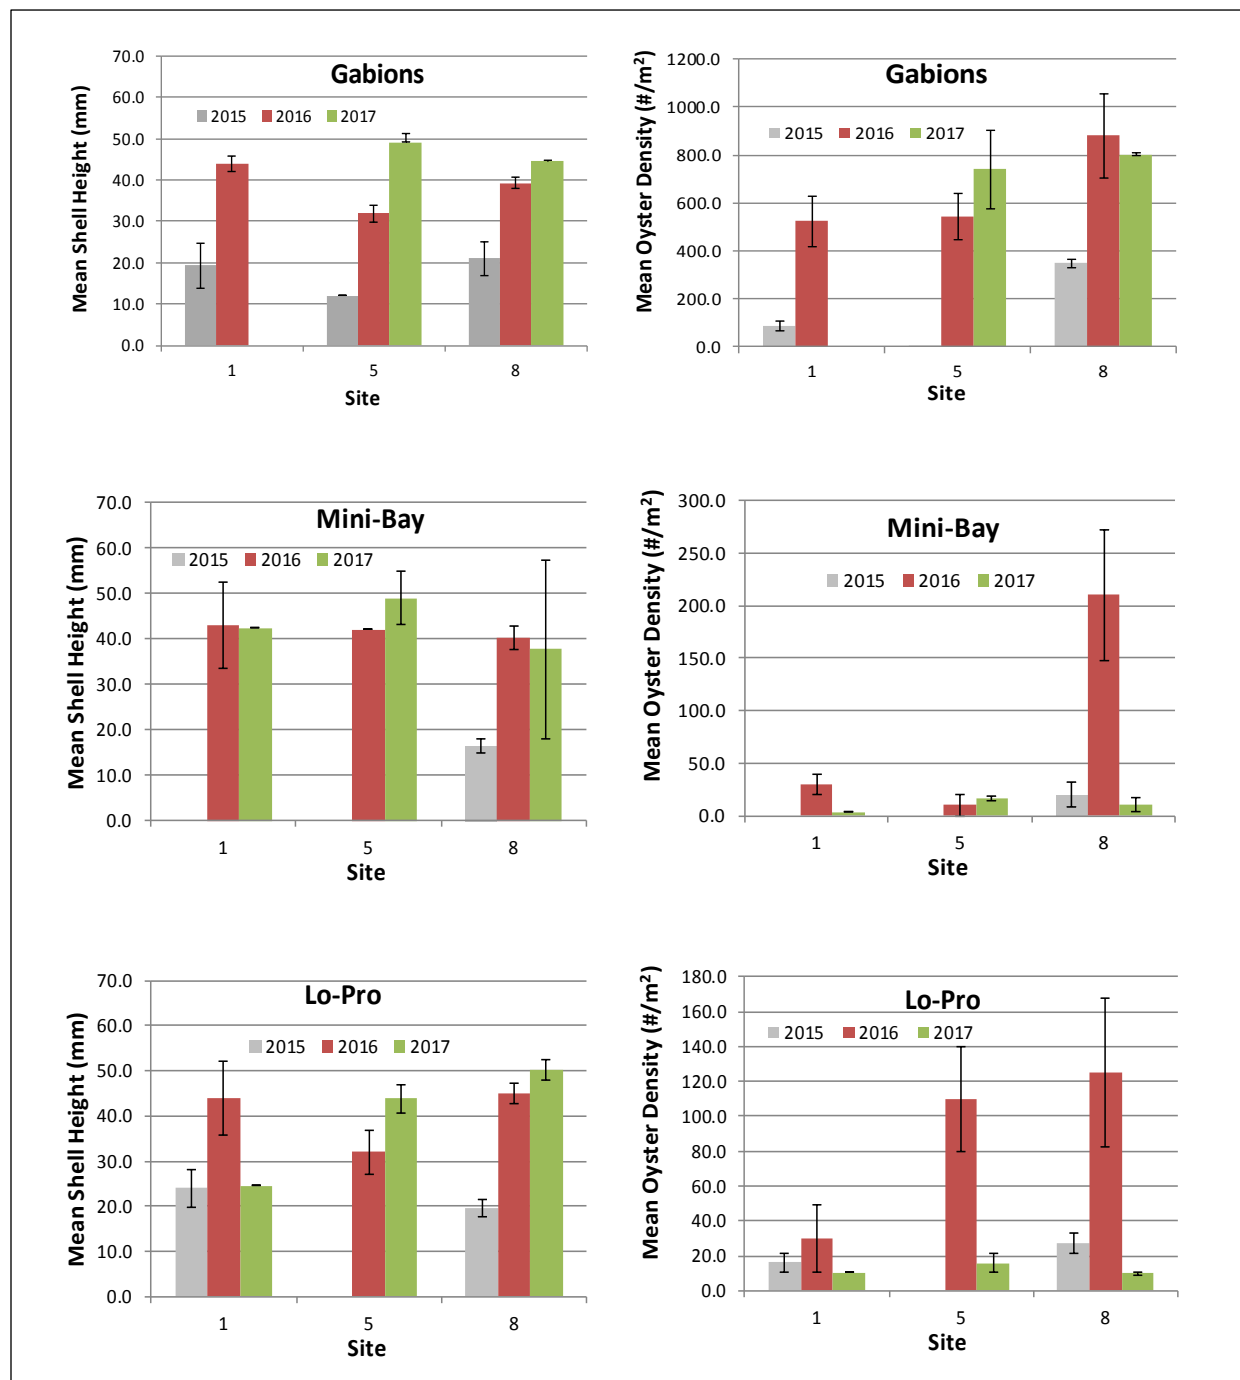
Oyster size and density data were also assessed by site, substrate type, and year in order to visually inspect for interaction effects among the variables (Fig. 9). Shell height consistently showed similar mean values by year for all three substrates and all three sites; the only exception being the Lo-Pros at Site 1 in 2017, and this was perhaps due to small sample size (Table 1). Although oyster densities varied widely by both substrate and site, there were consistent trends such as the gabions consistently showing highest values across all three sites.

Fig. 9. Oyster mean size and mean density (± 1 SE) by substrate type and site. Note different scales on oyster density charts.

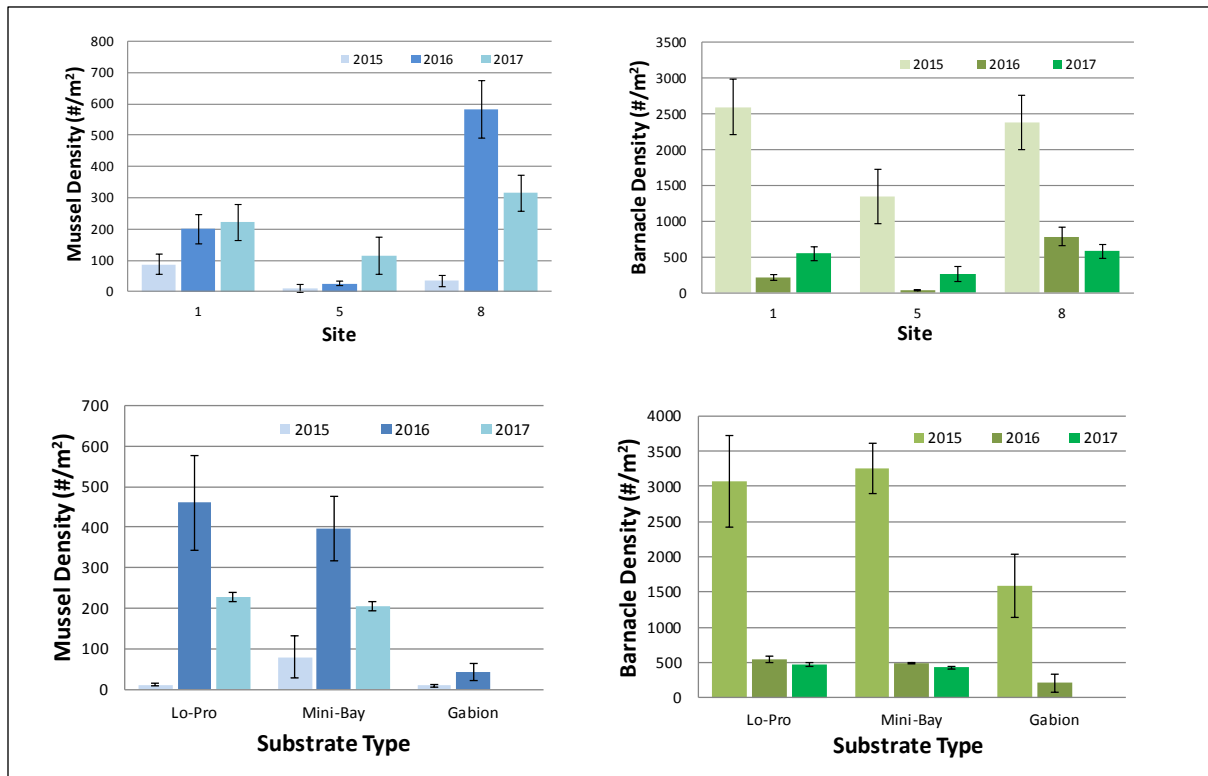
Fig. 10. Top row: mean (± 1 SE) mussel density by site with all three substrates combined. Lower row: barnacle density by substrate type with all three sites combined.

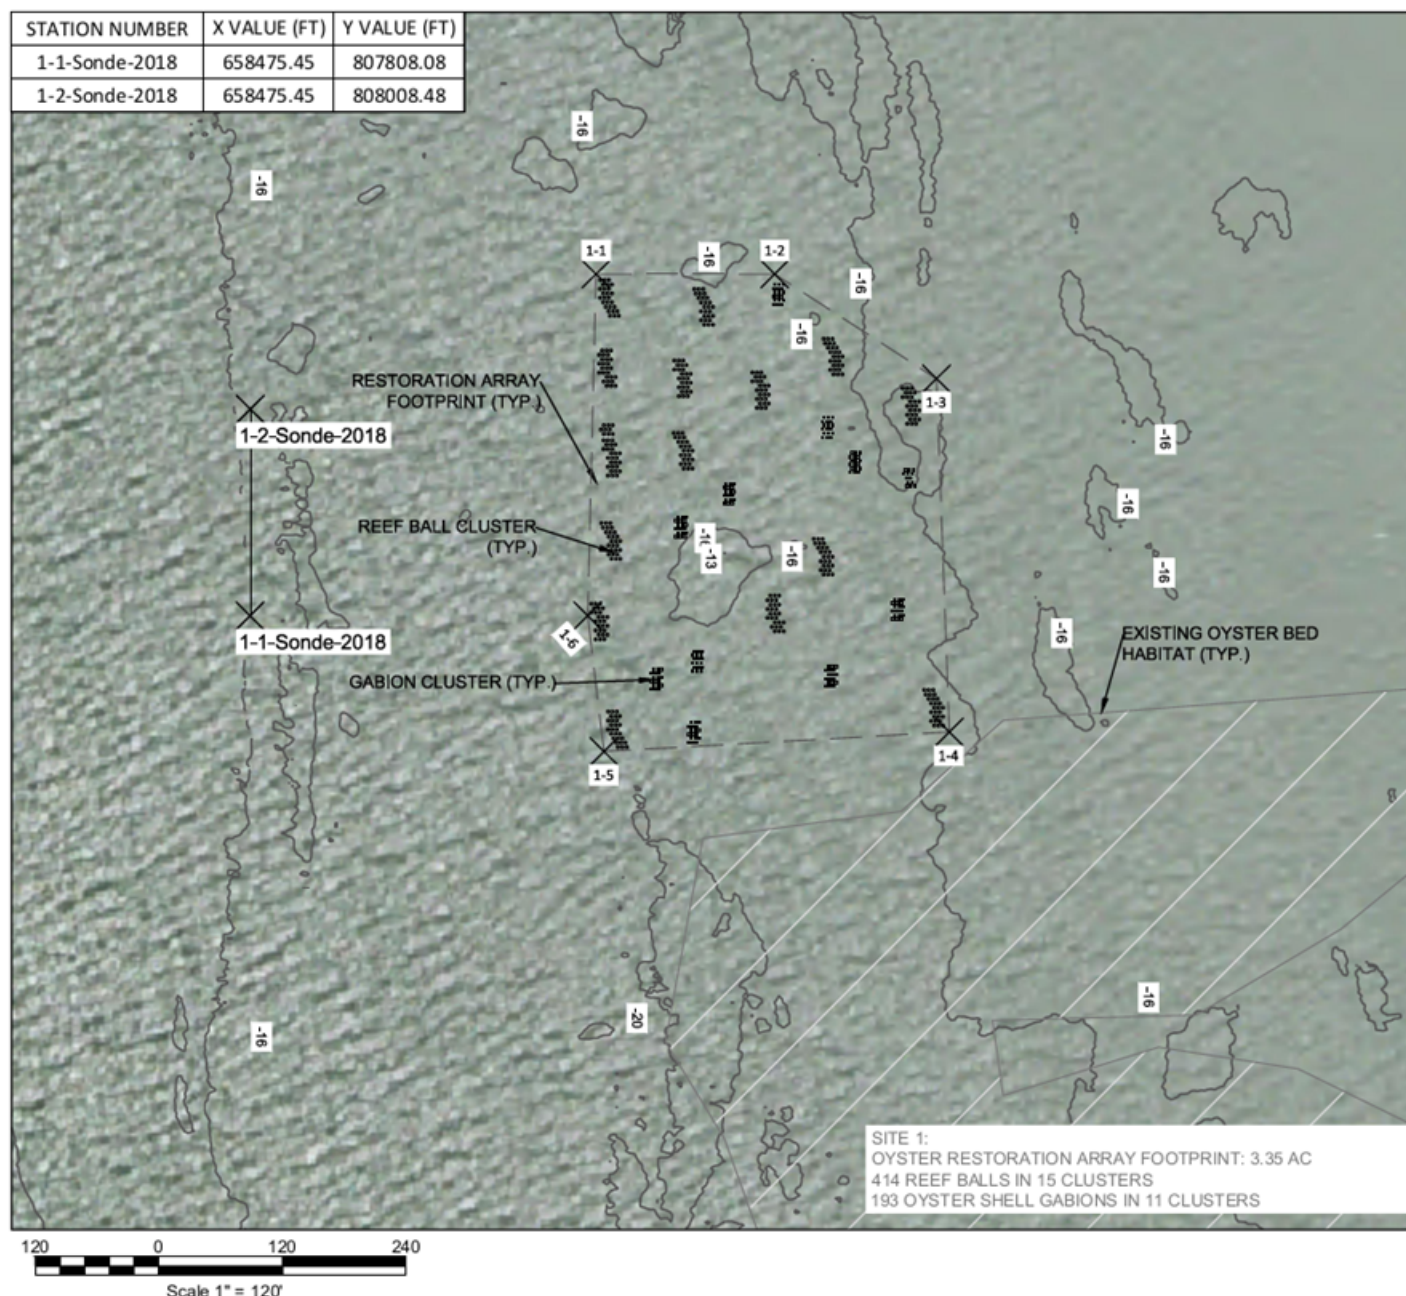
Figure 1. Locations for water quality sondes at Site 1 relative to the site boundaries and hypothetical placement of oyster substrates at the site.

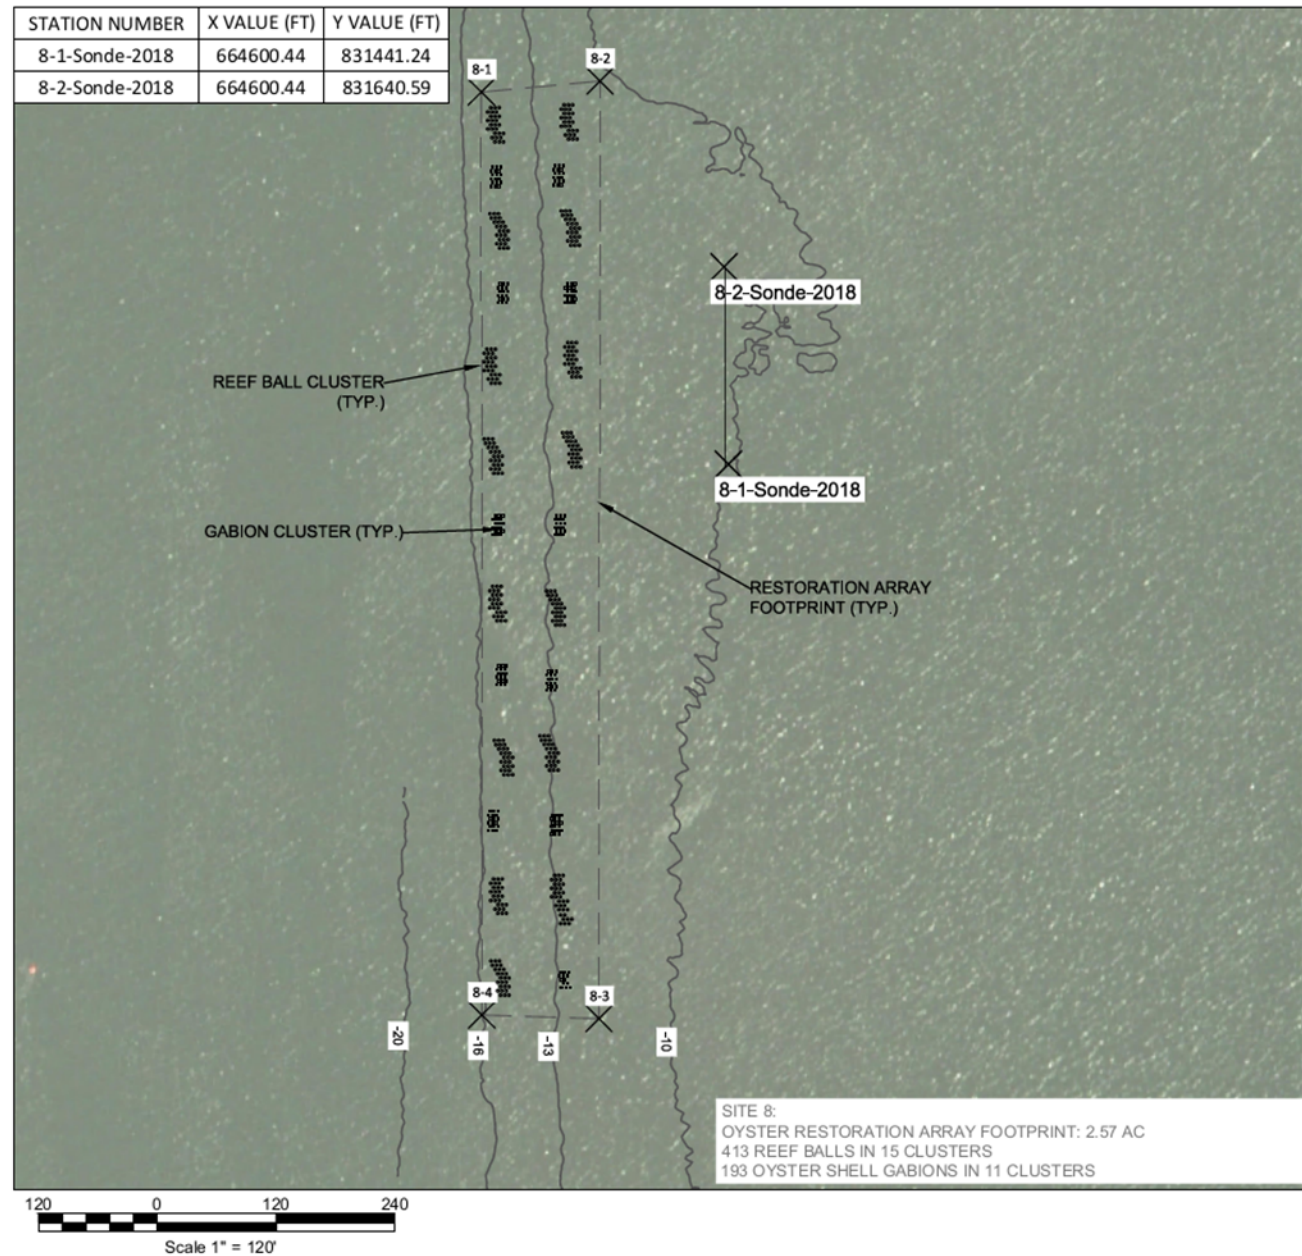
Figure 2. Locations for water quality sondes at Site 8 relative to the site boundaries and hypothetical placement of oyster substrates at the site.

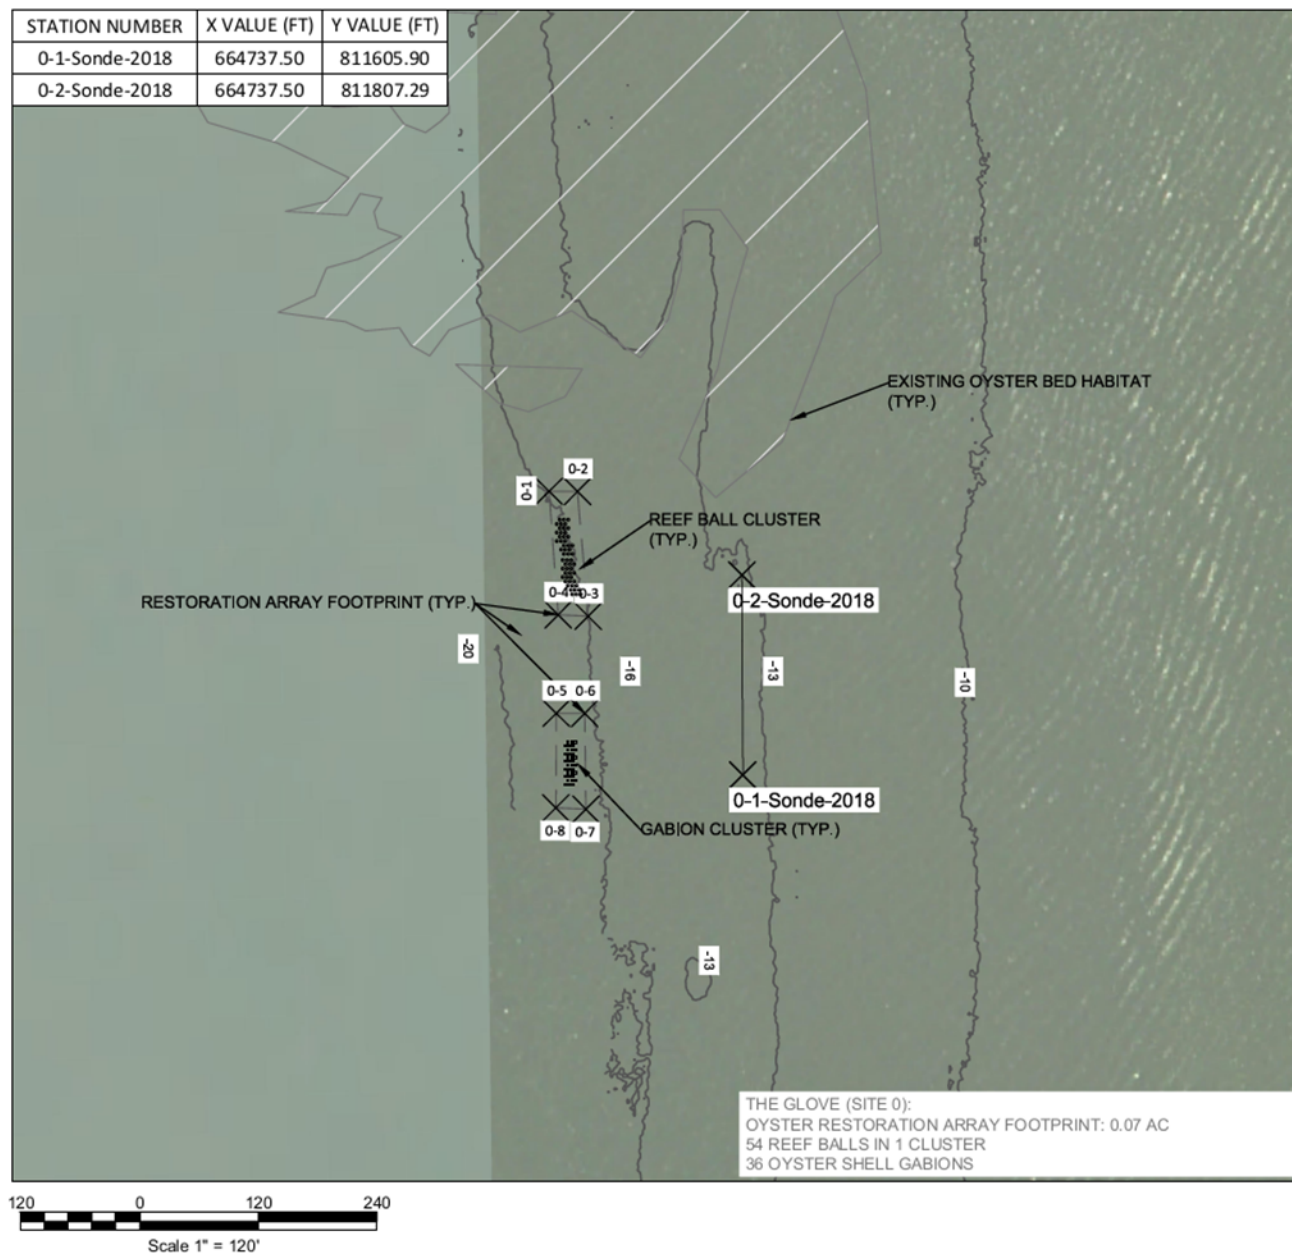
Figure 3. Locations for water quality sondes at Site 0 relative to the site boundaries and hypothetical placement of oyster substrates at the site.
