# Aquatic Connectivity Through Climate-Ready Infrastructure

## Deep Run Subwatershed

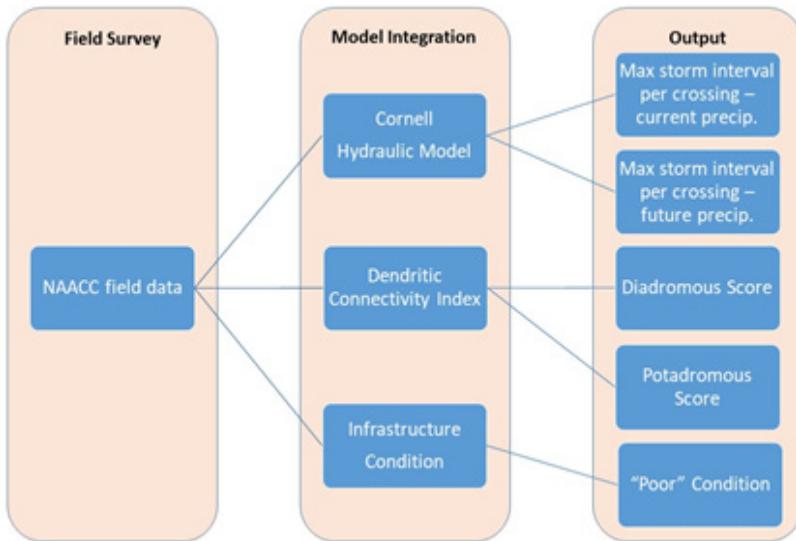
This diagram shows the evaluation process. First field measurements are taken to estimate how well fish can pass through the culverts and bridges. Then that data is plugged into the Cornell Model to estimate the size of the rain event the crossing can accommodate (as measured by the current projections of the 1 to 500-year storm events). Individual culverts were prioritized for passage for estuarine (diadromous) and freshwater (potadromous) species using a dendritic connectivity index. Finally, crossings were prioritized that were in poor condition (falling apart).

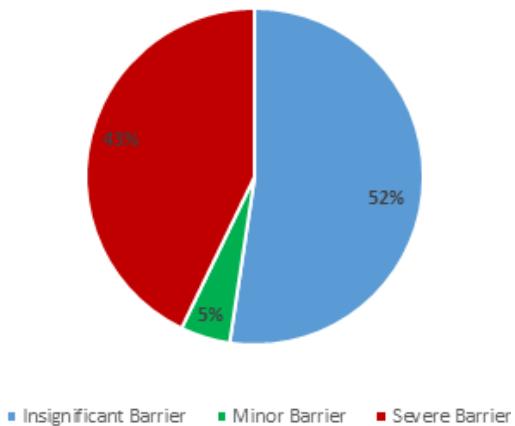
Aside from the dam (not included in the pie chart), the aquatic connectivity of this subwatershed is characterized by a section of buried stream (the severe barriers) and the remainder of the watershed does not hamper aquatic flow.

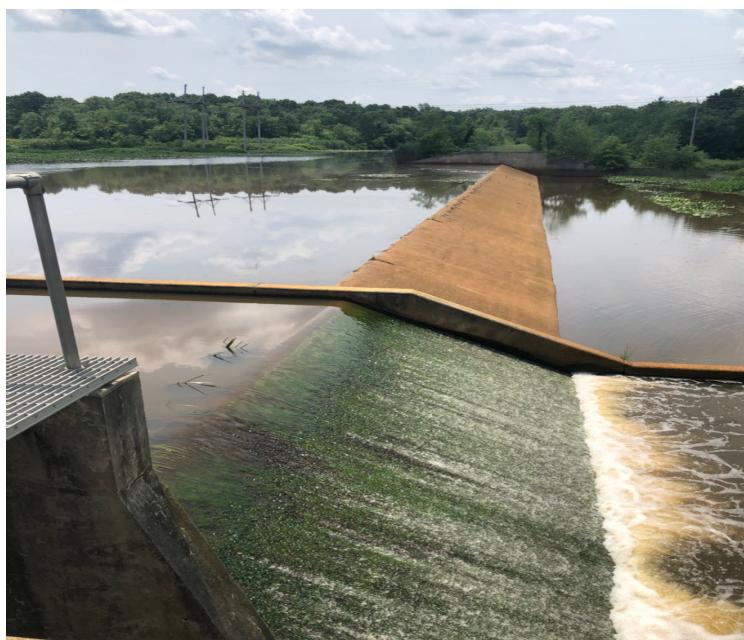
1. Deep Run Dam is the barrier mentioned in the summary on the utility property. This dam creates a wetland area in the stream with running spillway that lets the flow continue but blocks aquatic connectivity for likely all fish. Utility staff have caught fish upstream of the dam. This dam is unlikely to be removed so this may be a good project to establish a fish passage device.
