Aquatic Connectivity Through Climate-Ready Infrastructure

Matchaponix Subwatershed

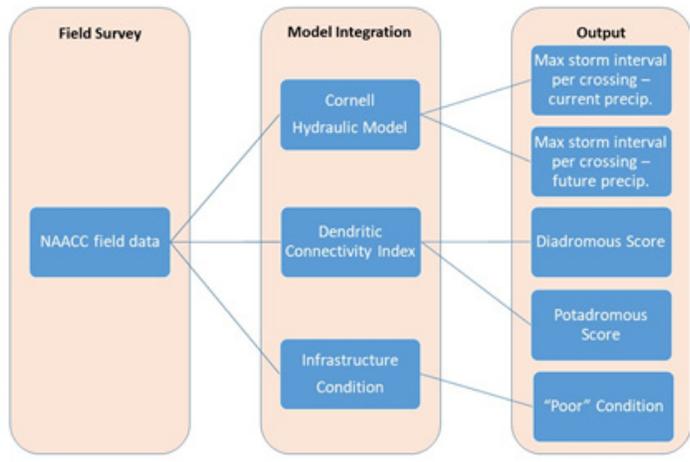
This diagram shows the evaluation process. First field measurements are taken to estimate how well fish can pass through the culverts and bridges. Then that data is plugged into the Cornell Model to estimate the size of the rain event the crossing can accommodate (as measured by the current projections of the 1 to 500-year storm events). Individual culverts were prioritized for passage for estuarine (diadromous) and freshwater (potadromous) species using a dendritic connectivity index. Finally, crossings were prioritized that were in poor condition (falling apart).

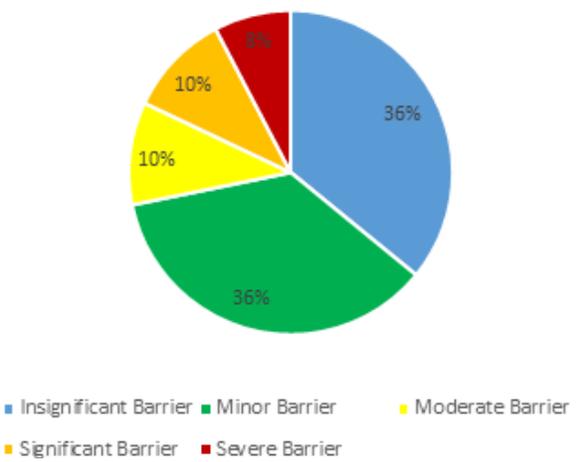
Aquatic Connectivity Results

The connectivity in the Matchaponix subwatershed is good overall. Most of the barriers to connectivity are on the upstream reaches of tributaries, which leaves the main stem and deeper sections of the streams passable. This is one of the only subwatersheds assessed in 2021 where the field team saw fish in the tributaries.

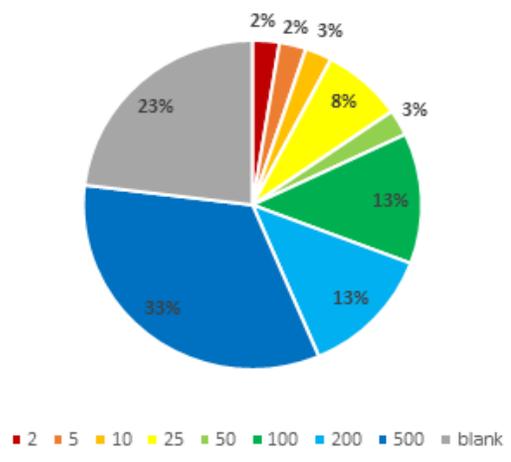
Capacity Model Results

This chart shows the maximum storm interval (e.g. 10-year storm event) that the structure can accommodate without flows overtopping the road or causing erosion. This represents current precipitation scenarios, which are expected to increase. Hydraulic Capacity in this subwatershed was better than other neighboring subwatersheds with less than a quarter considered undersized. The crossings listed as blank could not be modeled, primarily due to their large size, indicating likely no capacity issues.

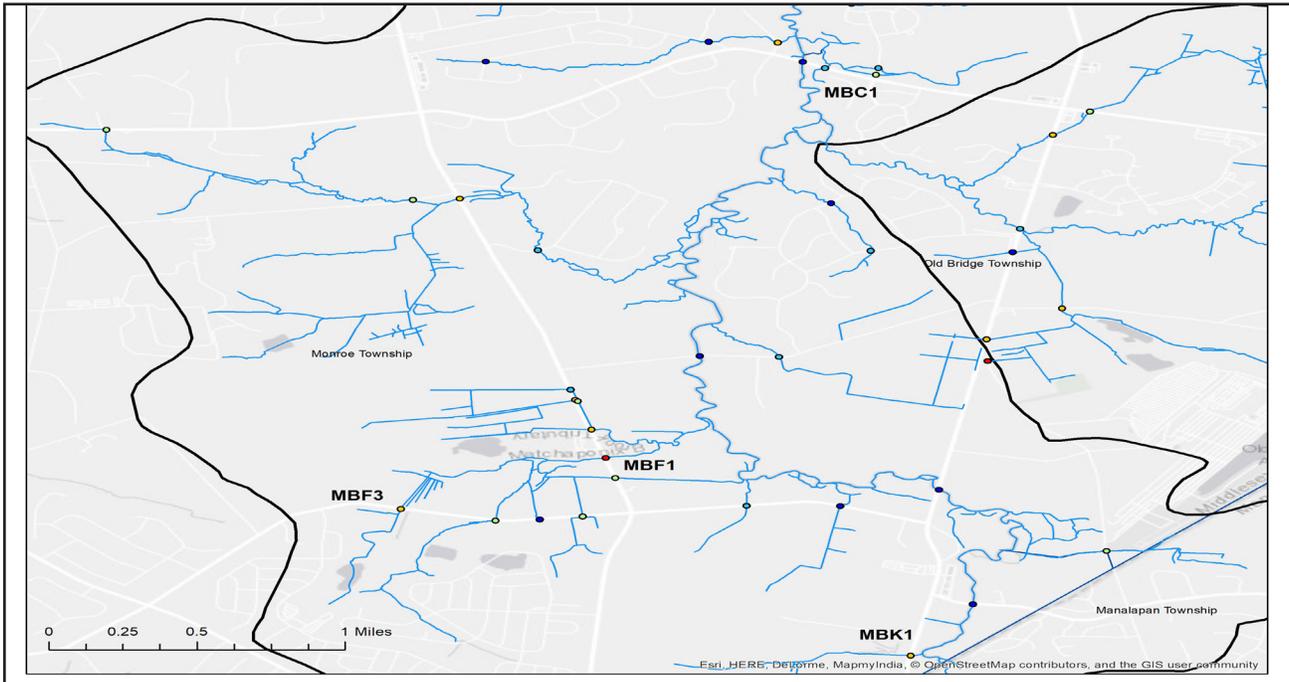
Priority Restoration Projects

MBC1 is located in Old Bridge Township, NJ. All others are in Monroe Township.

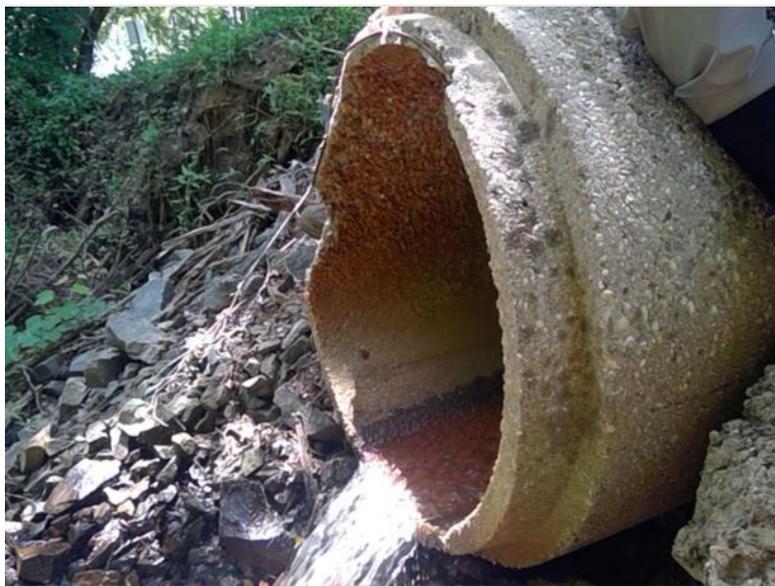
1. Matchaponix Brook Tributary F1 (MBF1) is the most important barrier for fish migration in the watershed. It is a small, undersized culvert that has a large outlet drop, completely blocking off connectivity and creating a large pool below the outlet. Some of the structure is also crumbling.

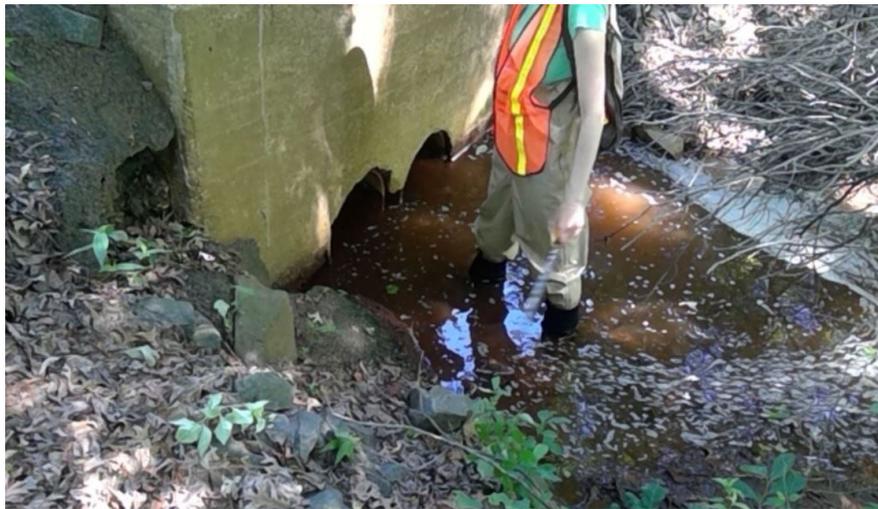
2. Matchaponix Brook Tributary K1(MBK1) is a small double culvert that is nearly completely filled with sediment and can only accommodate a 2-year storm event.

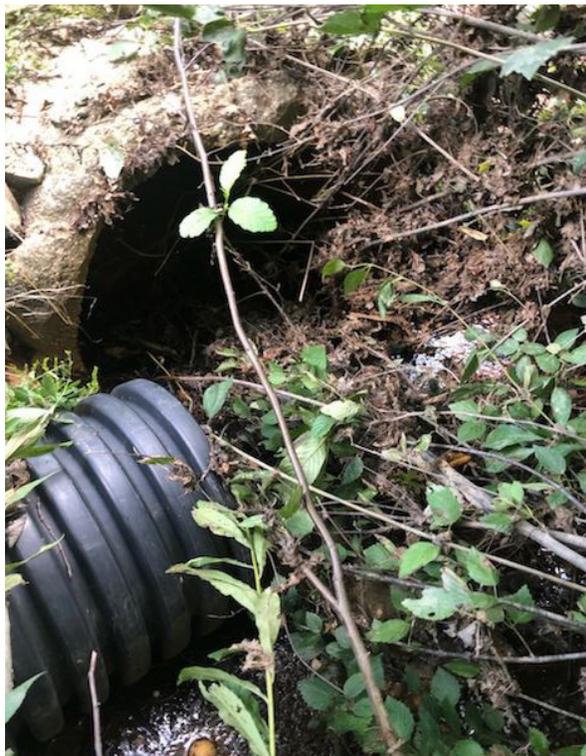
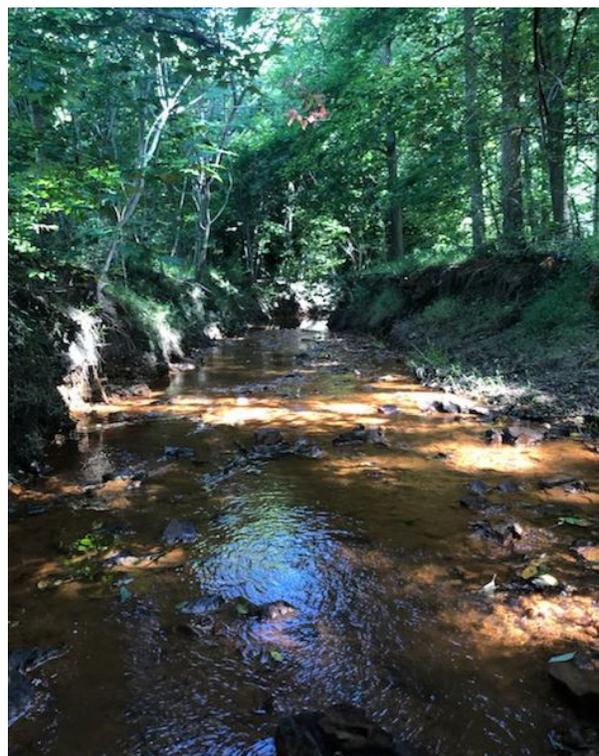
3. Matchaponix Brook Tributary F3 (MBF3) is a culvert that you do not need a model to tell you is undersized. At the time of assessment there were three separate water sources flowing into the same small and obstructed inlet: the MBF tributary upstream, a drainage ditch to the east and a plastic pipe entering from the west (photo left). The scour pool on the other side is huge, indicating very high velocities and it continues to be a large stream downstream (photo right).

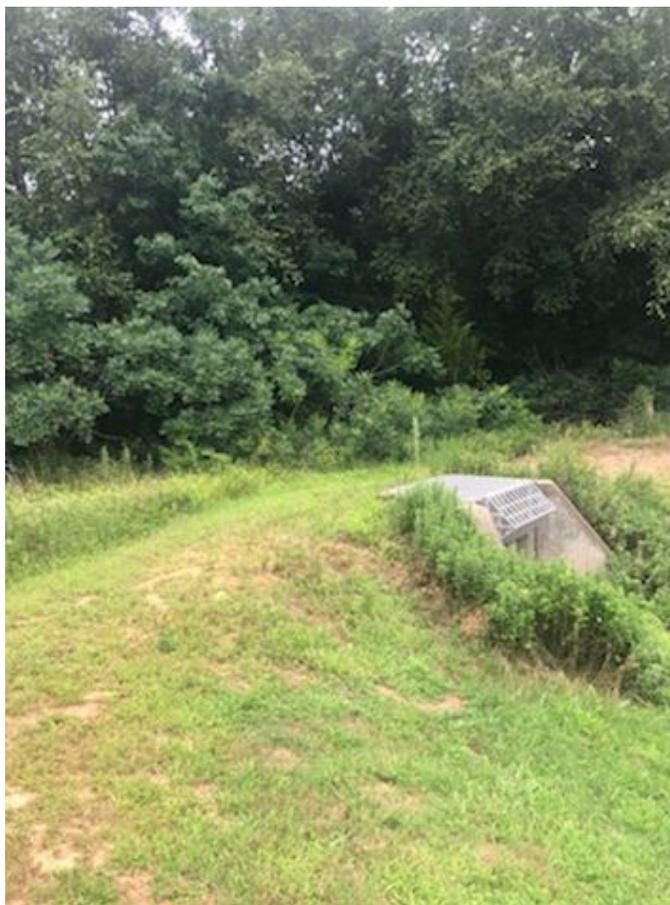
4. Matchaponix Brook Tributary C1 (MBC1) is a “ghost crossing,” a crossing that is not on a road but instead some other historical route. In this case, it is an earthen berm. The path on top does not appear to lead anywhere so the berm itself may be a flood control device. Though the stream was dry here during low-flow, the grate and drop at the inlet would completely block off all aquatic connectivity should waters rise.
