Aquatic Connectivity Through Climate-Ready Infrastructure

South River Subwatershed

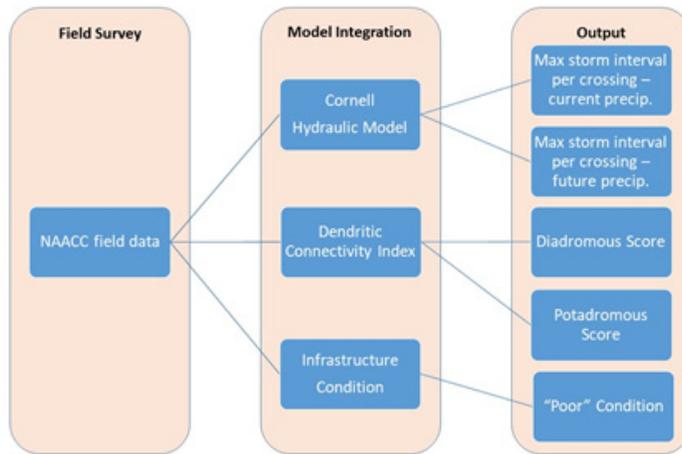
This diagram shows the evaluation process. First field measurements are taken to estimate how well fish can pass through the culverts and bridges. Then that data is plugged into the Cornell Model to estimate the size of the rain event the crossing can accommodate (as measured by the current projections of the 1 to 500-year storm events). Individual culverts were prioritized for passage for estuarine (diadromous) and freshwater (potadromous) species using a dendritic connectivity index. Finally, crossings were prioritized that were in poor condition (falling apart).

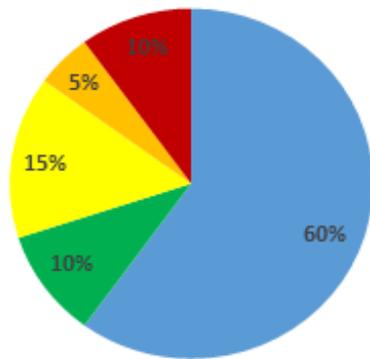
Aquatic Connectivity Results

■ Insignificant Barrier ■ Minor Barrier ■ Moderate Barrier
 ■ Significant Barrier ■ Severe Barrier

There are no barriers to fish passage on the mainstem of the South River in this subwatershed. Those that are moderate to severe barriers on the tributaries are largely so because they are so small in diameter that some fish species will avoid using them. Many of the crossings in this subwatershed are on railroads and there are two “ghost” crossings, structures that are no longer in use.

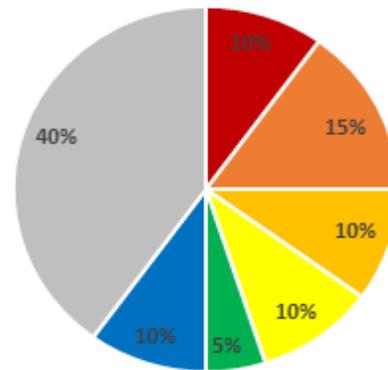
Capacity Model Results

■ 0 ■ 2 ■ 5 ■ 10 ■ 50 ■ 500 ■ blank

This chart shows the maximum storm interval (e.g. 10-year storm event) that the structure can accommodate without flows overtopping the road or causing erosion. This represents current precipitation scenarios, which are expected to increase. The blank crossings in this diagram are mostly crossings that could not be modeled as they are too large and therefore have ample capacity. Any maximum storm interval under 50 is generally considered undersized for a roadway.

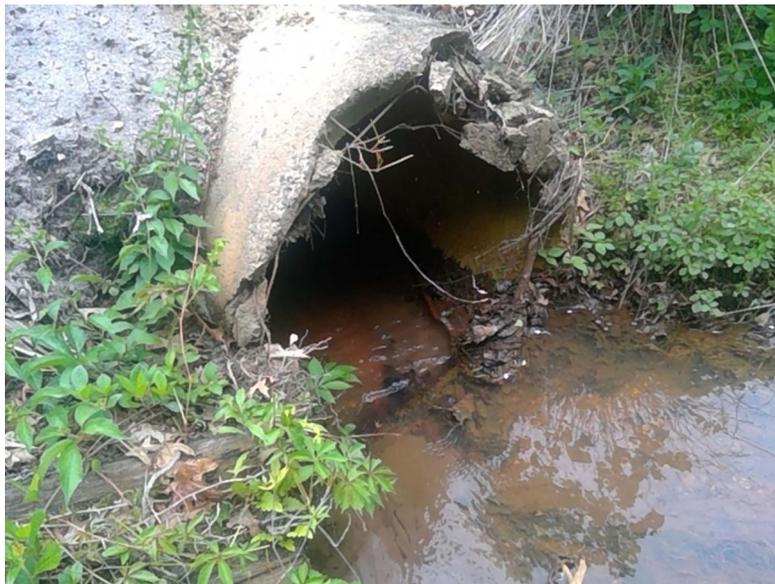
1. Pond Creek 3 and Pond Creek B1 (PC3 +PCB1) are two undersized railroad culverts that come from two different small tributaries into the same large scour pool. They are both in poor condition and allow for little to no fish passage due to their small diameter, length and subsequent high water velocity. There is also a historic crossing just downstream that no longer serves a purpose, although it does not hamper flow in the same way.

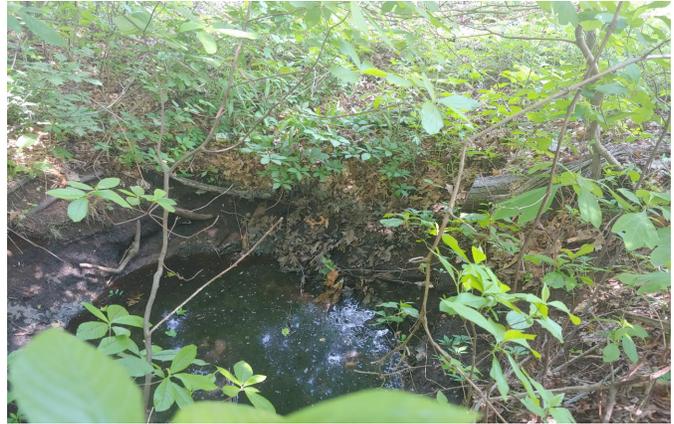
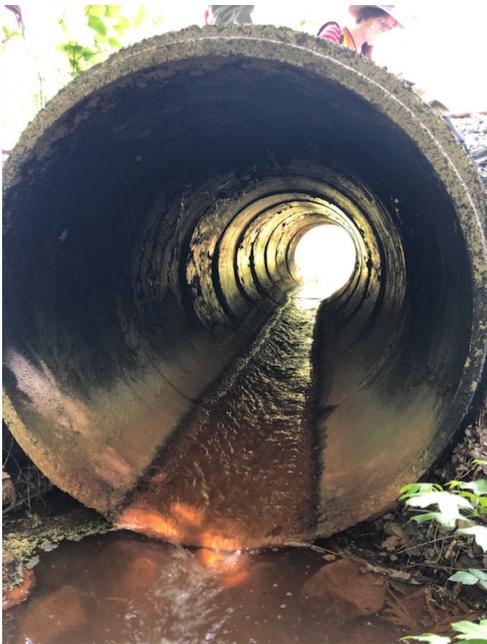
2. South River tributary A1 (SRA1) is a small culvert on an ephemeral tributary. It would not generally score very high, except at the time of assessment the inlet was completely buried in mud, debris and water, making it a high risk for roadway flooding. This crossing is in need of maintenance. The photo on the right shows the clogged outlet

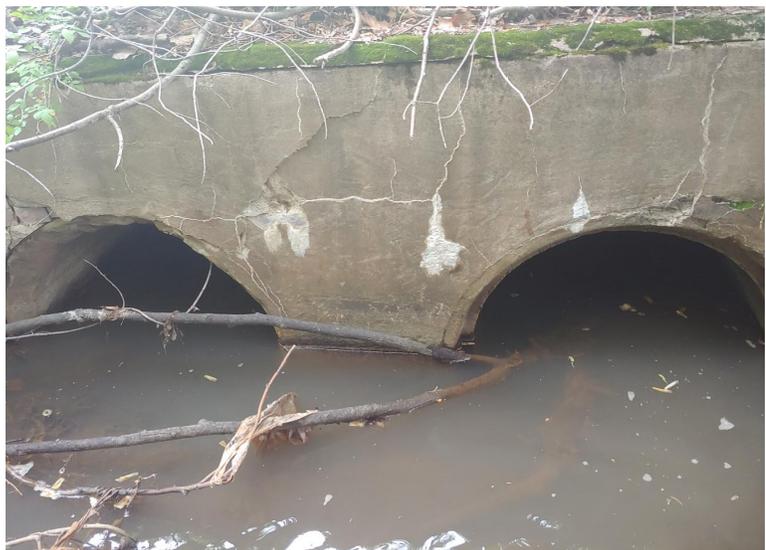
3. Selovers Brook 2 (SB2) is the most important barrier to remove for anadromous and potadromous fish in this subwatershed. The water at this railroad crossing is deep at both the inlet and outlet, and very shallow inside the culvert, indicating probable erosional issues. Improving this barrier would open up 1.2 miles of upstream aquatic habitat with full downstream access to the ocean.

4. Pond Creek A1 (PCA1) is a ghost crossing structure in the woods that appears to no longer serve a purpose. This crossing could be removed entirely to improve access for fish and reduce flood risk.
