Aquatic Connectivity Through Climate-Ready Infrastructure

Cheesequake Subwatershed

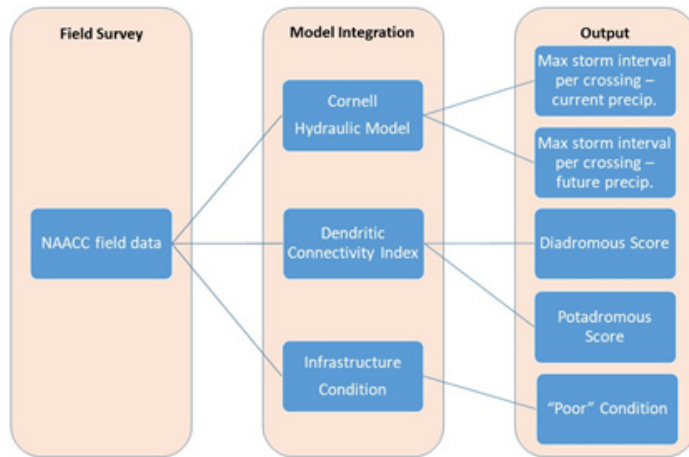
This diagram shows the evaluation process. First, field measurements are taken to estimate how well fish can pass through the culverts and bridges. Then that data is plugged into the Cornell model to estimate the size of the rain event the crossing can accommodate (as measured by the current projections of the 1-year to the 500-year storm events). Individual culverts were prioritized for passage for diadromous species (fish that migrate to the ocean for part of their life cycle), and potadromous species (fish that migrate to different parts of freshwater streams), using a dendritic connectivity index. Finally, crossings were prioritized that were in poor condition (falling apart).

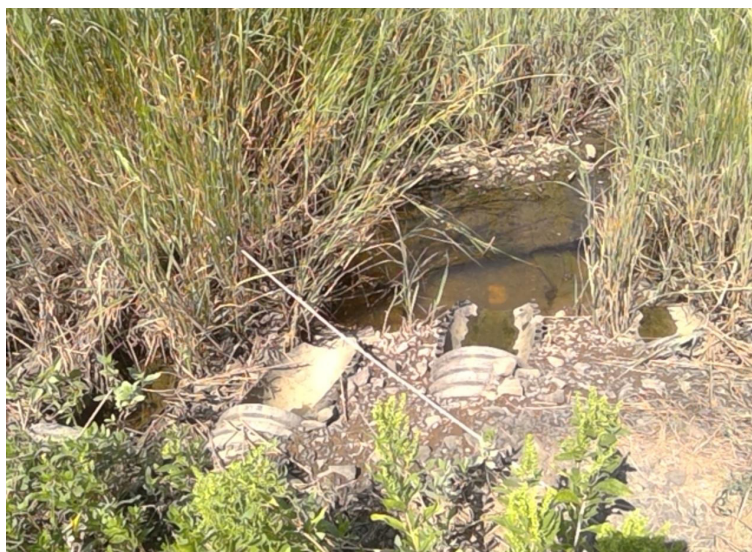
1. Long Neck A1 (@ Lakeshore Drive) is a series of five small plastic culverts in poor condition. The crossing can only accommodate a 2-year storm event and likely already experiences flooding. The crossing limits most aquatic passage and also appears to be a barrier to salt marsh migration further up the tributary. This crossing has also been identified as problematic by Monmouth County as part of their new Coastal Resilience Plan that outlines a conceptual restoration and resilience project at Long Neck/Whale Creek.

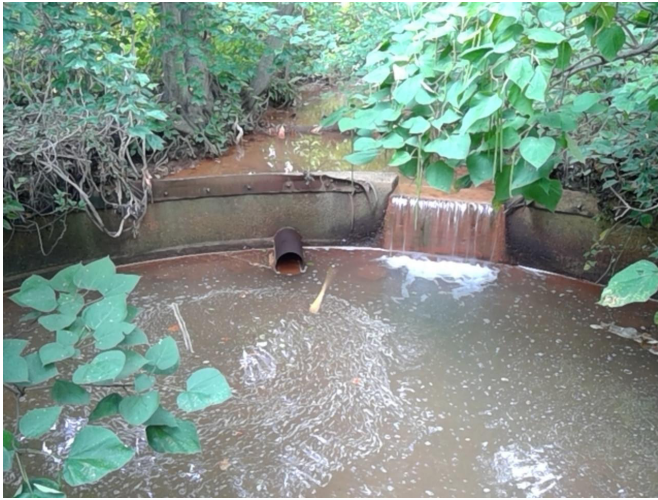
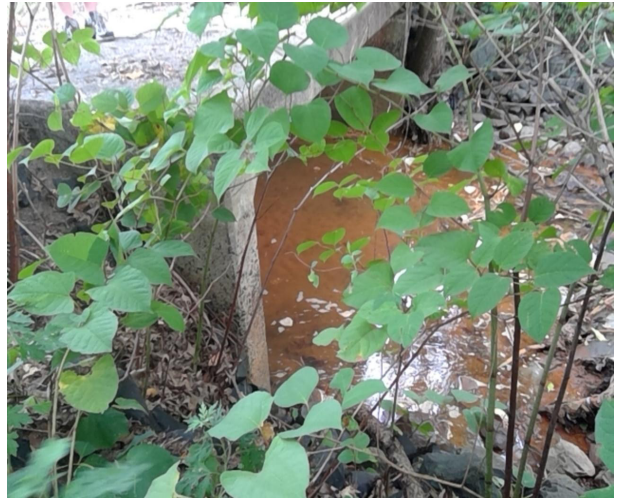
2. GD1 (@ Lorrain Ave) is the first barrier on a tributary that runs into Cheesequake Marsh from the west. This crossing is severely undersized and can only accommodate a 25-year storm event. There is also a drop and large pool at the inlet of this structure that likely ends most passage upstream at this first barrier for anadromous fish.

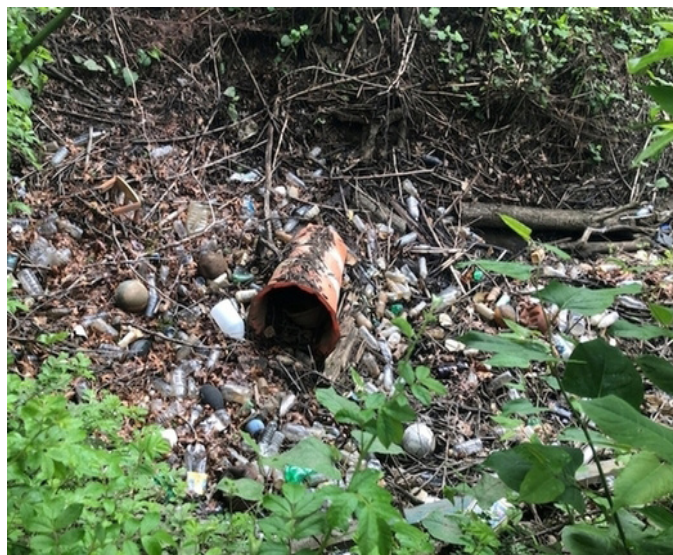
3. Long Neck 4 (@ railroad) was not able to be assessed because it is fully blocked by debris to the extent that we could not find the crossing structure. It is possible that this structure is in good condition and adequately sized but as of now, aquatic connectivity is non-existent and intensive maintenance is needed as well as an evaluation of the causes of such a severe blockage.

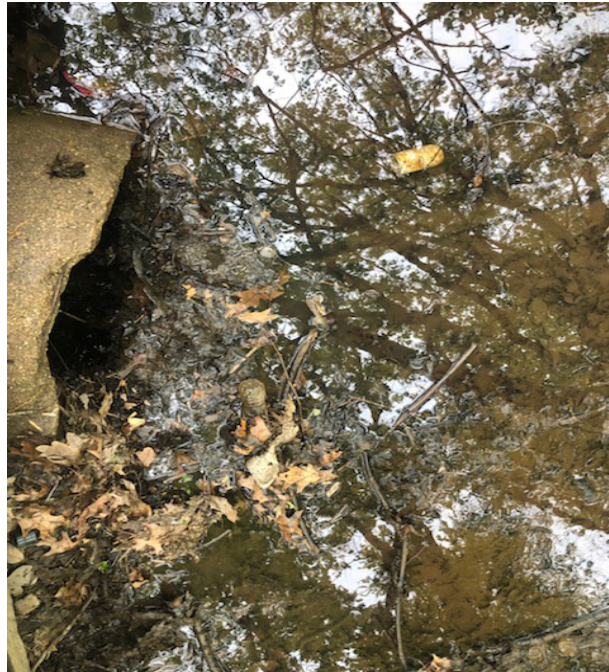
4. Long Neck 5 (@ trail behind Midland Park) is a small culvert under a paved path just upstream of the railroad crossing. This crossing is in poor condition and has been severely blocked by debris which has led to an inlet drop affecting aquatic connectivity. Maintenance is needed.
