Aquatic Connectivity Through Climate-Ready Infrastructure

Raritan Mouth and Center Subwatersheds

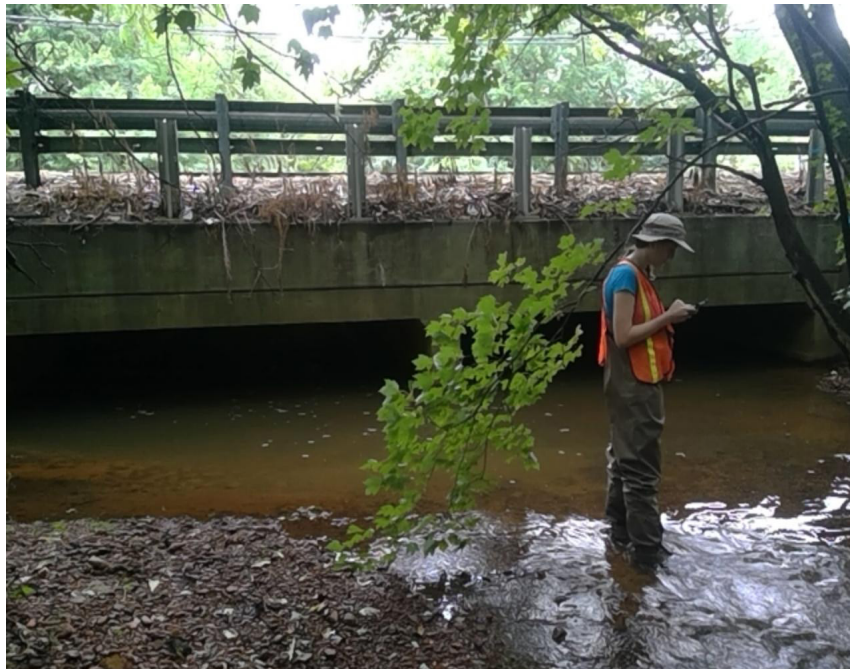
1. Burt Creek 1 (@ Main Street) is a severely undersized small bridge that is the most important barrier in these watersheds for diadromous fish migration.

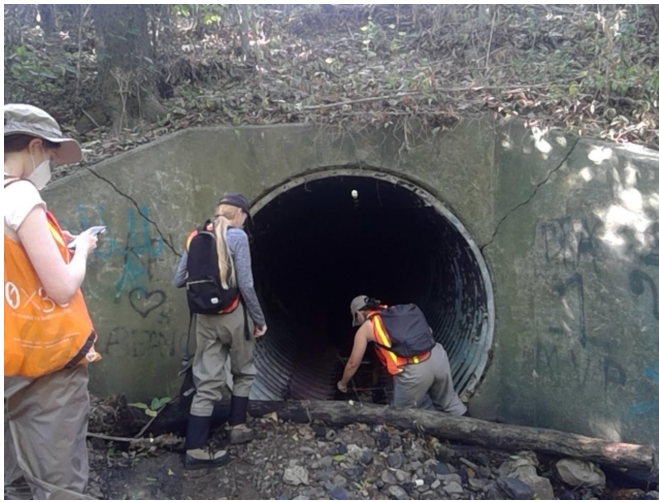
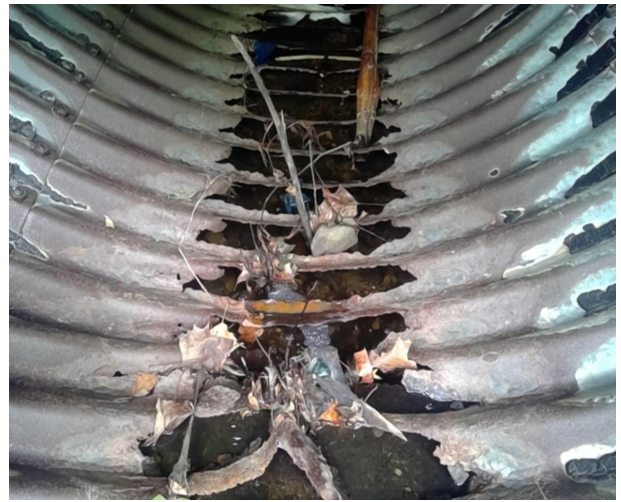
2. Crows Mills Tributary 5 (@ NJ 440) is a large metal and concrete culvert that goes under Hwy. 440, that is in very poor condition. The bottom of the culvert has completely rusted out in parts and the concrete headwalls are cracking. This bottom rusting out of the culvert is also problematic for fish passage.

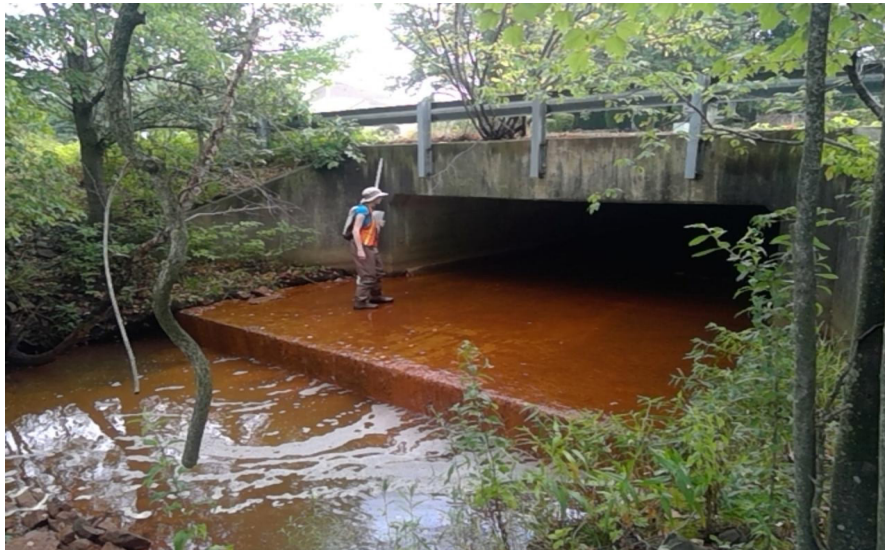
3. Burt Creek Tributary 3 (@ N. Ernston Rd.) is a bridge over a small tributary that has a large drop at the outlet that completely cuts off aquatic connectivity.
