*Tier 2 Oyster Sampling Report
Tappan Zee Bridge Hudson River Crossing Project
Westchester and Rockland Counties, New York*

Princeton Hydro, LLC

15 May 2015

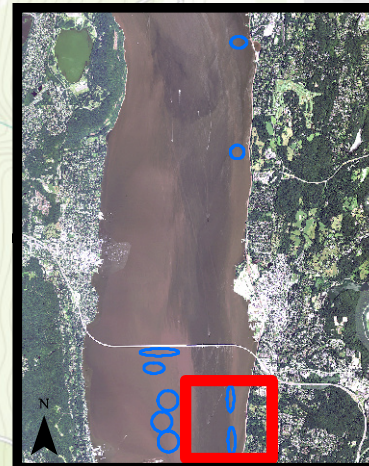
SAMPLING LOCATIONS -MAY 2015- ROUND 1

NOTES:
 1. Sample locations were randomly selected using ArcGIS.
 2. Topographic basemap obtained from ArcGIS Online Basemaps.
 3. 2011 NAD orthoimagery obtained from USDA GeoSpatial Data Gateway.

Lab ID	Map ID	Lat	Long
9-1-1	1	41.14068	-73.87338
9-1-2	2	41.13975	-73.87141
9-1-3	3	41.14176	-73.87205
9-1-4	4	41.14056	-73.87220
9-1-5	5	41.14130	-73.87009
9-1-6	6	41.13973	-73.87225
9-1-7	7	41.14137	-73.87060
9-1-8	8	41.14091	-73.87124
9-1-9	9	41.14186	-73.87112
9-1-10	10	41.14006	-73.86969
8-1-1	11	41.11508	-73.87233
8-1-2	12	41.11588	-73.87326
8-1-3	13	41.11476	-73.87090
8-1-4	14	41.11414	-73.87188
8-1-5	15	41.11495	-73.87375
8-1-6	16	41.11432	-73.87273
8-1-7	17	41.11568	-73.87242
8-1-8	18	41.11562	-73.87110
8-1-9	19	41.11380	-73.87239
8-1-10	20	41.11676	-73.87182

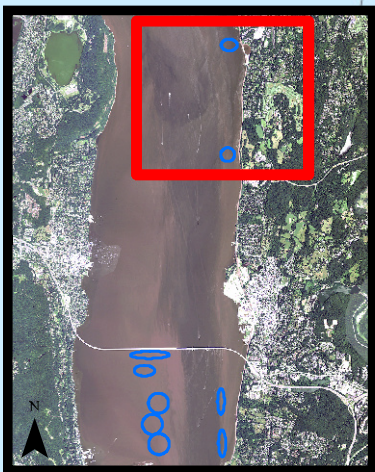
SAMPLING LOCATIONS -MAY 2015- ROUND 1

NOTES:
 1. Sample locations were randomly selected using ArcGIS.
 2. Topographic basemap obtained from ArcGIS Online Basemaps.
 3. 2011 NAD orthorectification obtained from USDA GeoSpatial Data Gateway.

Sample ID	Map ID	Lat	Long
5-2-1	31	41.05904	-73.89277
5-2-2	32	41.05583	-73.89343
5-2-3	33	41.05889	-73.89540
5-2-4	34	41.05549	-73.89616
5-2-5	35	41.05716	-73.89448
5-2-6	36	41.05748	-73.89569
5-2-7	37	41.05740	-73.89365
5-2-8	38	41.05825	-73.89445
5-2-9	39	41.05607	-73.89233
5-2-10	40	41.05794	-73.89193
5-2-11	41	41.05564	-73.89237
5-2-12	42	41.05676	-73.89395
5-2-13	43	41.05612	-73.89588
5-2-14	44	41.05530	-73.89446
5-2-15	45	41.05719	-73.89127
3-2-1	46	41.05206	-73.89666
3-2-2	47	41.05308	-73.89379
3-2-3	48	41.05381	-73.89557
3-2-4	49	41.05128	-73.89359
3-2-5	50	41.05107	-73.89725
3-2-6	51	41.05053	-73.89441
3-2-7	52	41.05352	-73.89669
3-2-8	53	41.05435	-73.89721
3-2-9	54	41.05037	-73.89621
3-2-10	55	41.05252	-73.89809
3-2-11	56	41.05262	-73.89316
3-2-12	57	41.05104	-73.89861
3-2-13	58	41.05138	-73.89622
3-2-14	59	41.05193	-73.89402
3-2-15	60	41.05267	-73.89511
1-2-1	61	41.04551	-73.89409
1-2-2	62	41.04601	-73.89641

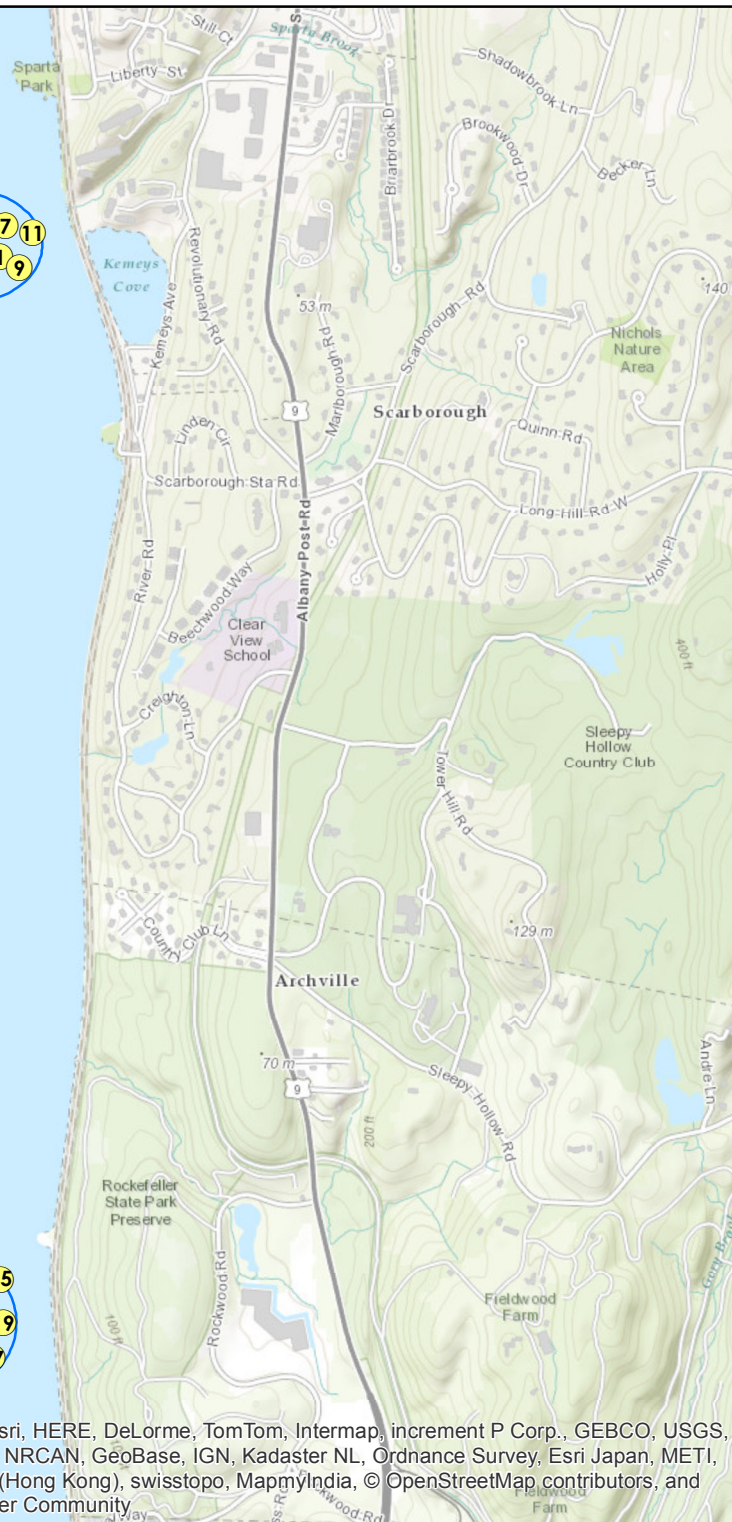
SAMPLING LOCATIONS -MAY 2015- ROUND 2

- NOTES:
1. Sample locations were randomly selected using ArcGIS.
 2. Topographic basemap obtained from ArcGIS Online Basemaps.
 3. 2011 NAIP orthoimagery obtained from USDA GeoSpatial Data Gateway.
