## Aquatic Connectivity Through Climate-Ready Infrastructure

### Passaic Subwatershed Fact Sheet

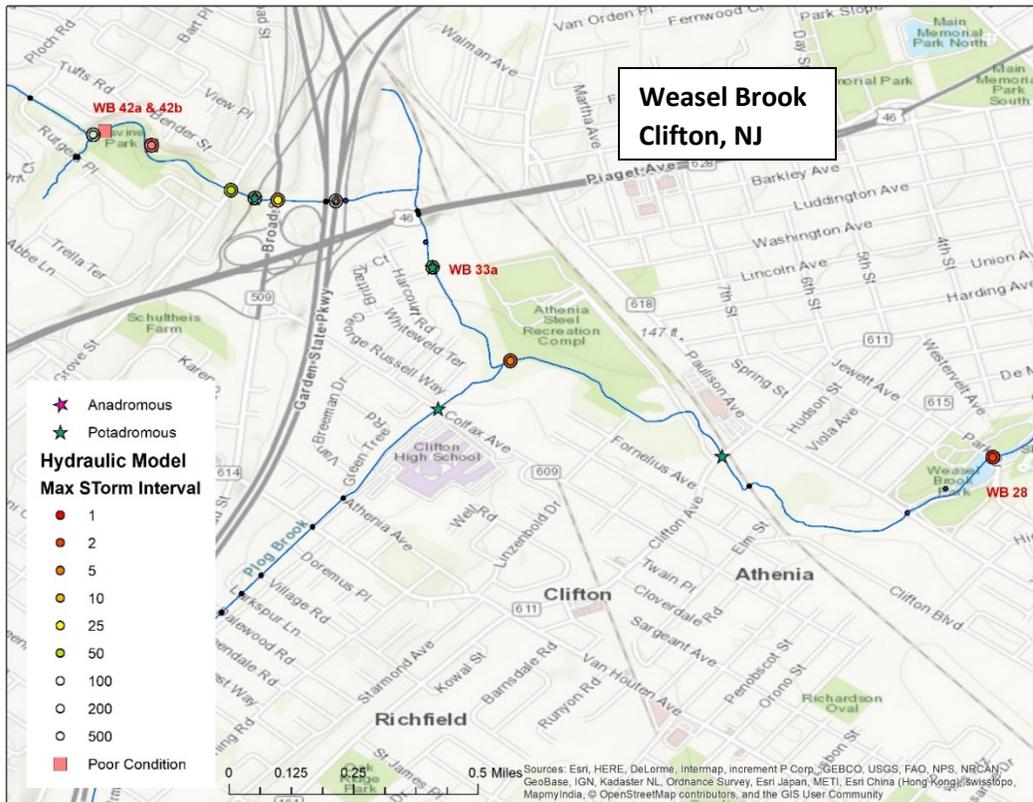
Stars indicate a key barrier for diadromous or potadromous fish movement. The colored circles are the maximum storm interval that a crossing can accommodate without flows causing erosion or road overtopping. Pink squares or crossings with damaged infrastructure.
