Aquatic Connectivity Through Climate-Ready Infrastructure

Barclay Brook Subwatershed

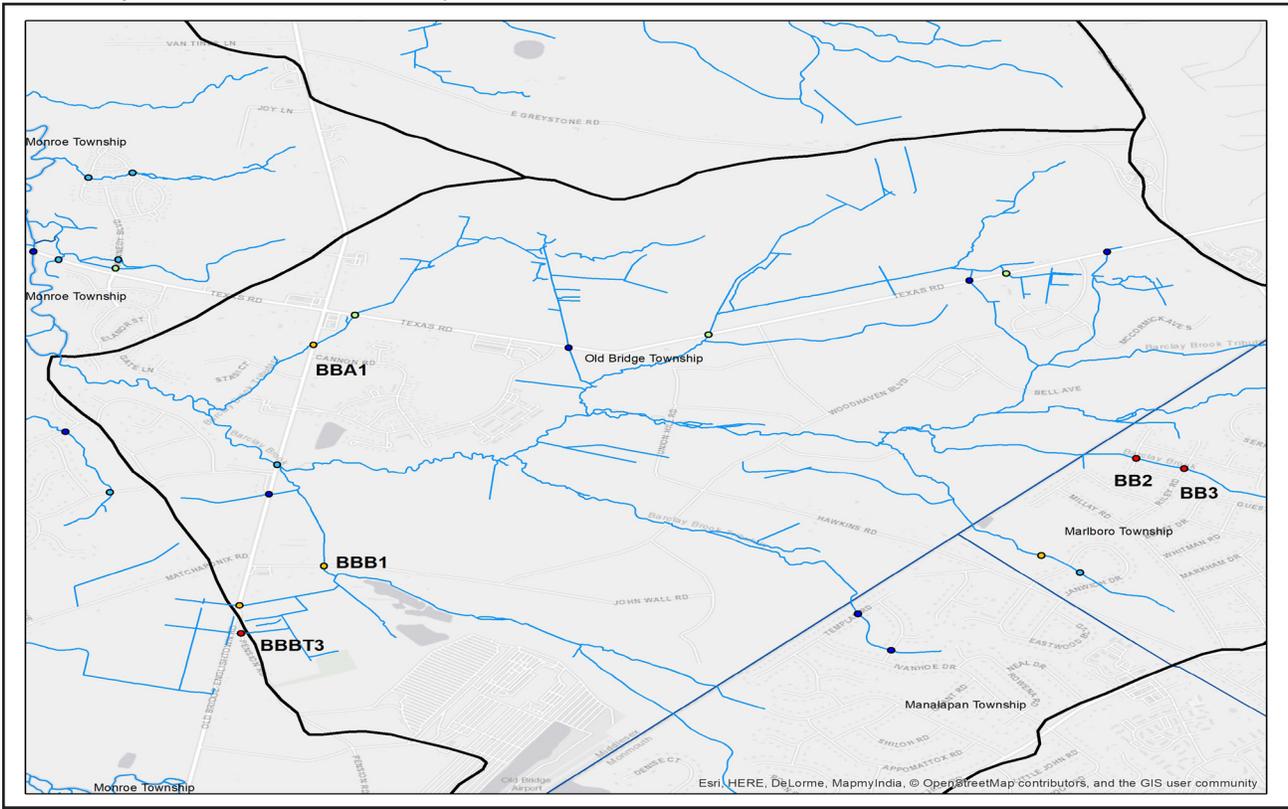
Priority Restoration Projects

BB2 and BB3 are located in Marlboro Township, NJ. All others are located in Old Bridge Township.
