Aquatic Connectivity Through Climate-Ready Infrastructure

Iresick Brook Subwatershed

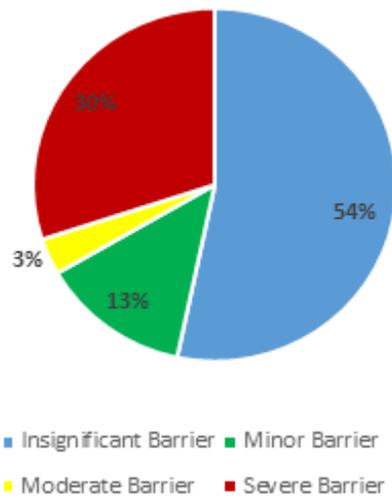
Aquatic Connectivity Results

The aquatic connectivity of this subwatershed is largely fine except for a few sections of buried stream or extra-long culverts (the severe barriers) as the tributaries reach the downstream section of the watershed.

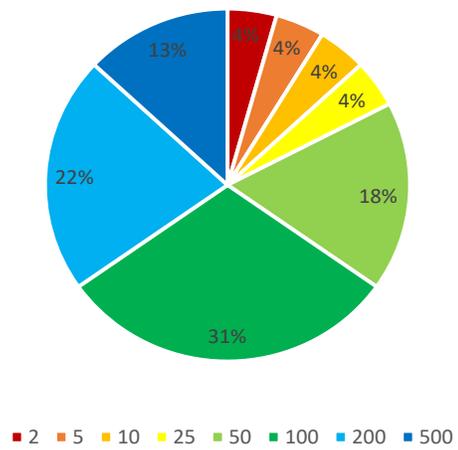
Capacity Model Results

This graph shows the maximum storm event a crossing can accommodate under current precipitation scenarios. Hydraulic Capacity in this subwatershed was variable. While most of the crossing structures were small culverts, the streams also tended to be small. However, this may become more of an issue with increased precipitation with climate change. Over half of the culverts modeled drop down to the next lower maximum capacity under a 15% increase in precipitation. Capacity under 50 is usually considered undersized for roadways.
