Aquatic Connectivity Through Climate-Ready Infrastructure

Mill Brook Subwatershed

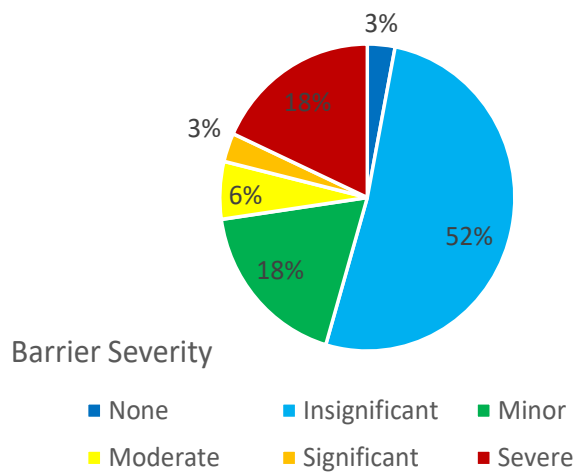
Aquatic Connectivity Results

Aquatic connectivity in this watershed is good overall with most of the problematic barriers occurring in the upstream reaches of the watershed. This may allow for diadromous fish migration, as evidenced by the presence of mature eels in this stream. There are still a good portion of the crossings with severe barriers, however, many of which are good candidates for restoration. Removing those barriers would enhance the habitat value for the wildlife already utilizing it.

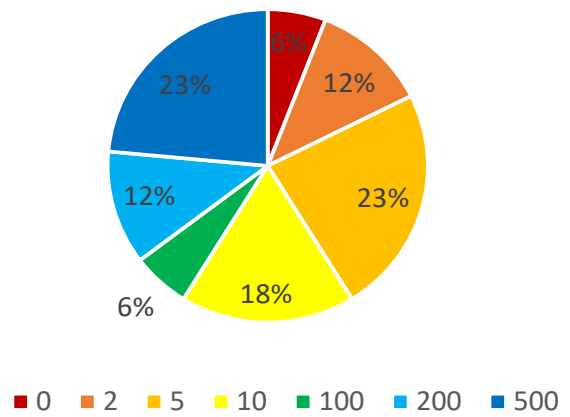
Capacity Model Results

This chart shows the maximum storm interval (e.g. 10-year storm event) that the structures can accommodate without flows overtopping the road or causing erosion. The model used current precipitation scenarios, which are expected to increase. Roughly half of the crossings in this subwatershed were not able to be modeled because of wide widths (>25 ft are not included in the model) or other issues. The ones with wide widths likely do not have capacity issues. However, of the crossings that were able to be modeled, more than half of them are severely undersized, shown in the yellow to red in the graph above.
